34-087-20415 Pinkerman # 2 ERP CN

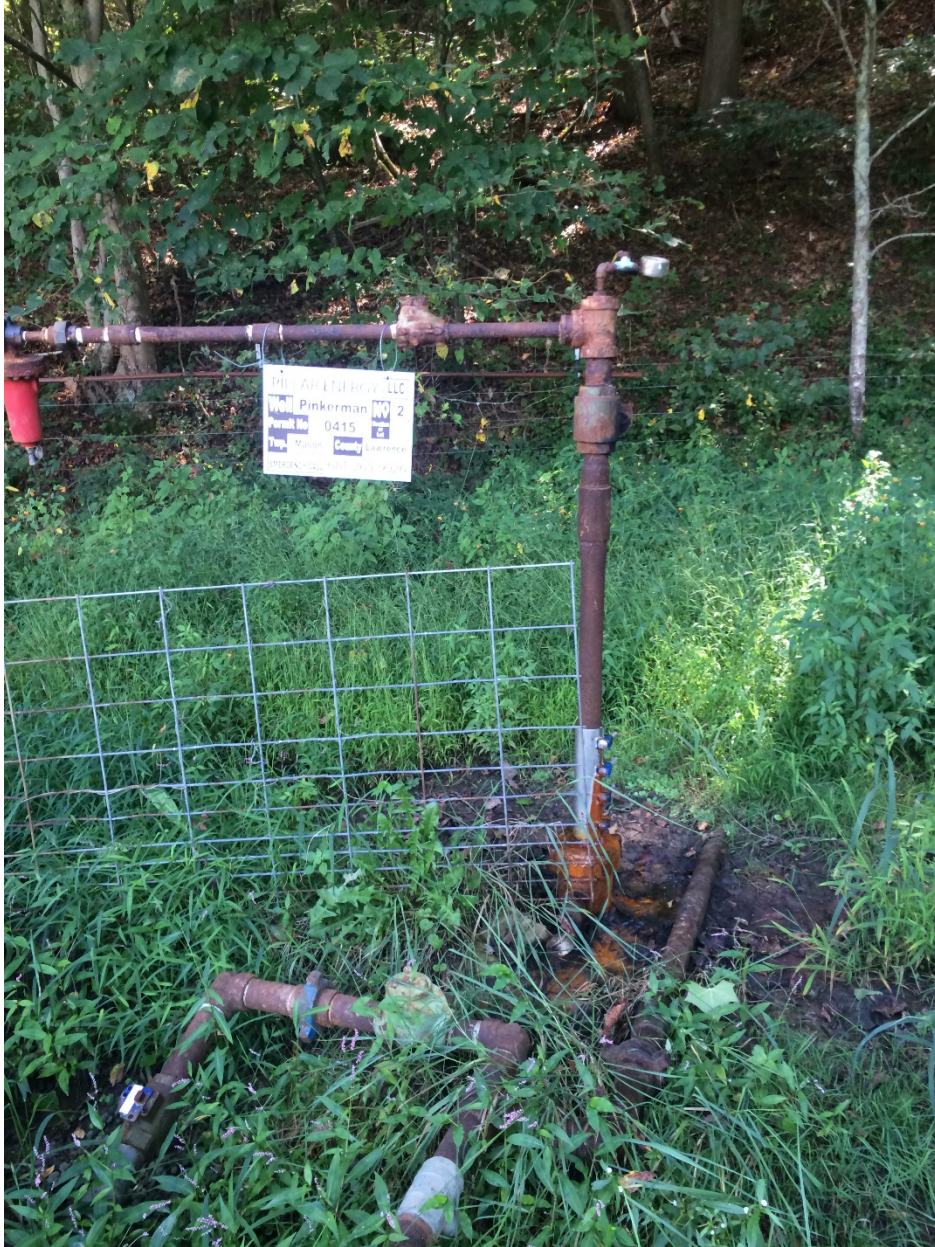
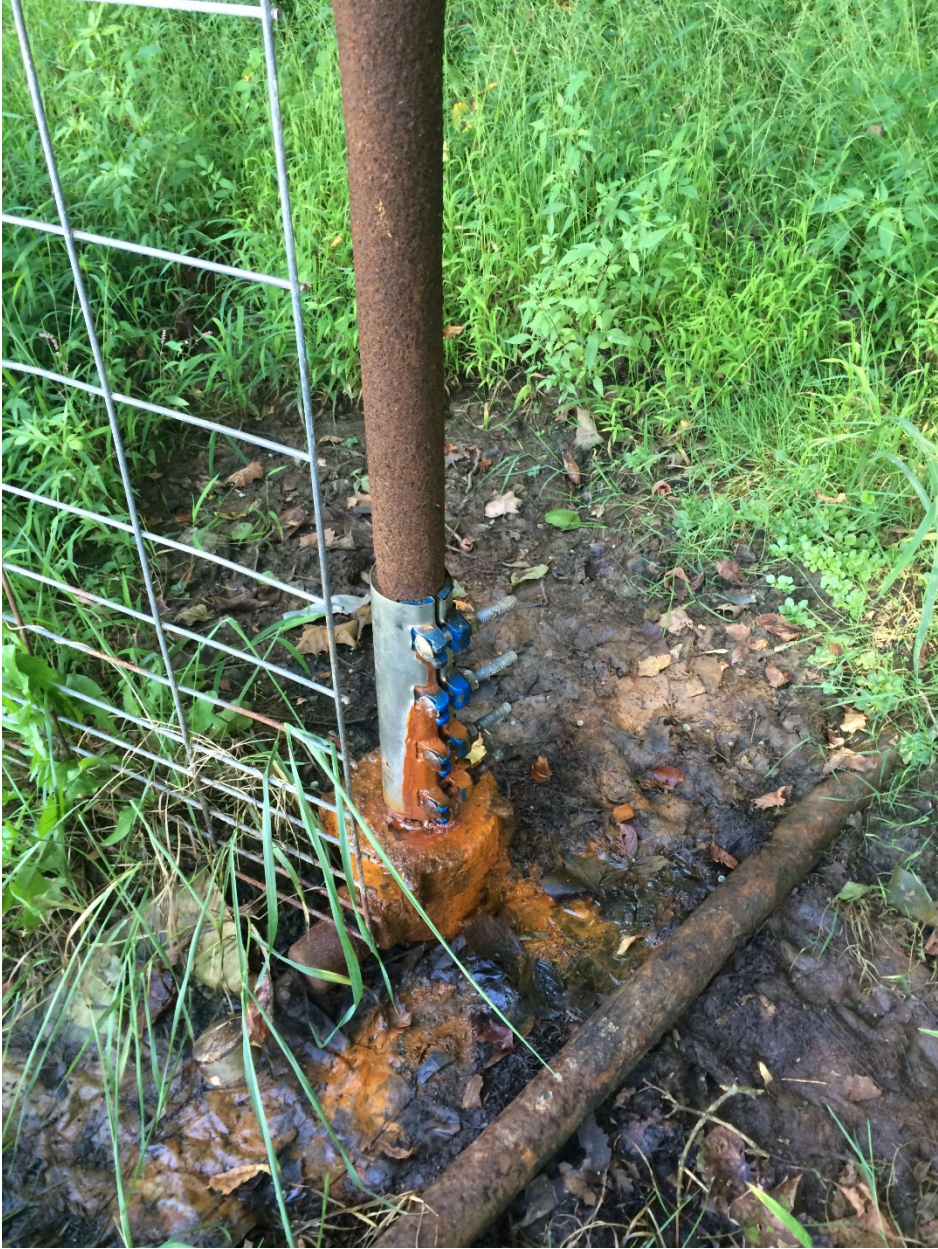
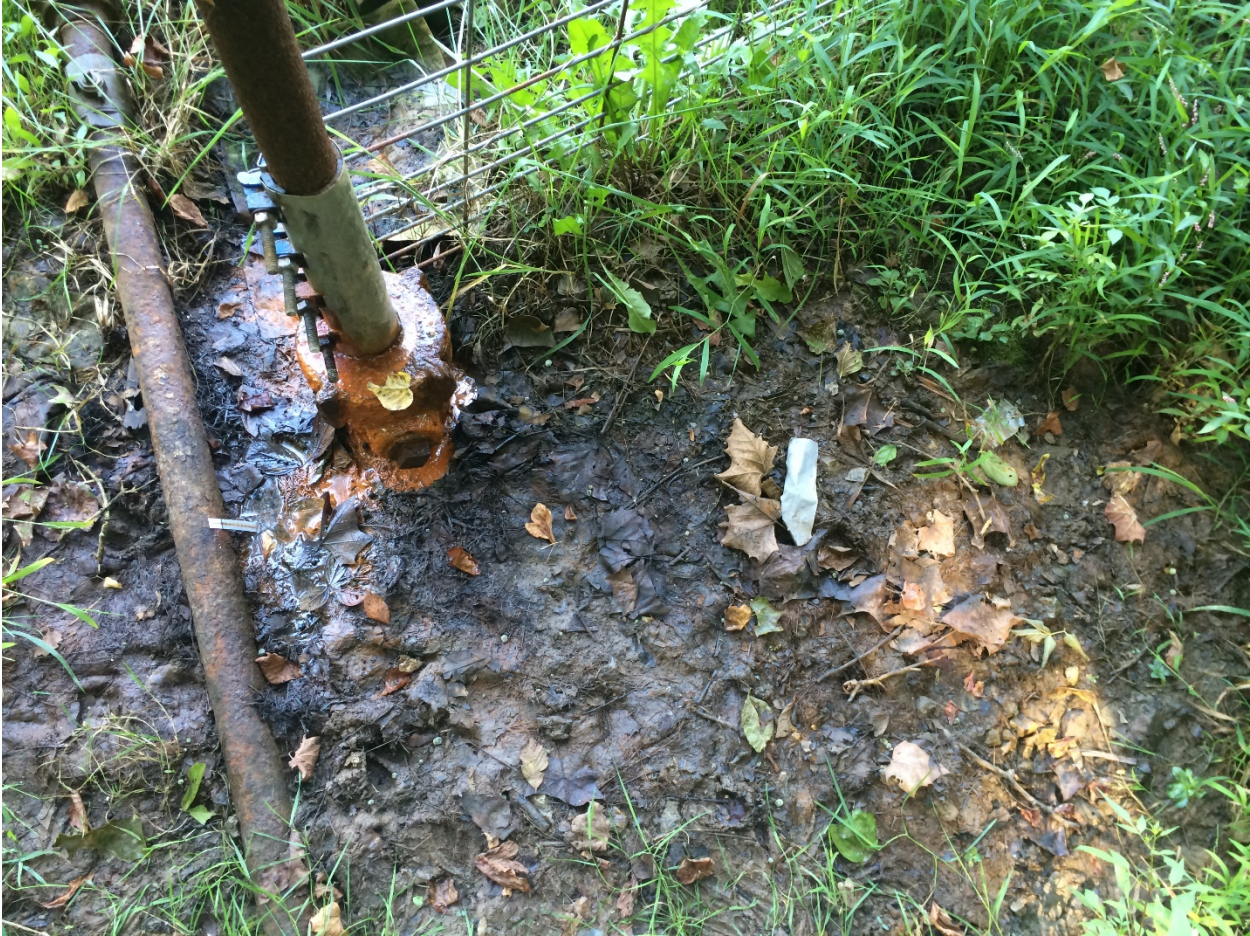
9-4-2018 UIC Quarterly inspection of the well revealed that the stainless steel compression clamp on the injection tubing is leaking brine. A scald area 5 feet by 3 feet is at the wellhead. The standing water was tested with a high range Quantab. The Quantab was maxed out at greater than 6620 ppm Cl. The top joint of injection tubing needs to be repaired or replaced. All contaminated soil must be removed and disposed of at an EPA approved landfill.

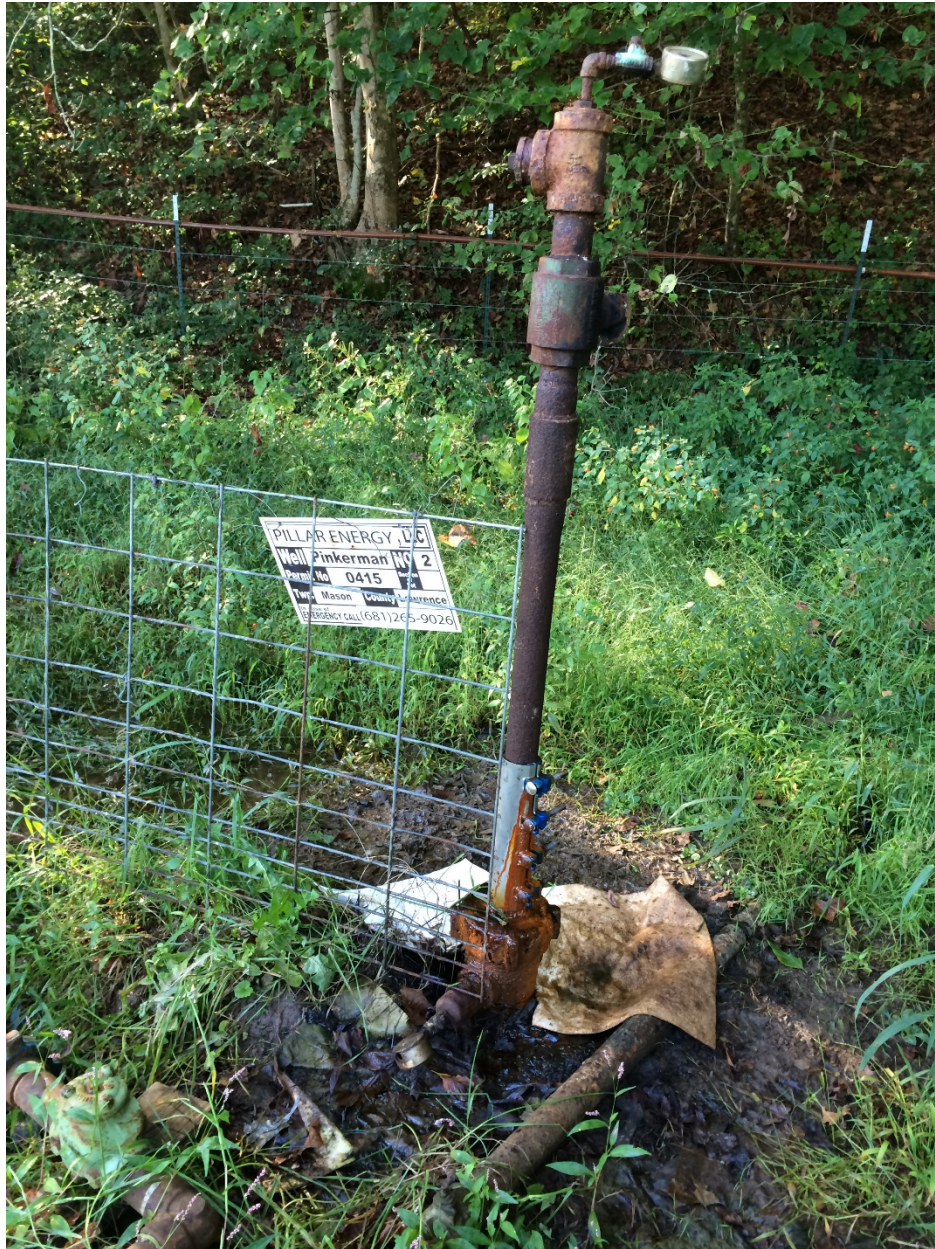
9-14-2018 Compliance Notice # 1536086906 follow up inspection. The injection line has been disconnected from the injection tubing with both ends plugged off. The stainless steel compression clamp is showing signs of leaking, orange stain running down to the ground. Absorbent pads have been placed on the ground recently. No contaminated soil has been removed from the location. Identification is posted.

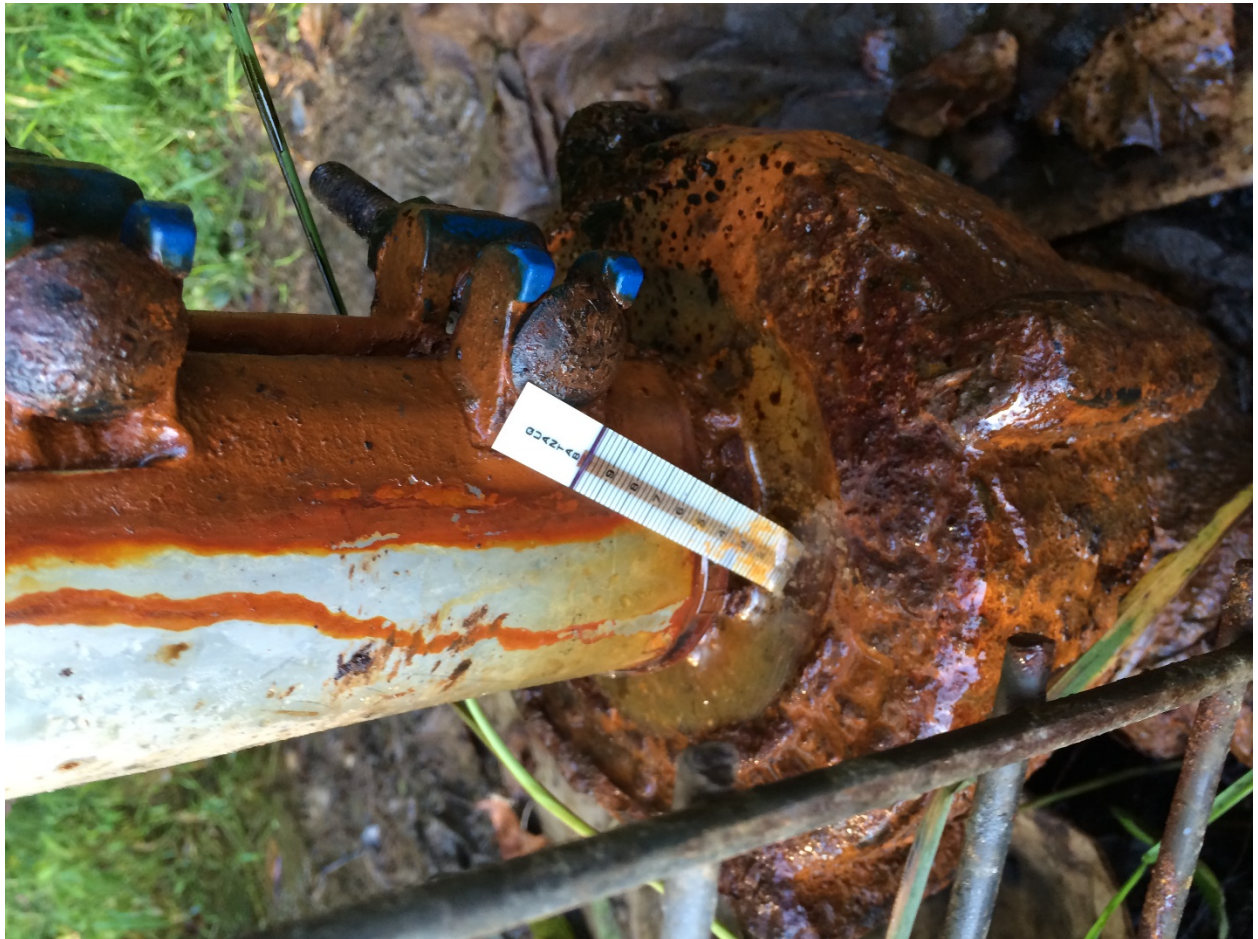
9-21-2018 Compliance Notice # 1536086906 follow up inspection. The injection tubing is disconnected from the injection line. The stainless steel clamp on the injection tubing is seeping brine onto the wellhead. A High Range Quantab was used to test the fluid on the wellhead ring. The fluid tested at more than 6907 ppm Cl. No contaminated soil has been removed from the location. The injection tubing pressure is 60

psi.

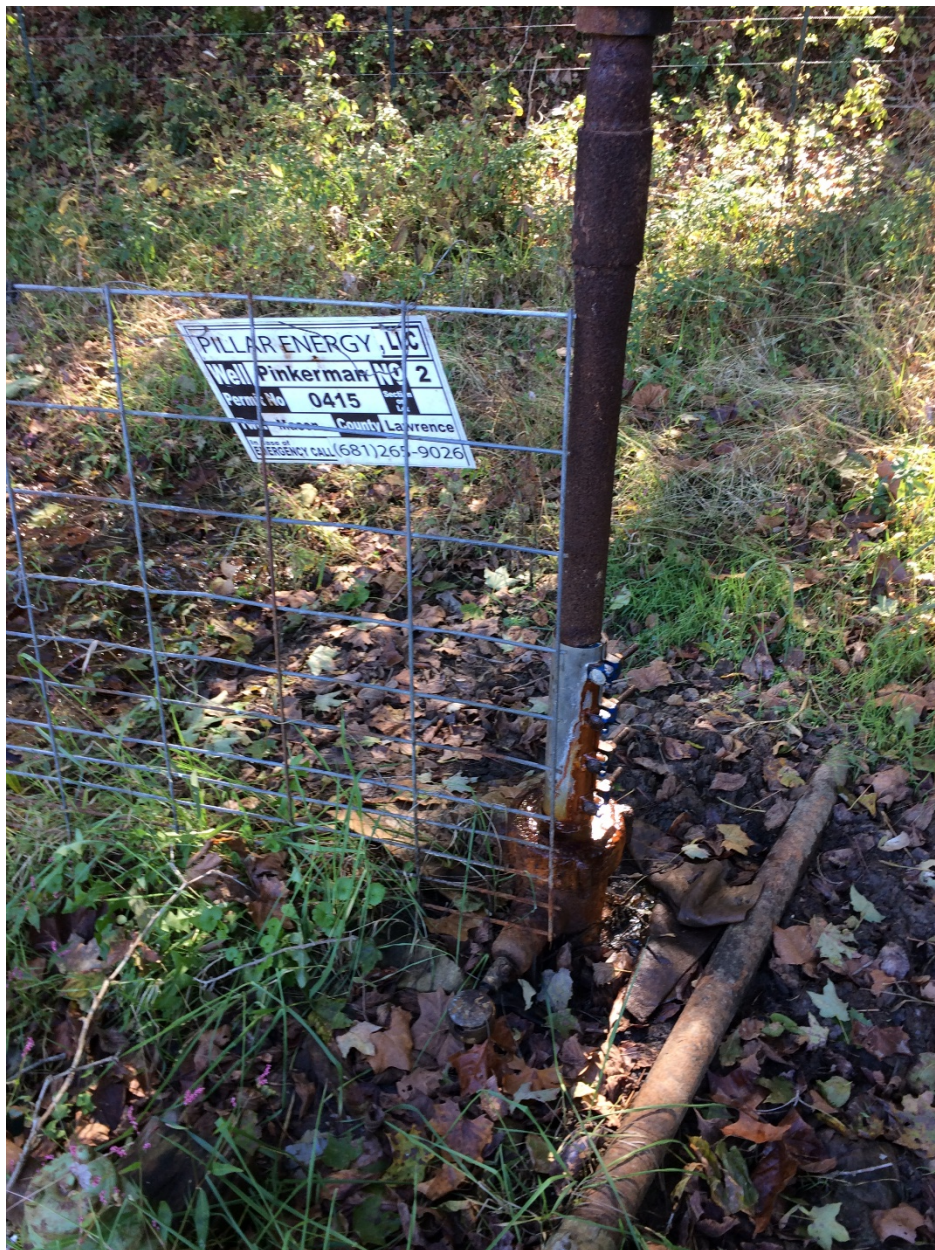
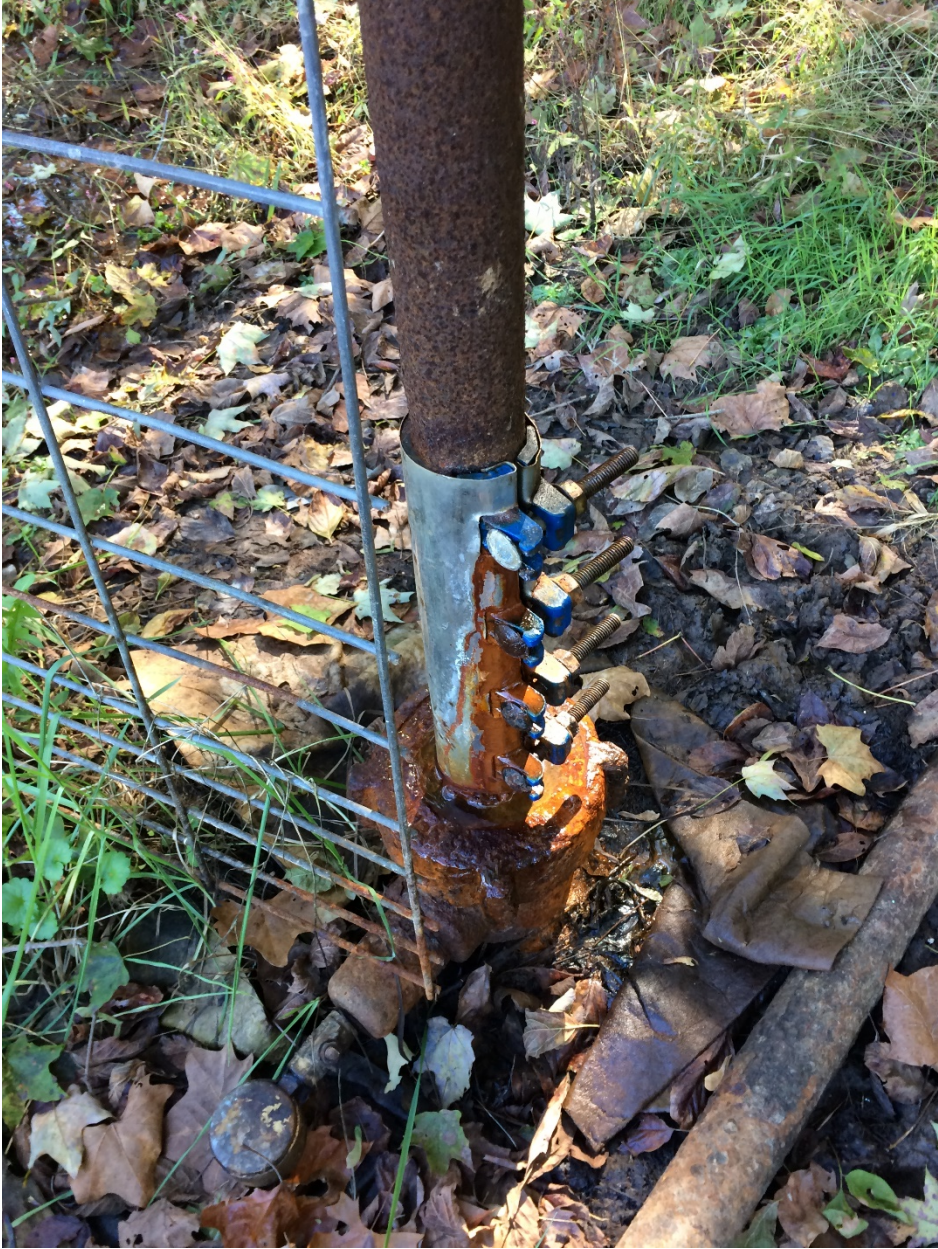
10-22-2018 Compliance Notice # 1536086906 follow up inspection. The injection line is disconnected from the injection tubing. The injection tubing has 64 psi. the compression clamp is located below the injection tubing master valve. The compression clamp is seeping brine out on to the wellhead slips and on to the ground.

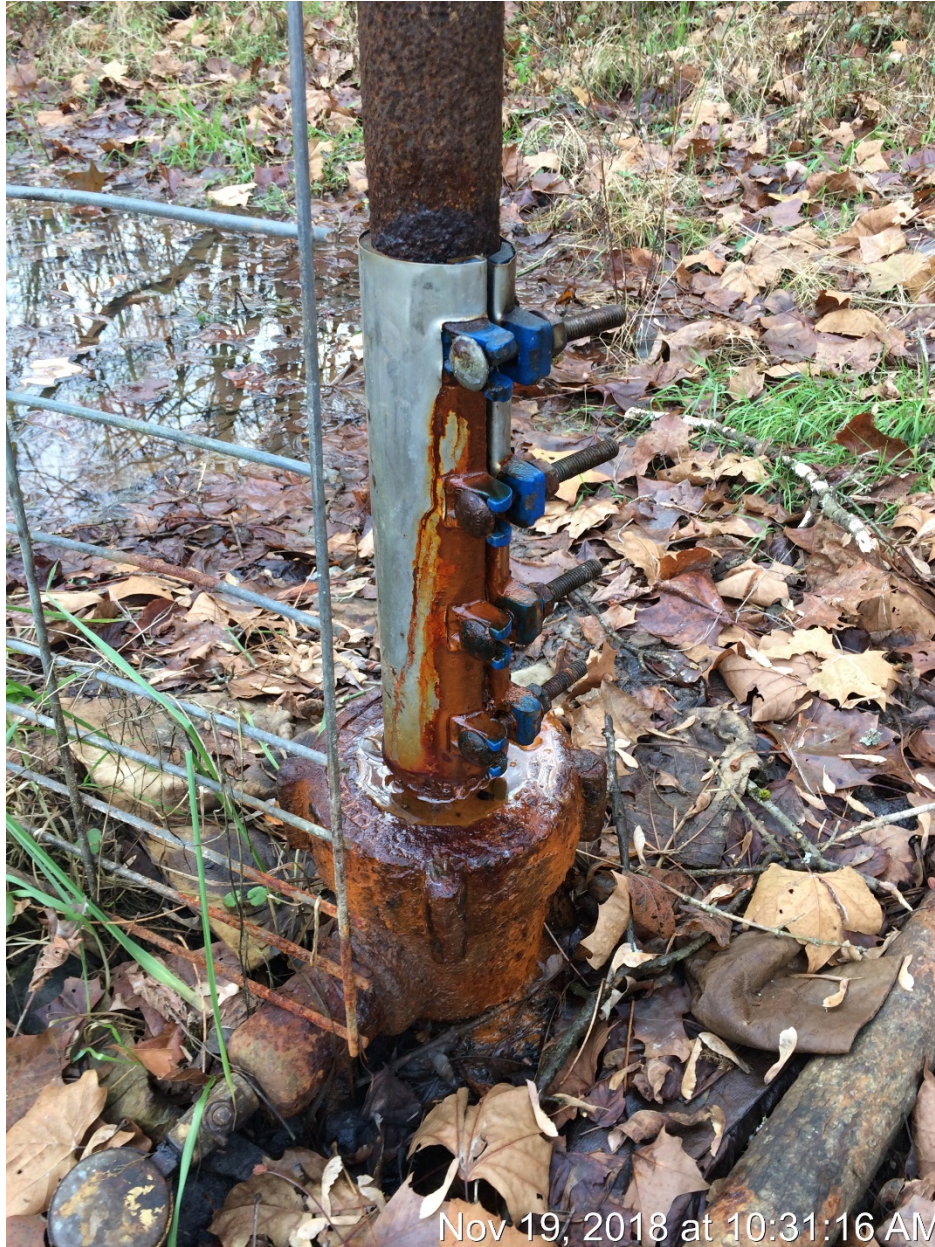
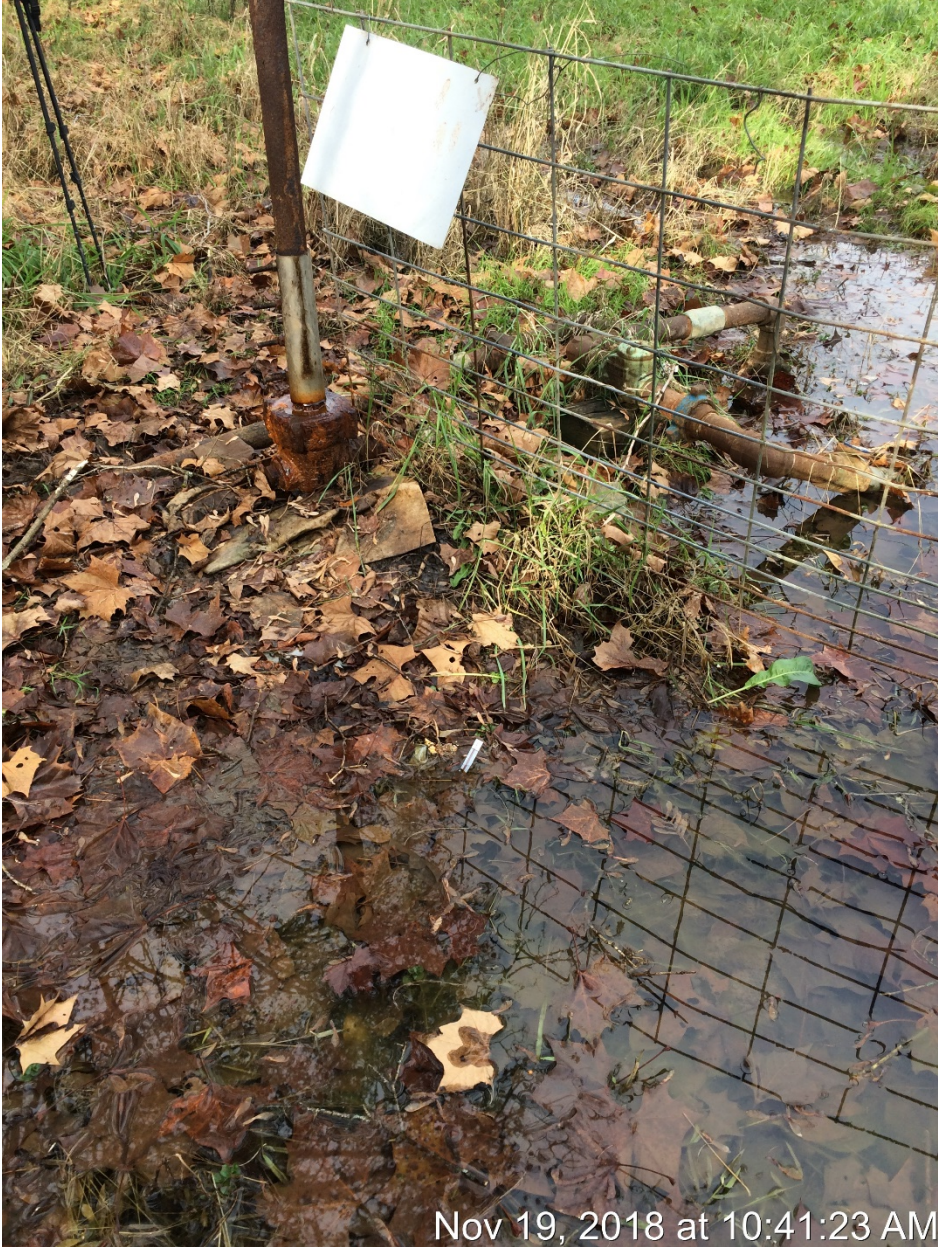
11-19-2018 Compliance Notice # 1536086906 follow up inspection. The injection line is disconnected from the injection tubing. The injection tubing has a compression clamp located above the wellhead slip ring. The compression clamp is seeping brine. The injection tubing has 70 psi. A High Range Quantab was used on the brine seeping from the clamp. The Quantab maxed out at more than 6907 ppm Cl.

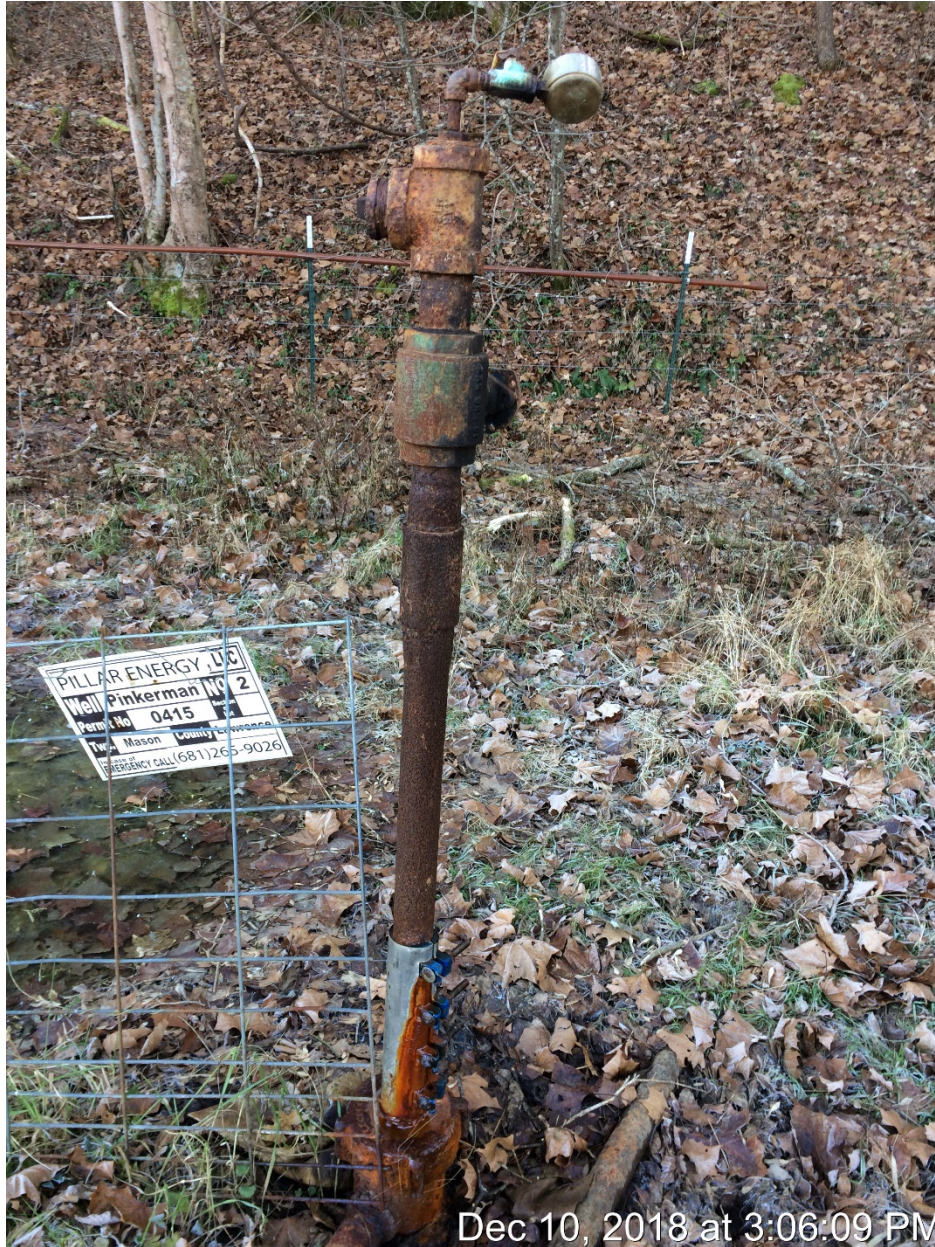
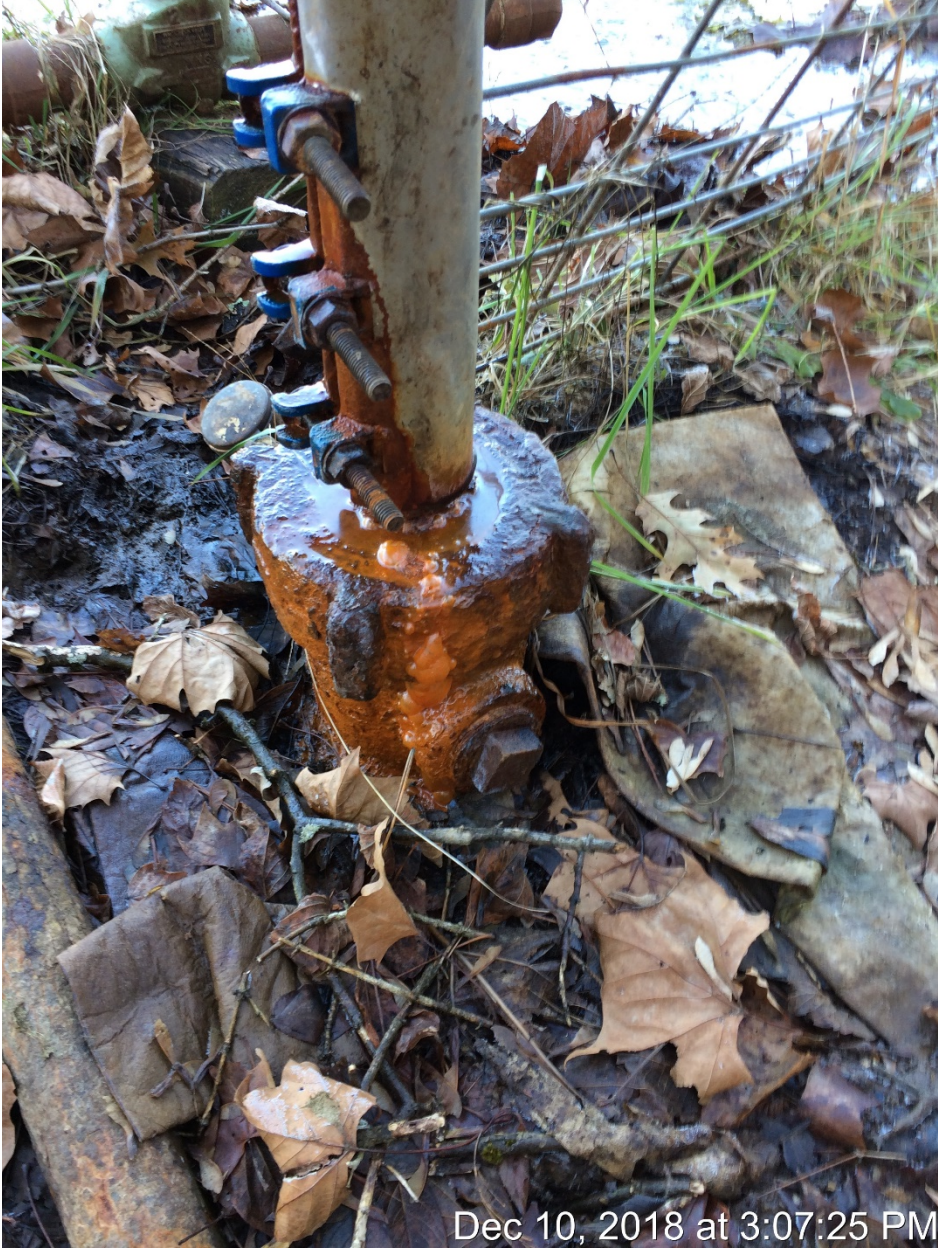
12-10-2018 Compliance Notice # 1536086906 follow up inspection. The injection line is disconnected from the injection tubing. The injection tubing has a stainless steel compression clamp installed. The compression clamp is seeping brine. The site is currently being used for cattle. The well does not have a fence around it.

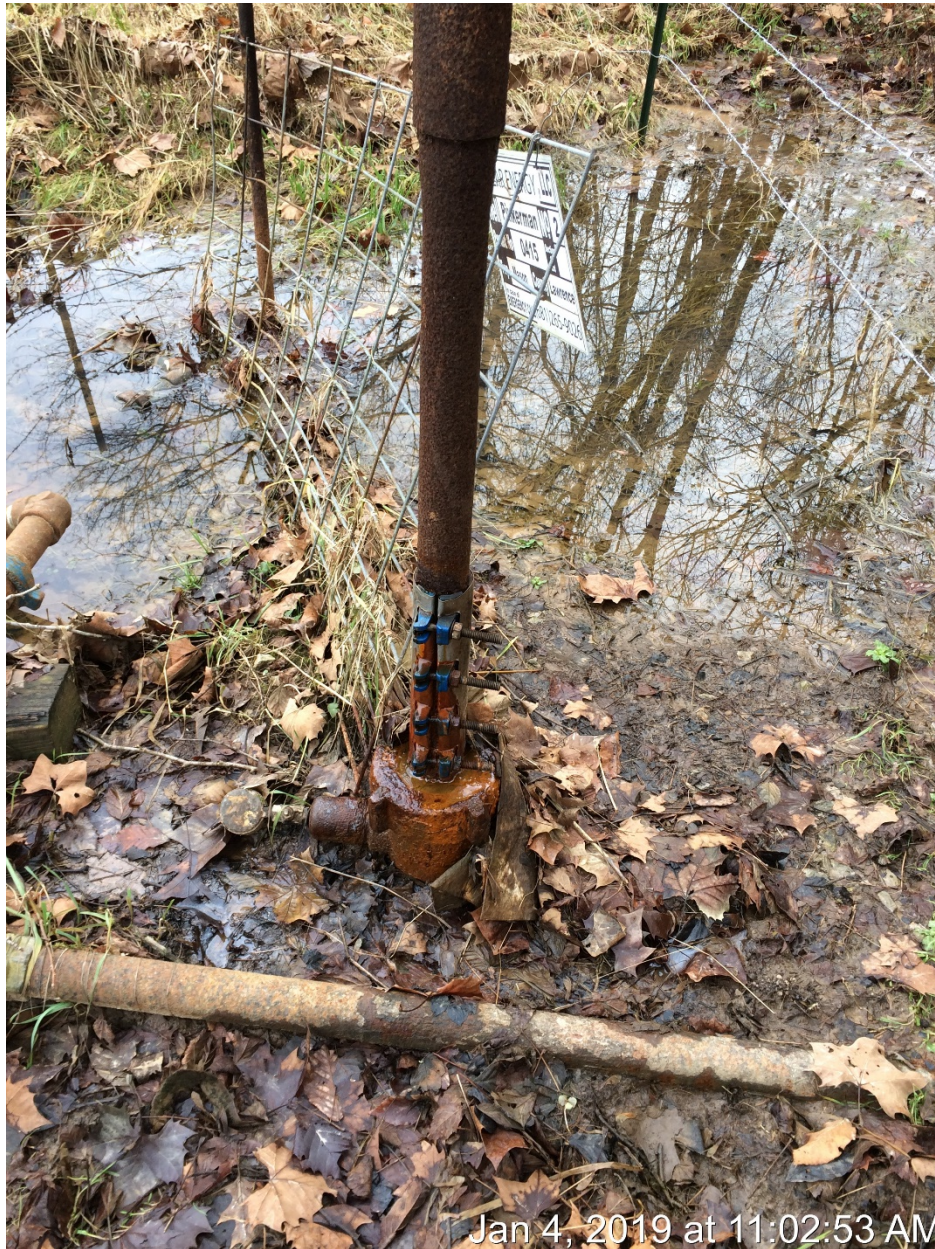
1-4-2019 Compliance Notice # 1536086906 follow up inspection. A barb wire enclosure has been installed around the well. The enclosure has no gate or access point. I was not able to install the state issued gauge and check pressures on the injection tubing and the annulus. The stainless steel compression clamp on the injection tubing was observed to be seeping brine.

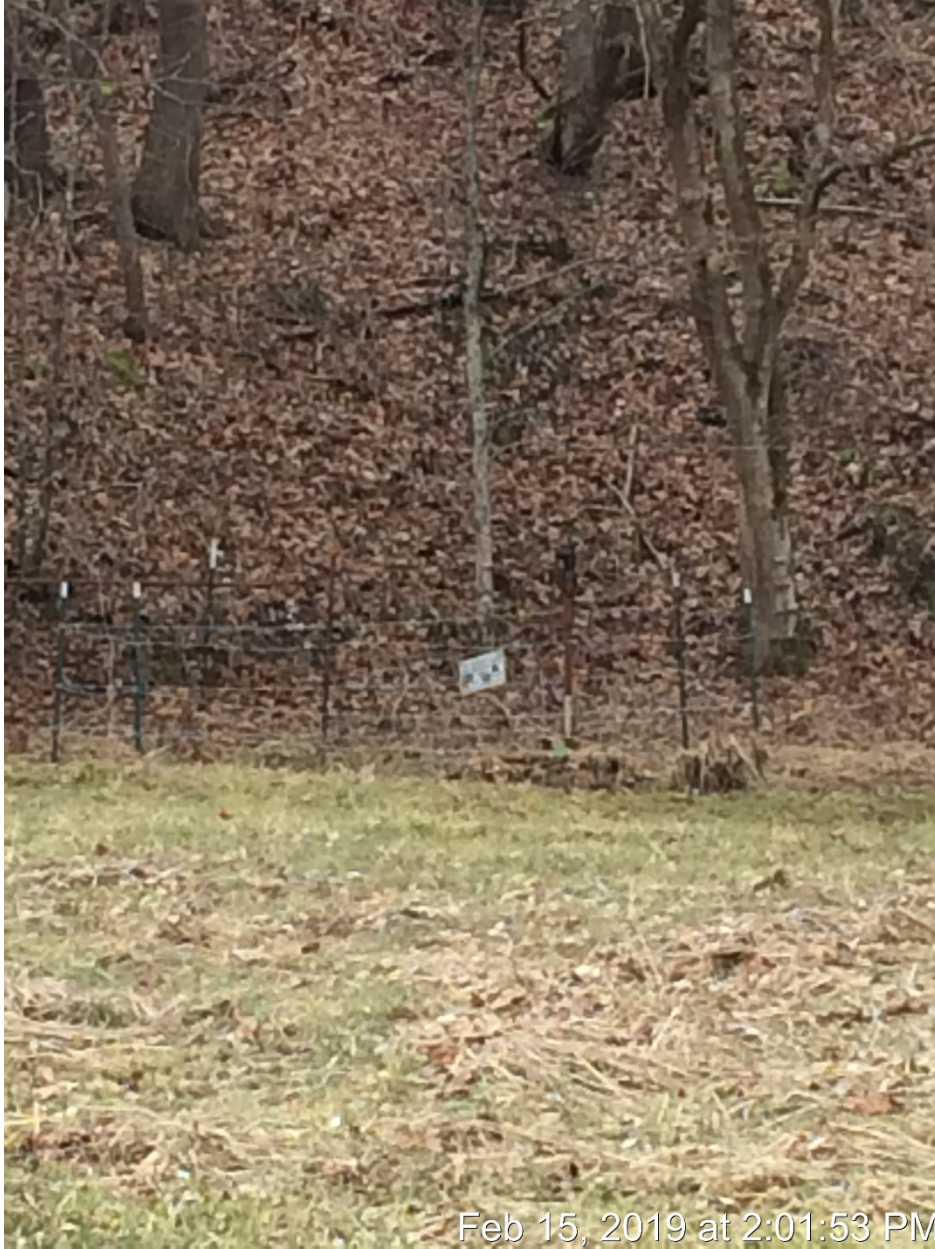
2-15-2019 Compliance Notice # 1536086906 follow up inspection. Access to well is flooded.

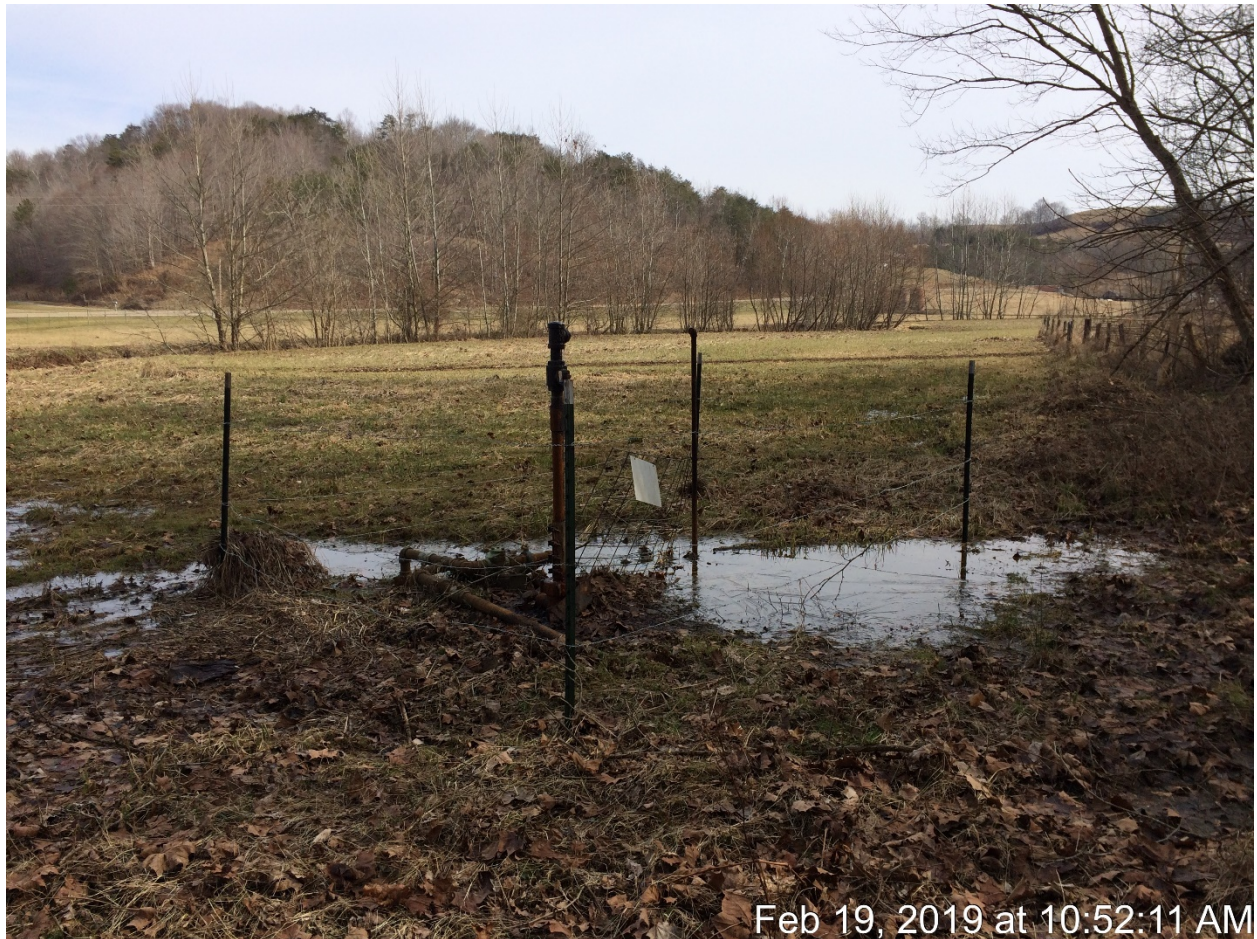
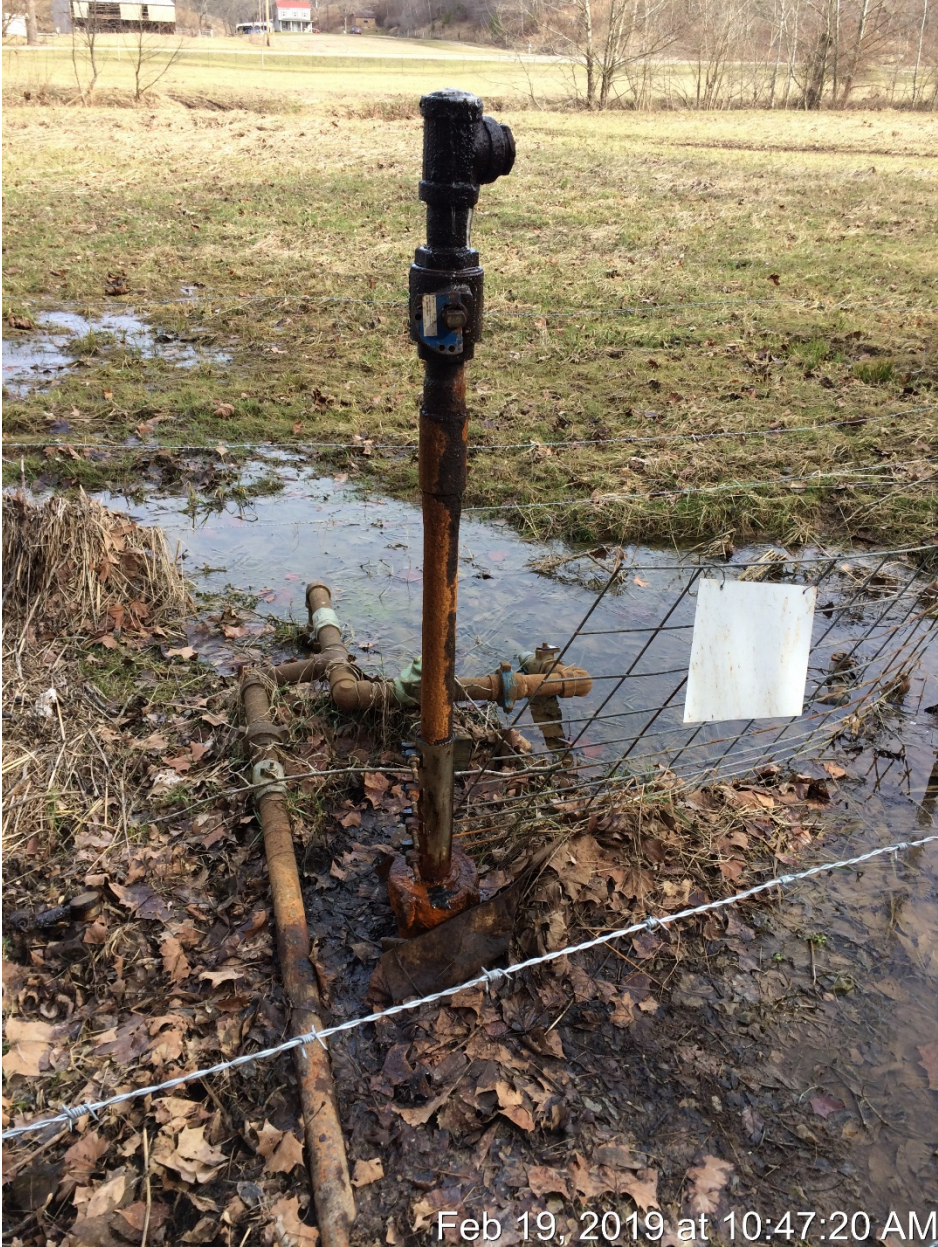
2-19-2019 Compliance Notice # 1536086906 follow up inspection. Barb wire fence with out a gate is surrounding the well. Unable to check pressures on the well due to the fence. The stainless steel clamp on the injection tubing is seeping brine. The 2 inch by 1/4 inch bushing with the 1/4 inch valve and gauge has frozen and broke the 2 inch by 1/4 inch bushing. The broken portion is on the ground. It consists of a piece of the bushing, the 1/4 inch valve and gauge. The injection tubing master valve is closed.

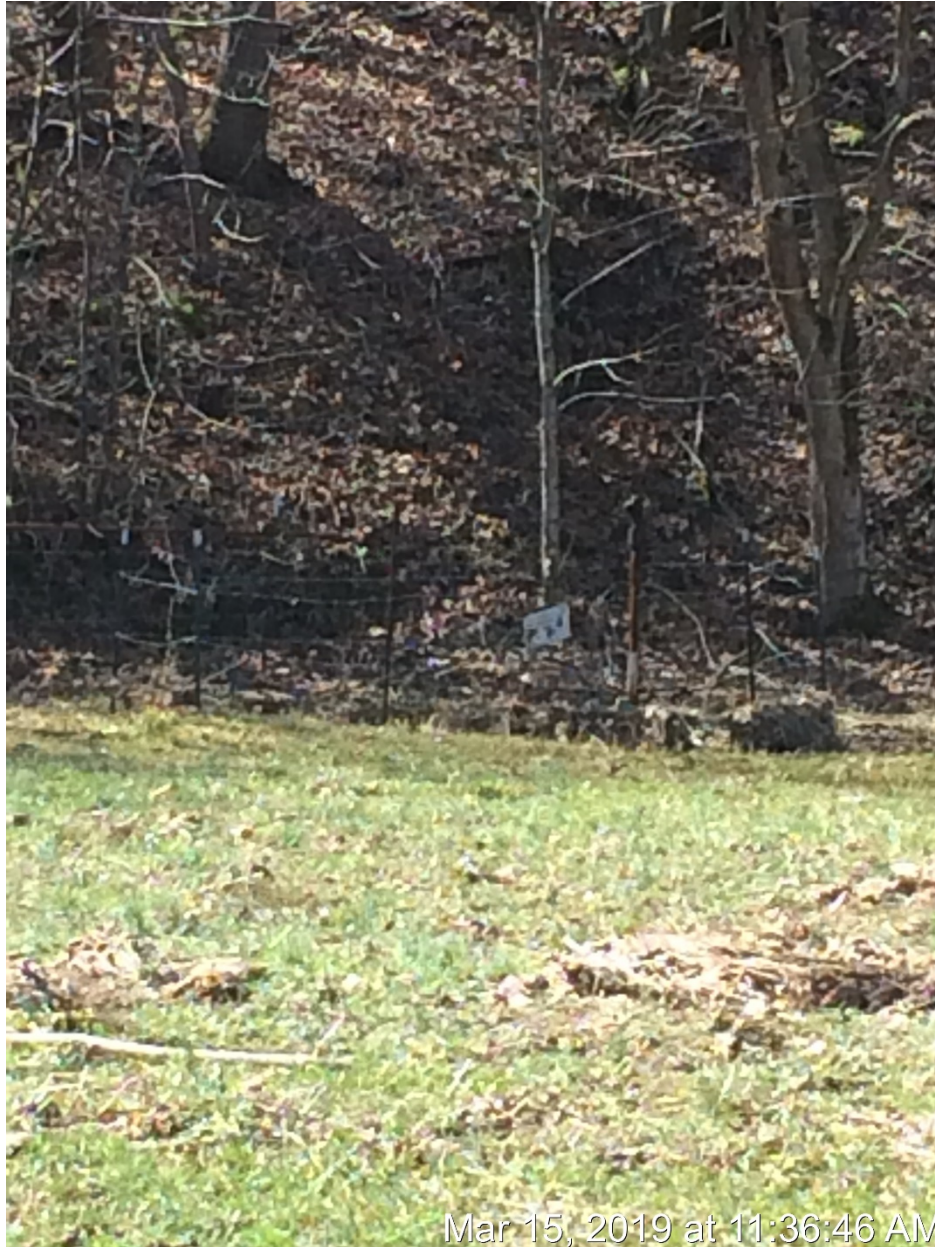
3-15-2019 Compliance Notice # 1536086906 follow up inspection. The well is disconnected from the injection line. The injection tubing is seeping brine from the hole in the injection tubing (between the wellhead slip ring and the injection tubing master valve.) The well is fenced in with barb wire and no access point to the well. Due to the fence, I was not able to install state issued pressure gauge to check the annulus pressure. The 1/4 inch fitting on the injection tubing has broken off.

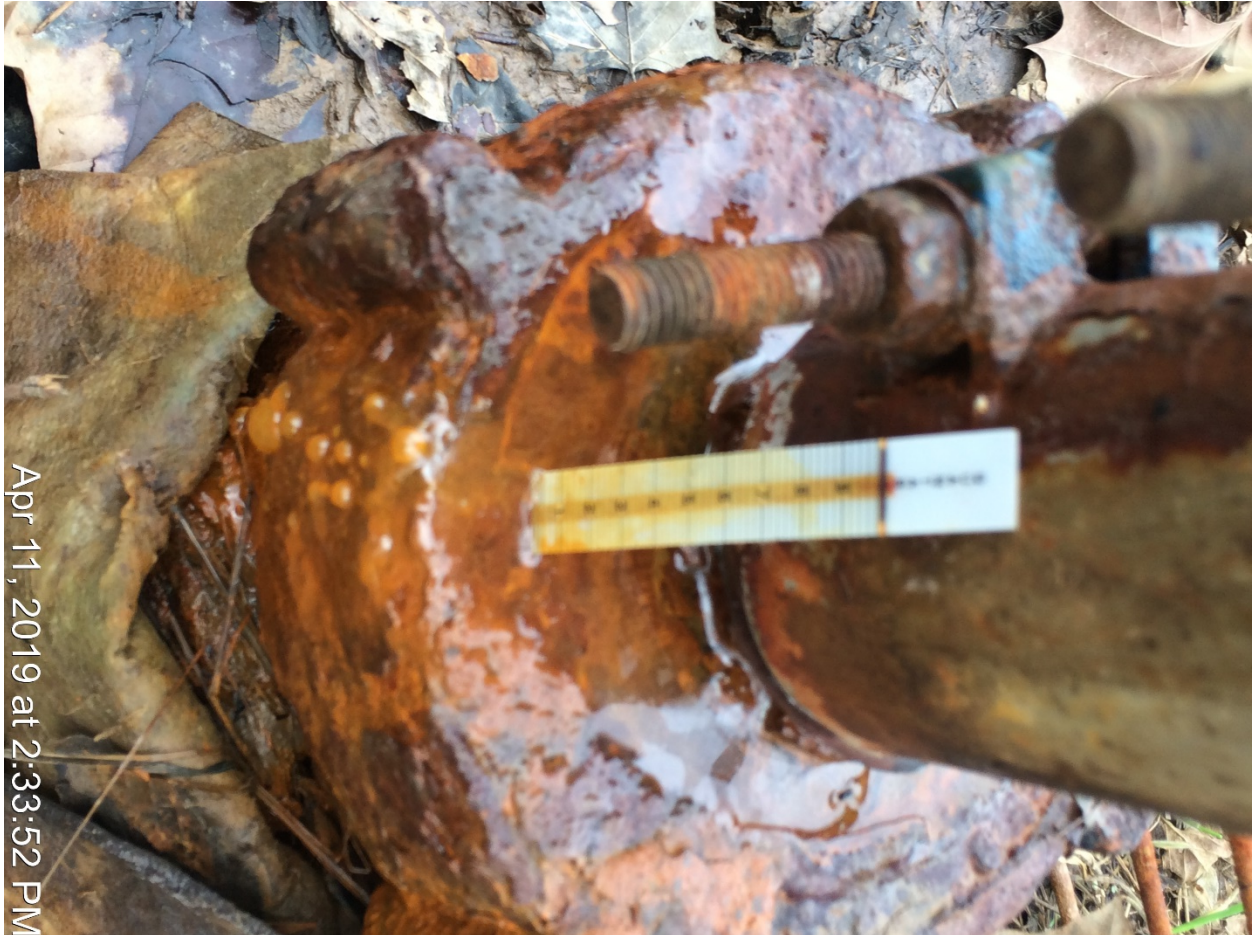
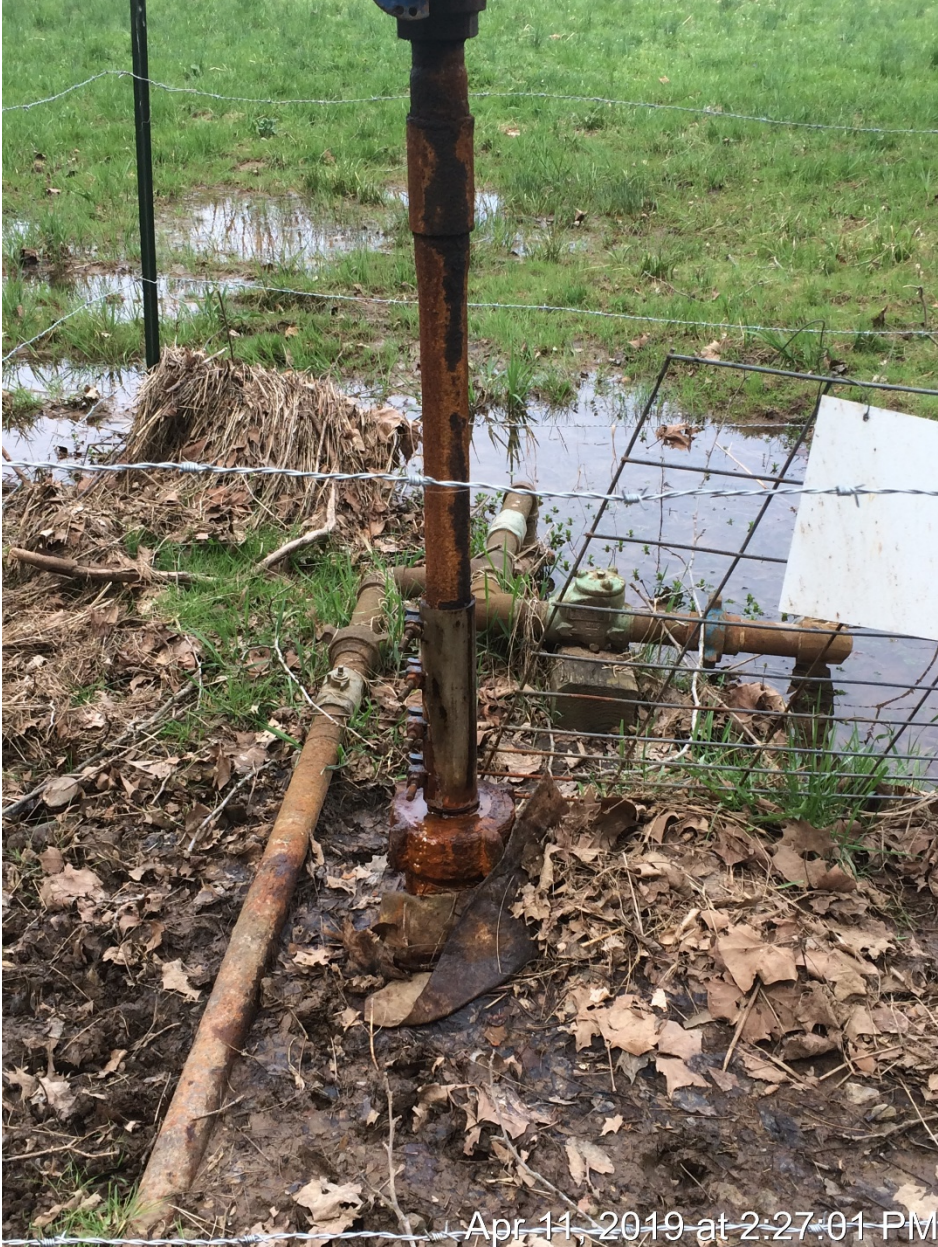
4-11-2019 Compliance Notice # 1536086906 follow up inspection. There is a barb wire fence around the well site. The fence has been knocked down by deer. The injection line is disconnected from the injection tubing. There is oil seeping out of the injection tubing tee. The injection tubing has a stainless steel compression clamp located above the 4.5 inch wellhead slip ring and below the injection tubing master valve. The compression clamp is seeping brine on to the wellhead and on to the ground. A High Range Quantab was used to field test the brine. The high range quantab was maxed out at over 6700 ppm cl.
