34-087-20415 Pinkerman # 2 ERP CN

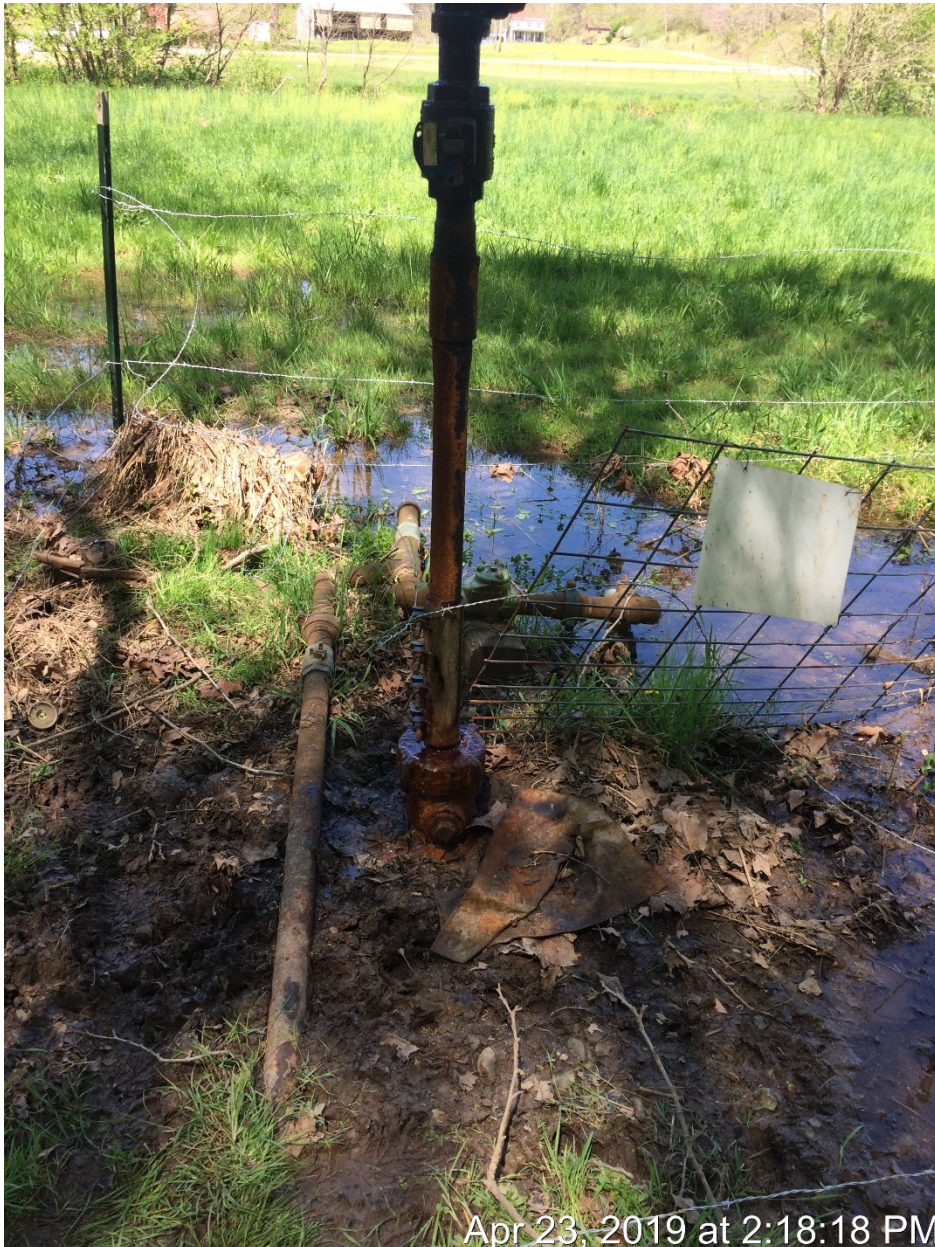
4-23-2019 Compliance Notice # 1536086906 follow up inspection. The injection line is disconnected from the injection tubing. The injection tubing master valve is shut. The injection tubing 2 inch by 1/4 inch bushing has broken at the top of the tee. Oil has ran down the injection tubing. The stainless steel compression clamp on the injection tubing between the wellhead slips and the master valve is seeping brine. The fence around the well site has come down in the back corner. Evidence of flooding can be seen on the fence around the well. Accompanied by UIC Supervisor and UIC Geologist. Contaminated area around the well site has not been remediated.

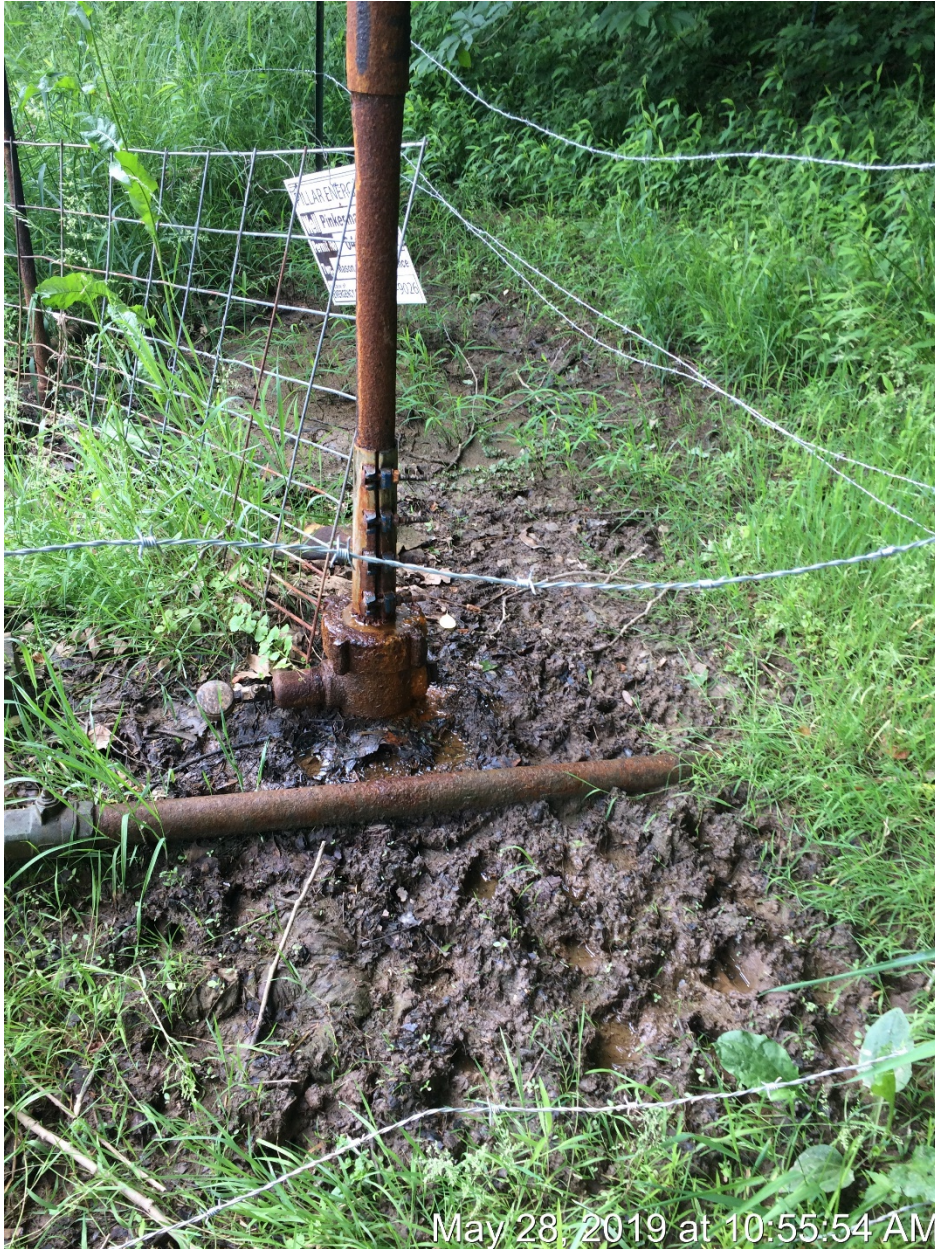
5-28-2019 Compliance Notice # 1536086906 follow up inspection. Brine is seeping from the hole in the injection tubing. The stainless steel compression clamp is not sealing off the brine leak. There is a 4 foot by 8 foot scald area at the well site. A 2inch steel plug has been installed in the 2 inch injection tubing master valve. The well site shows recent evidence of flooding with wood debris caught in the well fencing.

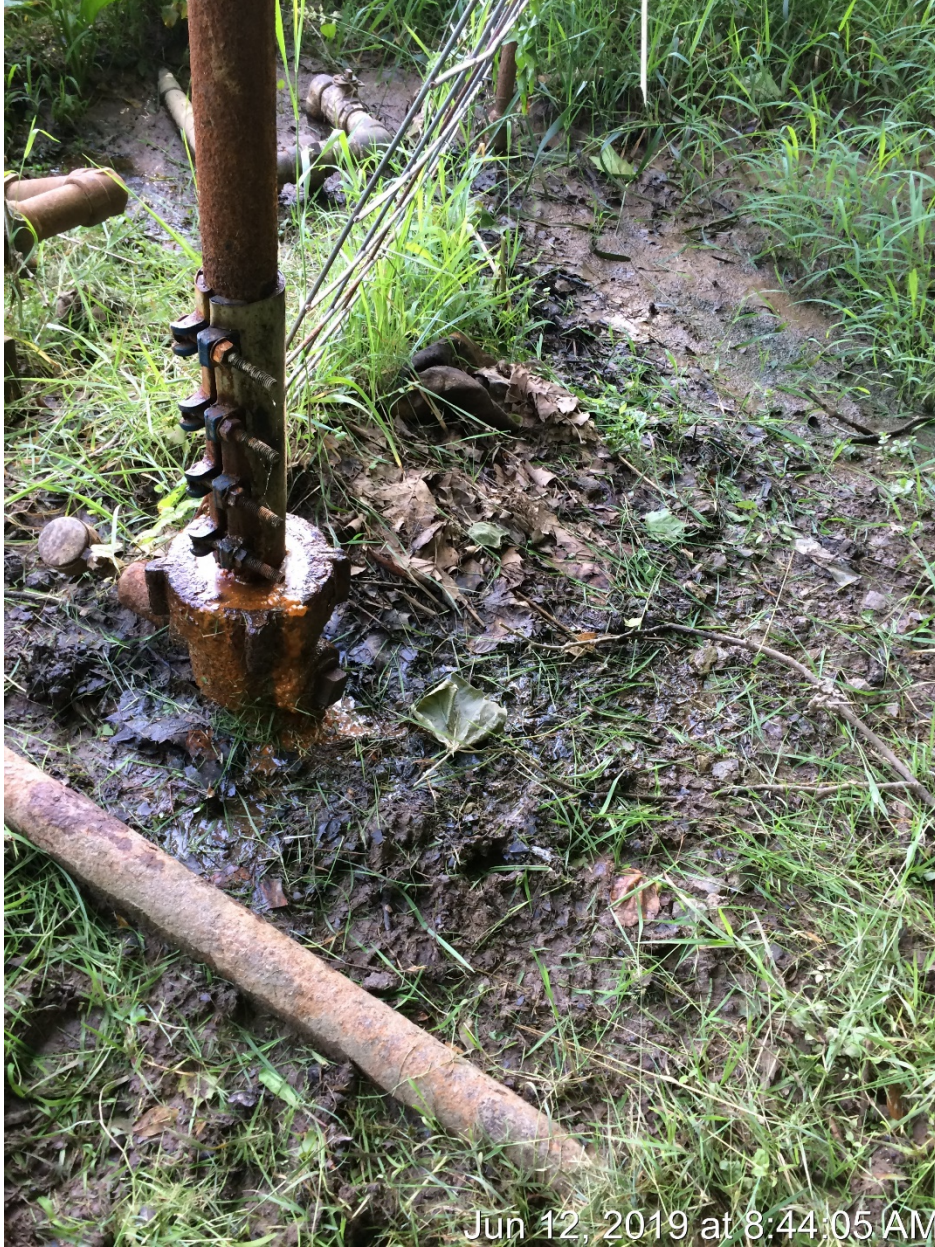
6-12-2019 Compliance Notice # 1536086906 follow up inspection. The injection tubing is disconnected from the injection line. The injection tubing has a stainless steel compression clamp that is located between the wellhead slip ring and the injection tubing master valve. The injection tubing is seeping brine onto the ground. The well site has a barb wire fence with no access point around the well.

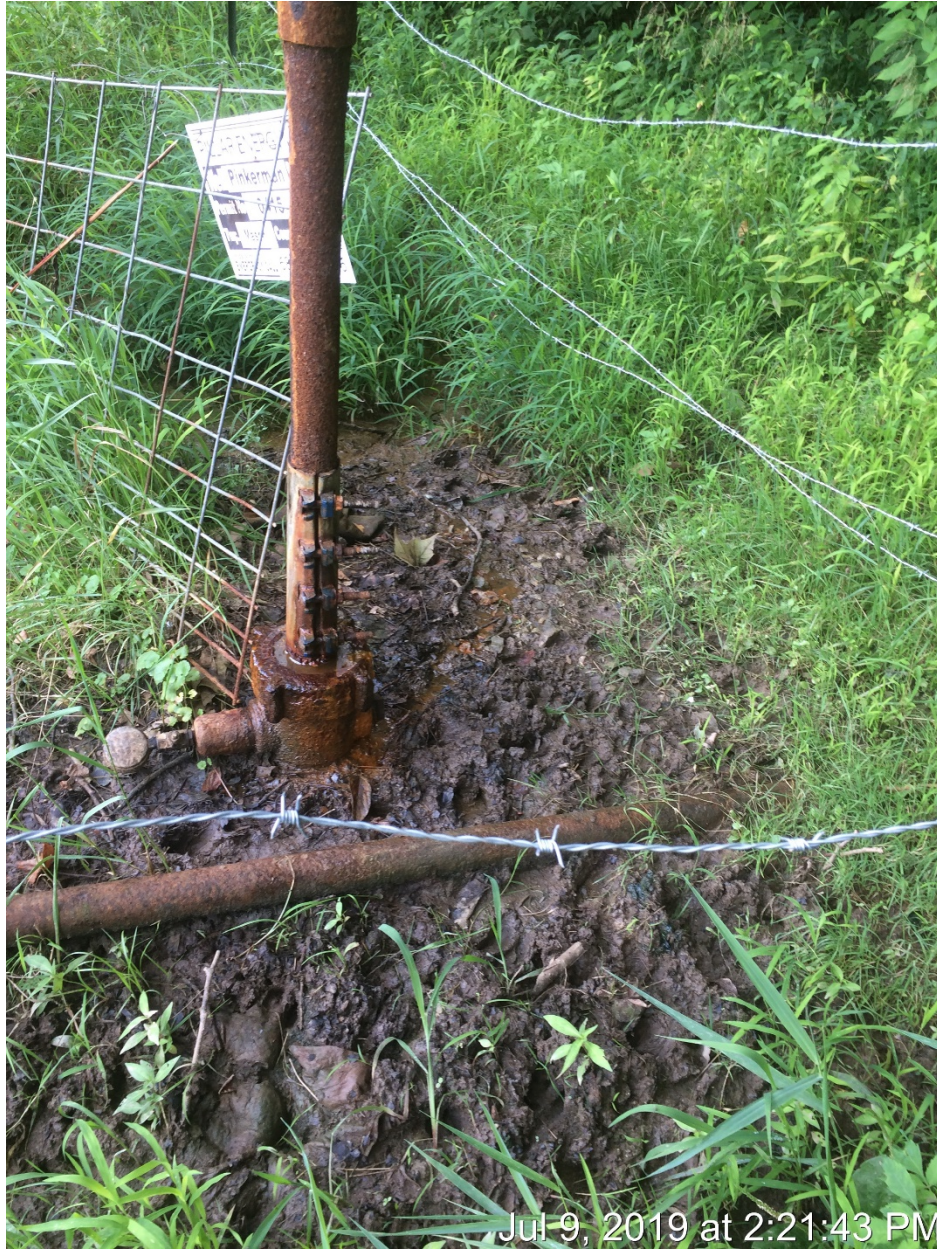
7-9-2019 Compliance Notice # 1536086906 follow up inspection. The injection tubing is leaking brine onto the ground. Contaminated area is approximately 8 feet by 4 feet. The well is fenced in with barb wire with no access to the well. The injection line is not connected to the injection tubing. Pillar has a service rig in the ERP field currently working on oil production wells.

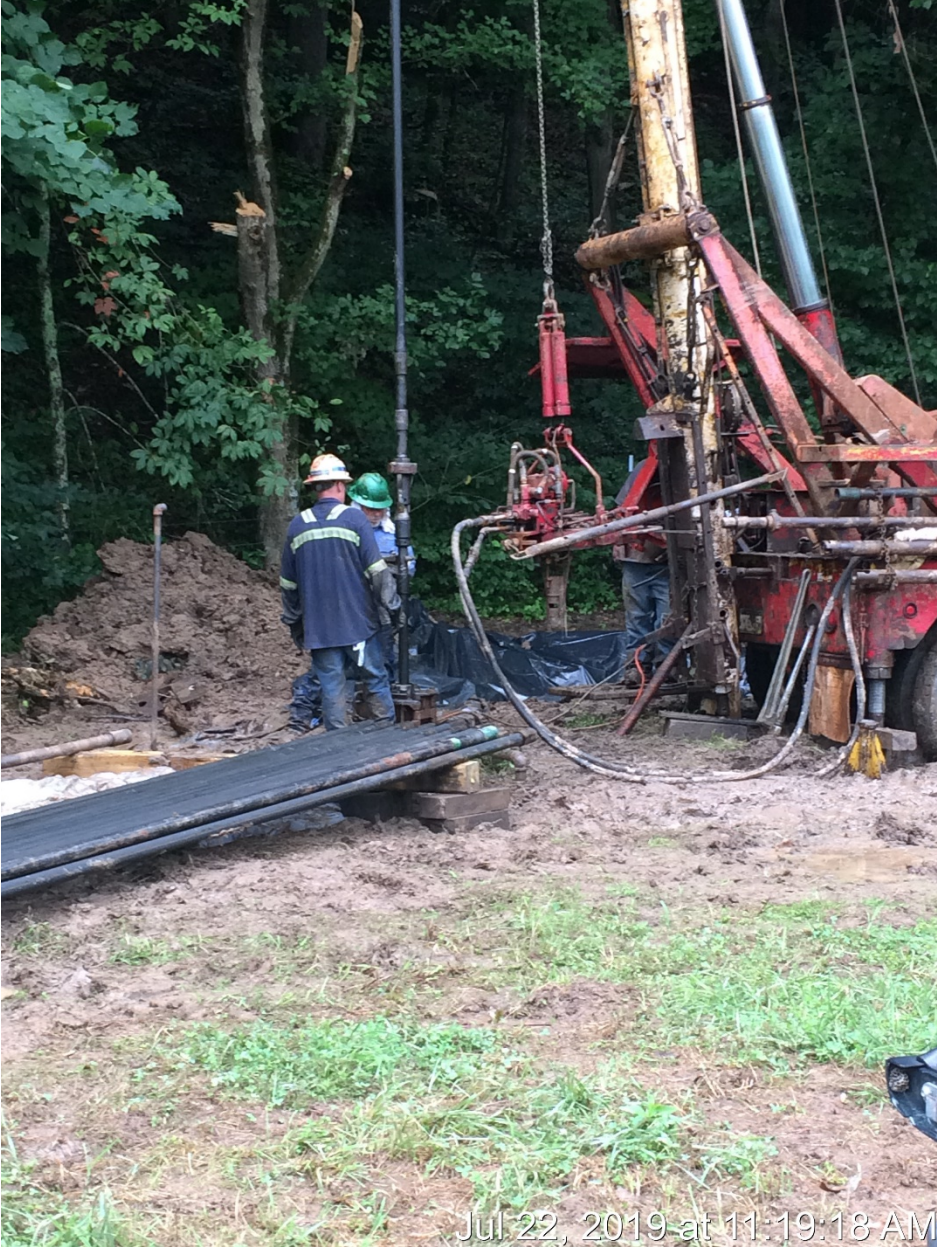
7-22-2019 Compliance Notice # 1536086906 follow up inspection. Francis Brothers service rig is on the well. They ran tubing sub joints with a tubing spear to retrieve the tubing and packer. Pulled the tubing and packer out of the well. Installed rebuilt Halliburton R-4 packer on used 2.375 inch tubing. Packer set at 522.95 feet. Tested annulus at 300 psi. at 5 minutes 290 psi, at 15 minutes 288 psi. The injection line is not connected to the injection tubing. Contaminated soil has not been removed from location.

7-16-2019 Compliance Notice # 1536086906 follow up inspection. Francis Brothers service rig is on the well. The injection tubing has holes above the wellhead slip ring. The 2 3/8 inch injection tubing was cut off above the wellhead slip ring. A tubing spear was installed in the 2 3/8 inch tubing. While attempting to release the packer the spear came out of the 2 3/8 inch tubing. The 2 3/8 inch tubing fell inside the 4.5 inch casing to 16.5 feet from surface. Mike Carr (Pillar ) installed a 2 3/8 inch sub joint with a collar and a 2 inch ball valve to shut in the well. The service rig moved off location. Pillar has not determined a course of action past this point.

7-18-2019 Compliance Notice # 1536086906 follow up inspection. Francis Brothers service rig is back on the well site. Mike Carr told me that they are attempting to find tools to fish out the tubing and packer. No activity today.

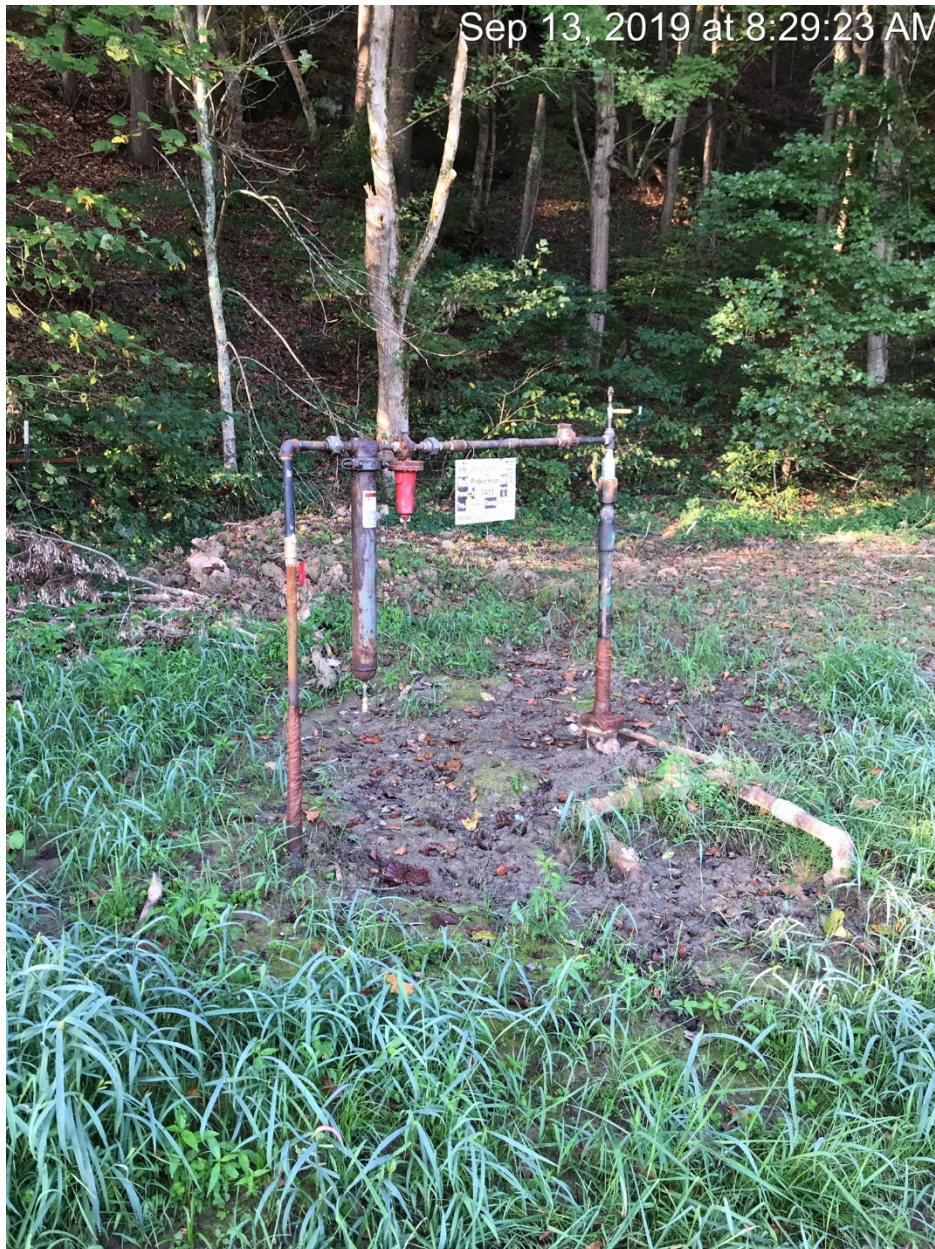
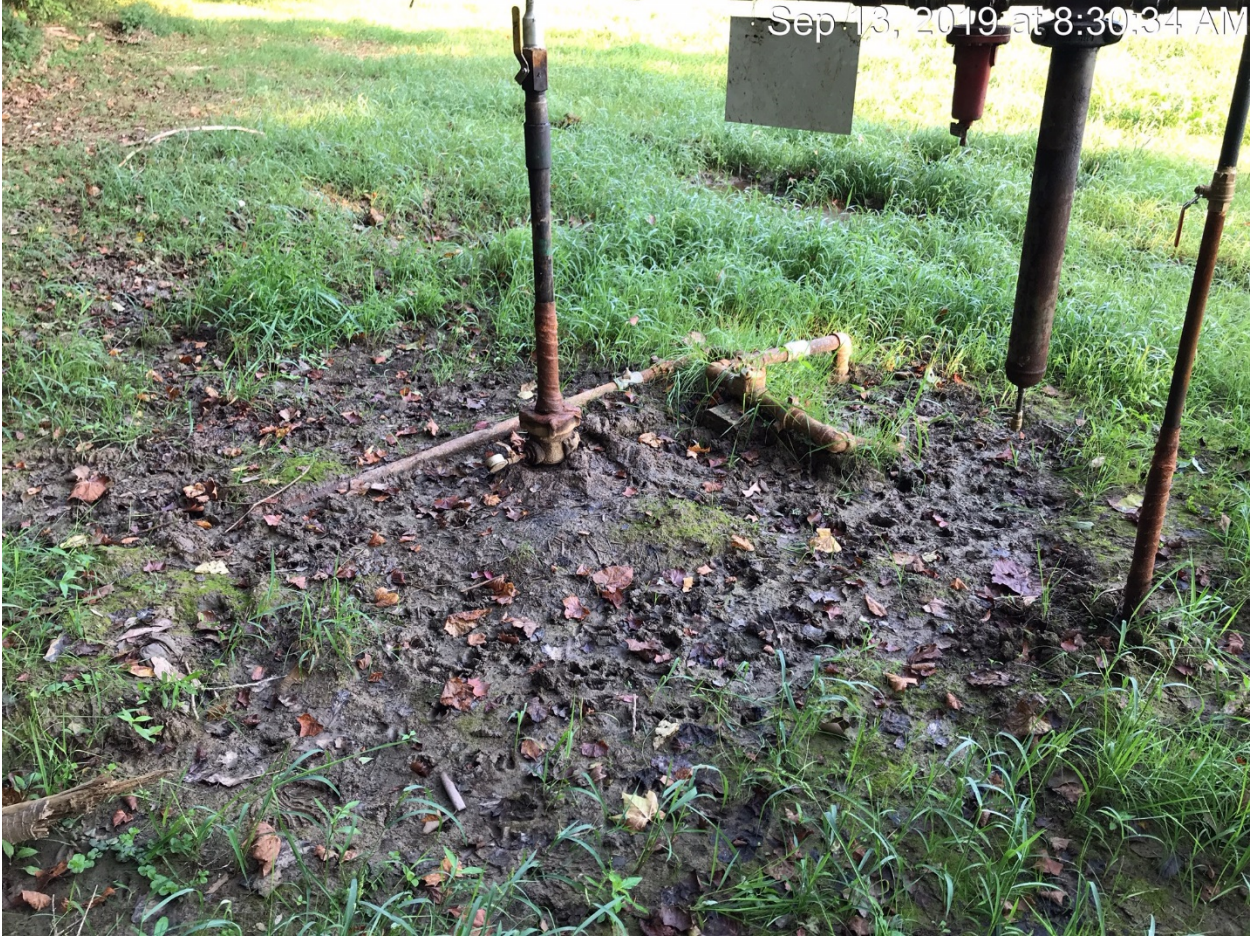
9-13-2019 Compliance Notice # 1536086906 follow up inspection. The contaminated soil has not been removed from the well site. The scald area around the well is 9 feet by 8 feet. The injection line has been connected to the injection tubing, all valves are open.

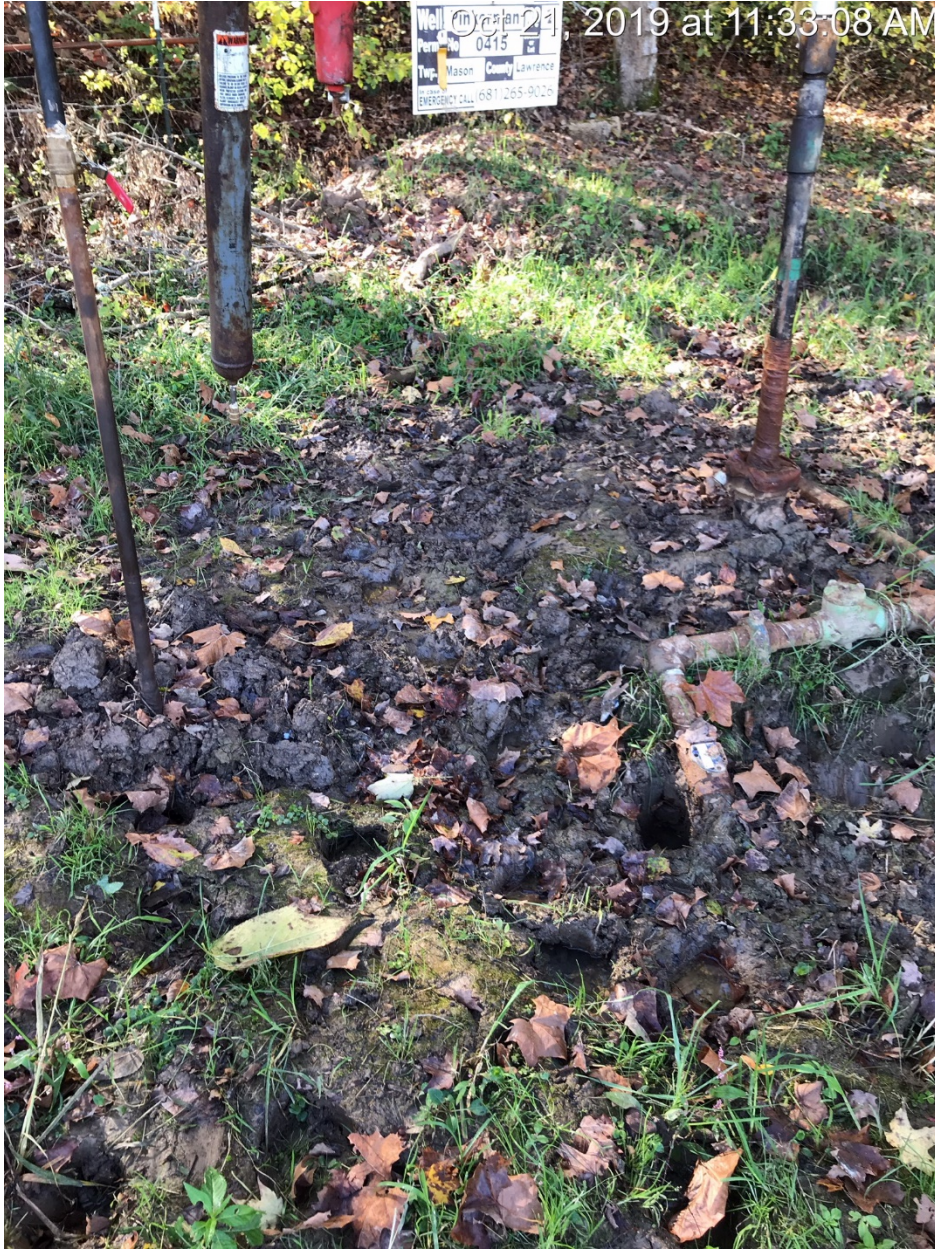
10-21-2019 Compliance Notice # 1536086906 follow up inspection. The access road gate was locked. Pillar well tender unlocked the gate. The injection line is connected to the injection tubing. All valves are open. Contaminated soil has not been removed from the well site. High range Quantab was used to test standing water at well site. Quantab result was 2840 ppm Cl.

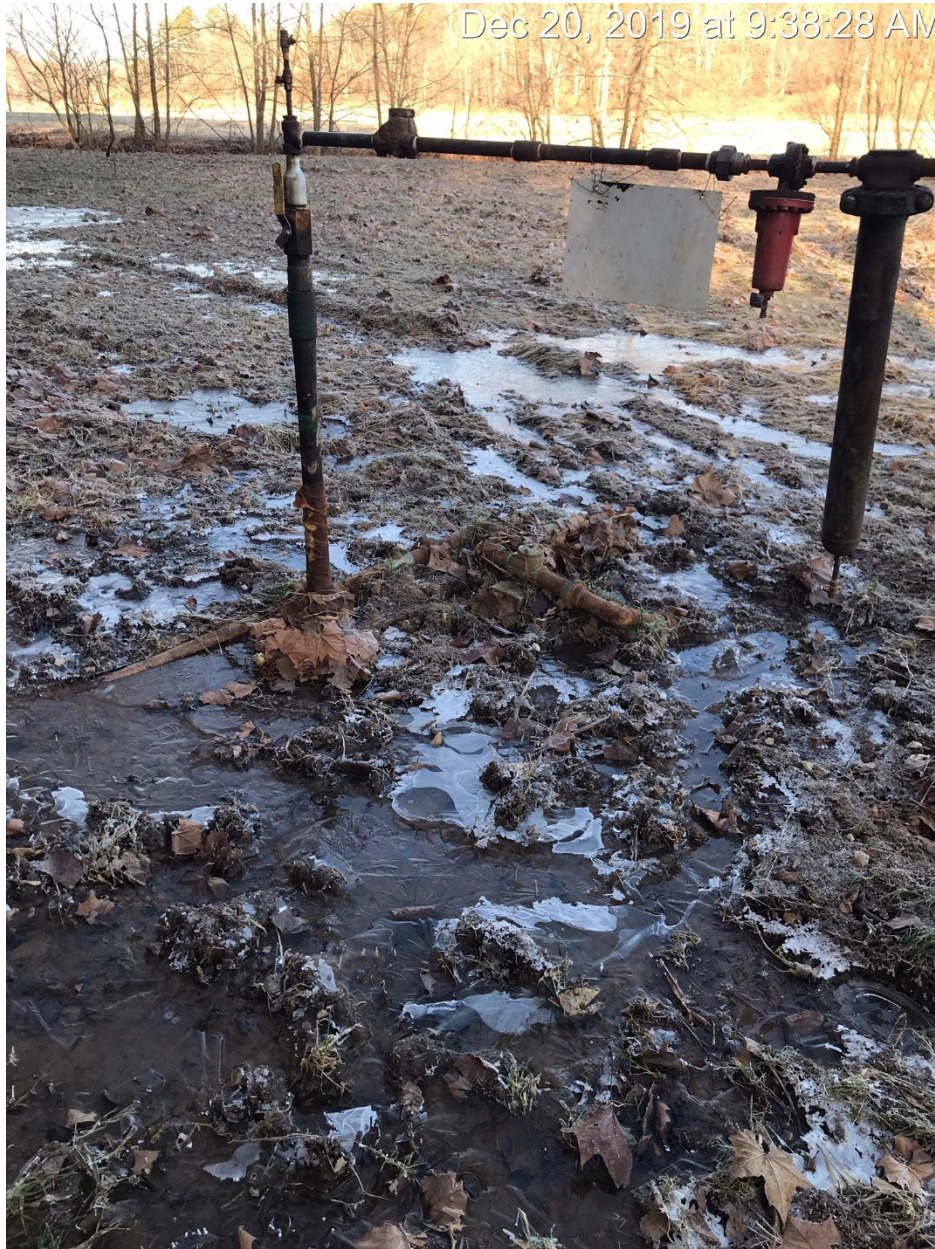
12-20-2019 Compliance Notice # 1536086906 follow up inspection. No contaminated soil has been removed from the location. The well site shows signs of recent flooding over the location including sticks, leaves and debris collected on piping and the wellhead. The annulus is frozen. The injection line valve and injection tubing master valve are open.

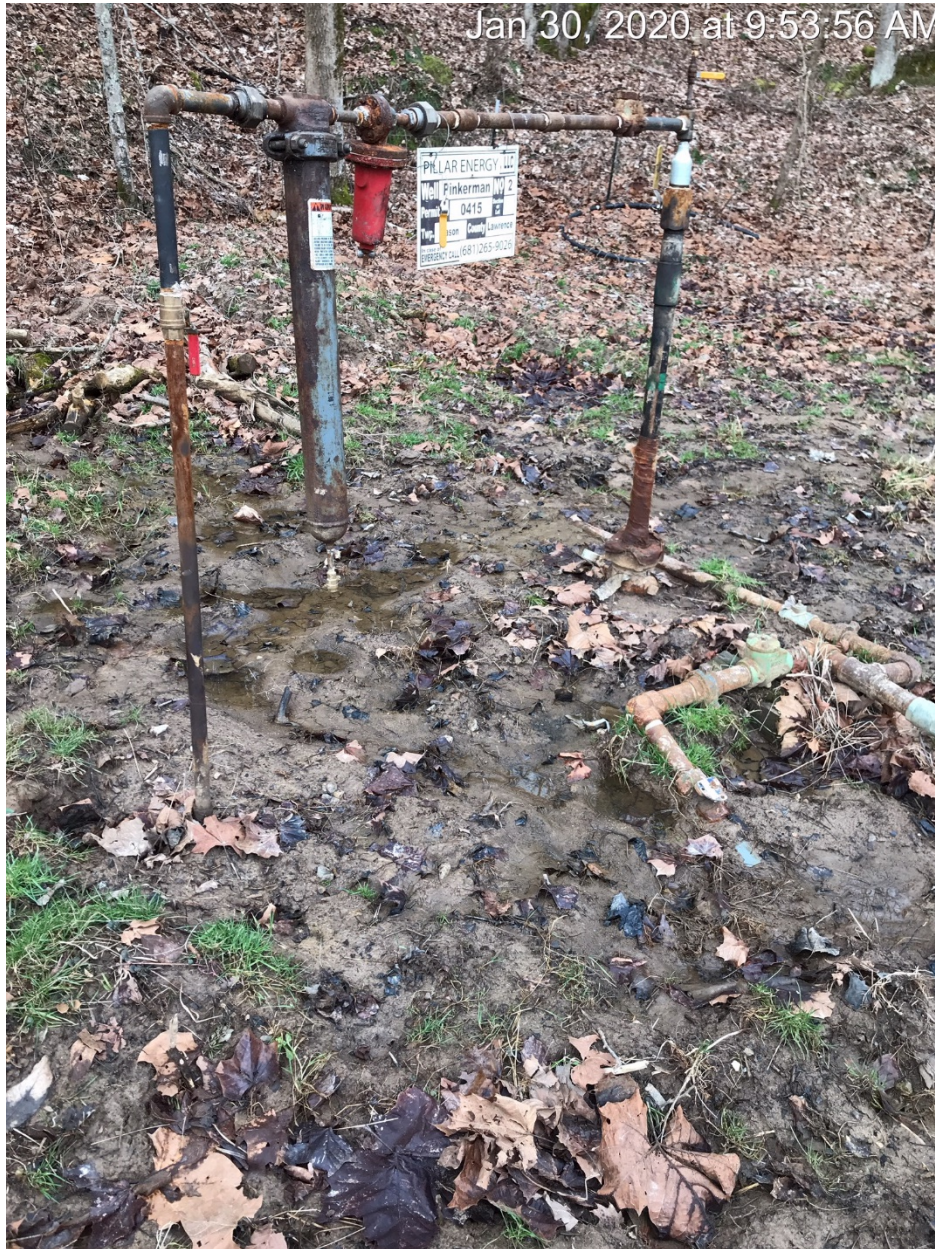
1-30-2020 Compliance Notice # 1536086906 follow up inspection. Inspected the unloading pad, containment dike, tanks, injection pressure and annulus pressure. There has been no contaminated soil removed from the well site. The injection tubing is connected to the injection line and injection line and injection tubing valves are open. Identification is posted, The containment dike is free of fluids. Meet with Mike Carr (Pillar Energy). Mike stated that they are not planning to remove soil from the site.

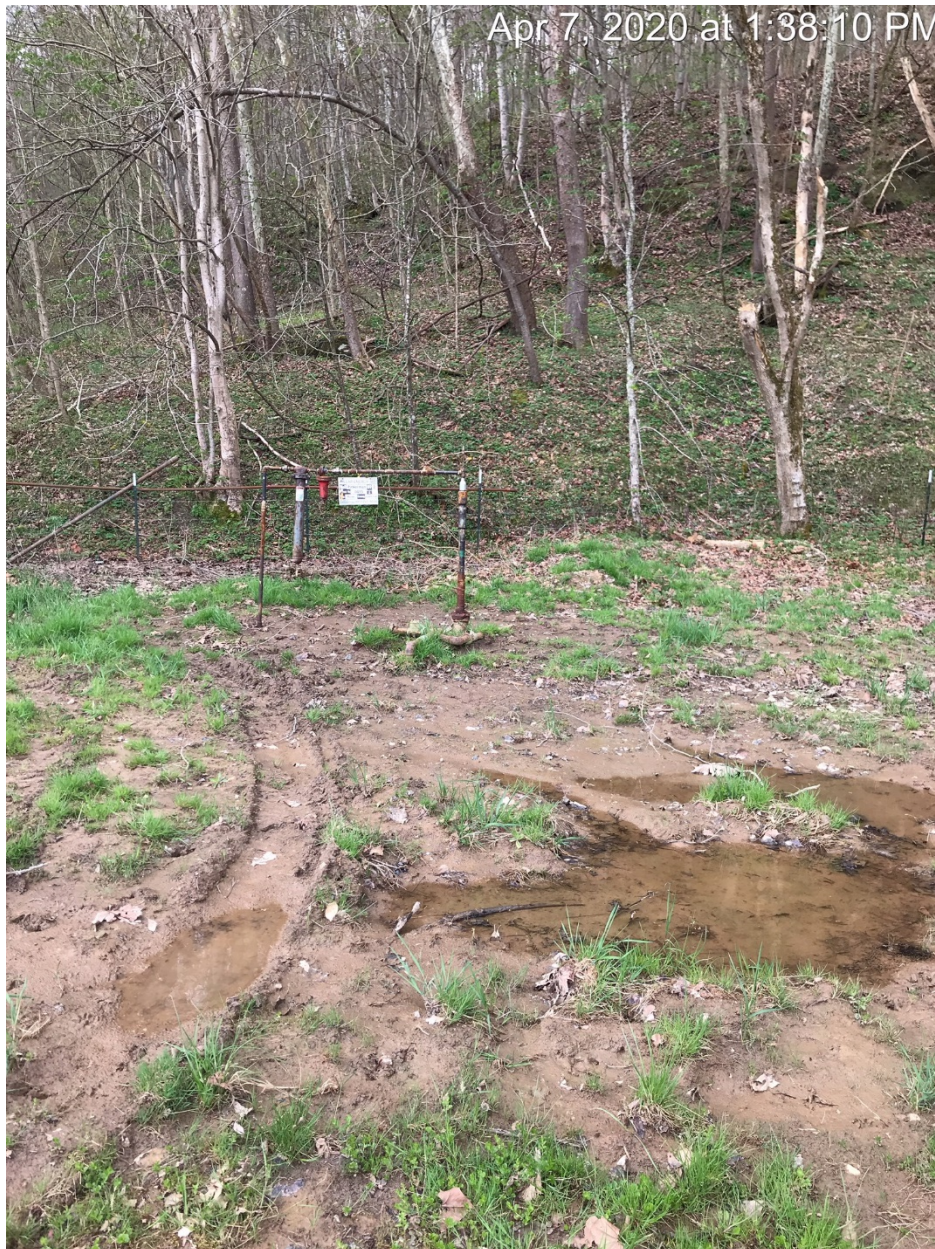
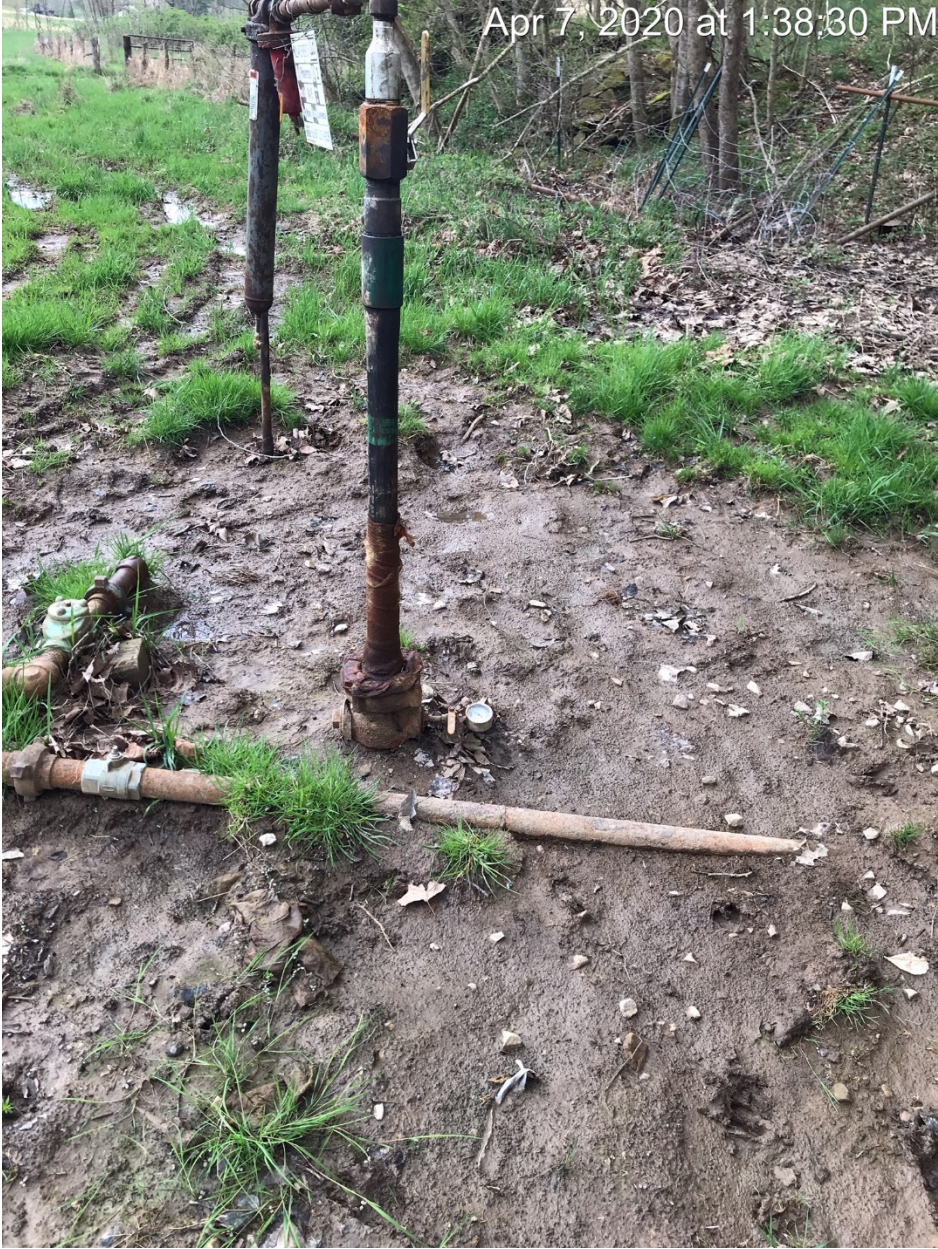
4-7-20 Compliance Notice # 1536086906 follow up inspection. Contaminated soil has not been removed from the location. Flood debris was observed at the well site from a recent event. Pictures were taken of the scald area.
