9-4-2019 CN #1567619883. UIC Quarterly inspection of the well revealed that the injection tubing is leaking brine onto the wellhead and onto the ground (a contaminated area 20 inches by 24 inches.) The standing water on the wellhead ring was tested with a high range Quantab. The Quantab was maxed out at greater than 6898 ppm Cl. The top joint of injection tubing needs to be repaired or replaced. All contaminated soil must be removed and disposed of at an EPA approved landfill. The injection line must be shut off until repairs have been completed. Contact UIC Inspector Jon Scott at 740-624-4963

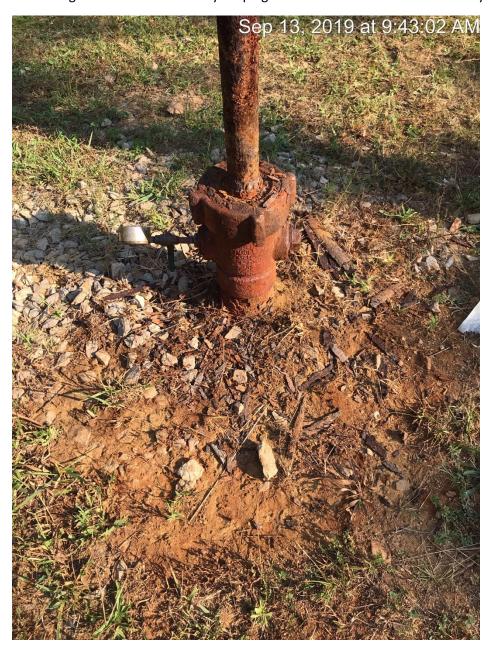
9-13-2019 Compliance Notice # 1567619883 follow up inspection. The injection line valve is closed. The injection tubing master valve is closed. The injection tubing insulation and scale have been removed. The tubing is wet but not currently seeping brine. The scald area is 24 inches by 24 inches.

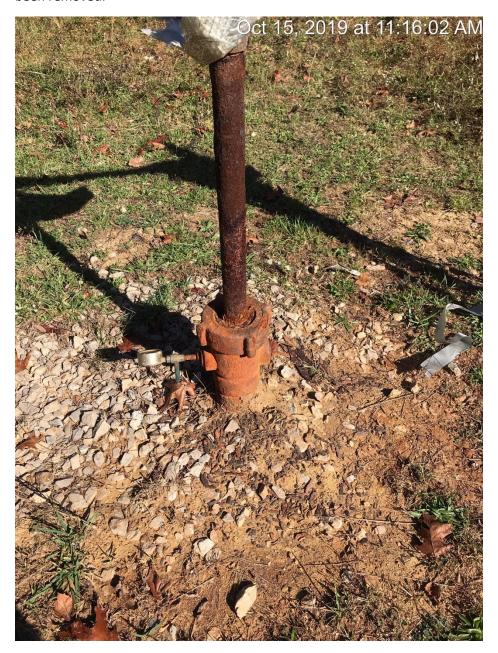
10-15-2019 Compliance Notice # 1567619883 follow up inspection. The injection line valve is closed. The injection tubing master valve is closed. The tubing leak has not been repaired. Contaminated soil has not been removed.

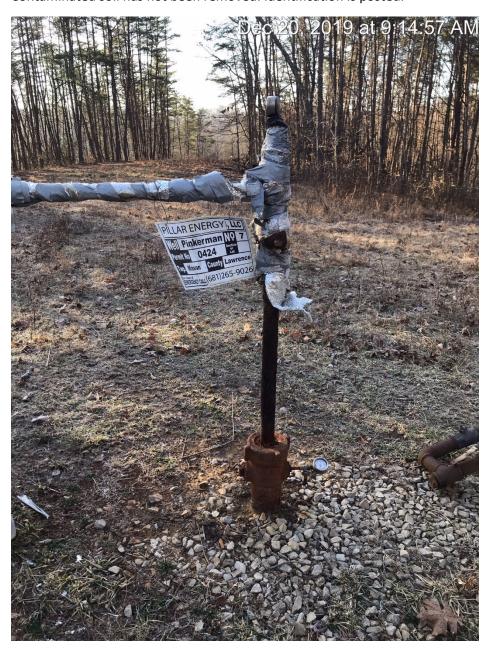
12-20-2019 Compliance Notice # 1567619883 follow up inspection. The injection tubing master valve is closed. The injection tubing hole is open with no fluid leaking out. The annulus has 202 psi. Contaminated soil has not been removed. Identification is posted.

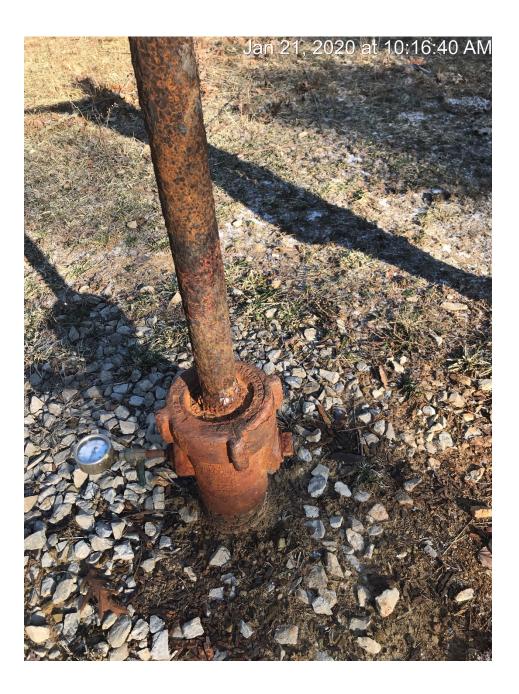
1-21-2019 Compliance Notice # 1567619883 follow up inspection. The injection tubing master valve is closed. The annulus valve is frozen shut. The tubing was not leaking during the inspection. Identification is posted.

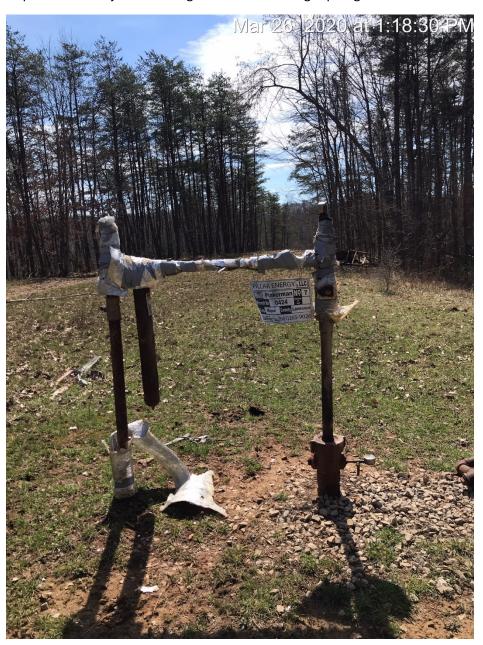
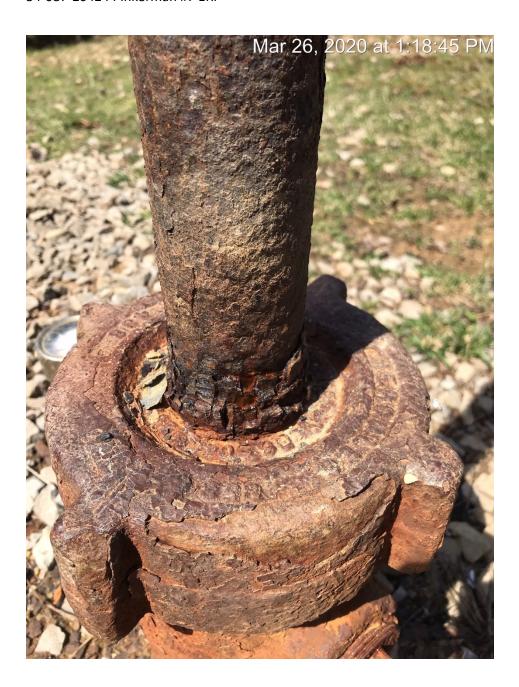
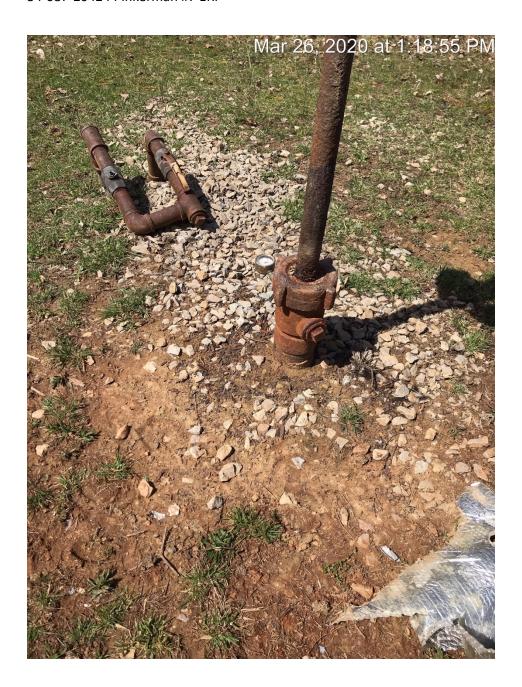
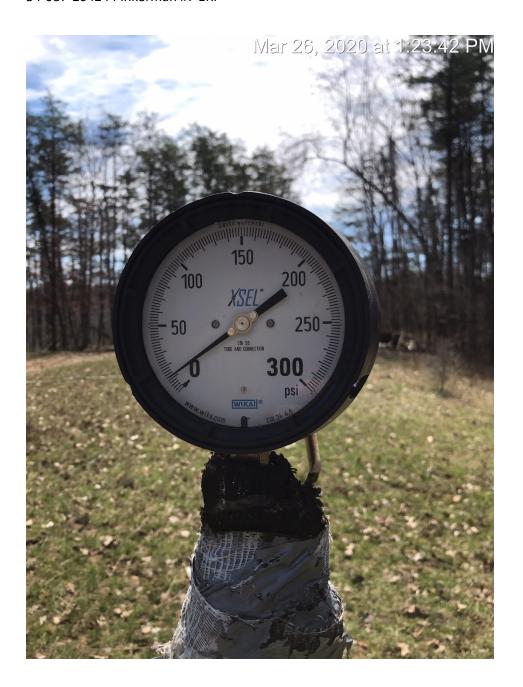
3-26-2020 Compliance Notice # 1567619883 follow up inspection. The injection line valve is closed. The injection tubing master valve is closed. The injection tubing master valve was not opened during the inspection. The injection tubing is wet at the casing slip ring. Pictures were taken.
