34-087-20476 Pinkerman #16 ERP CN Follow ups

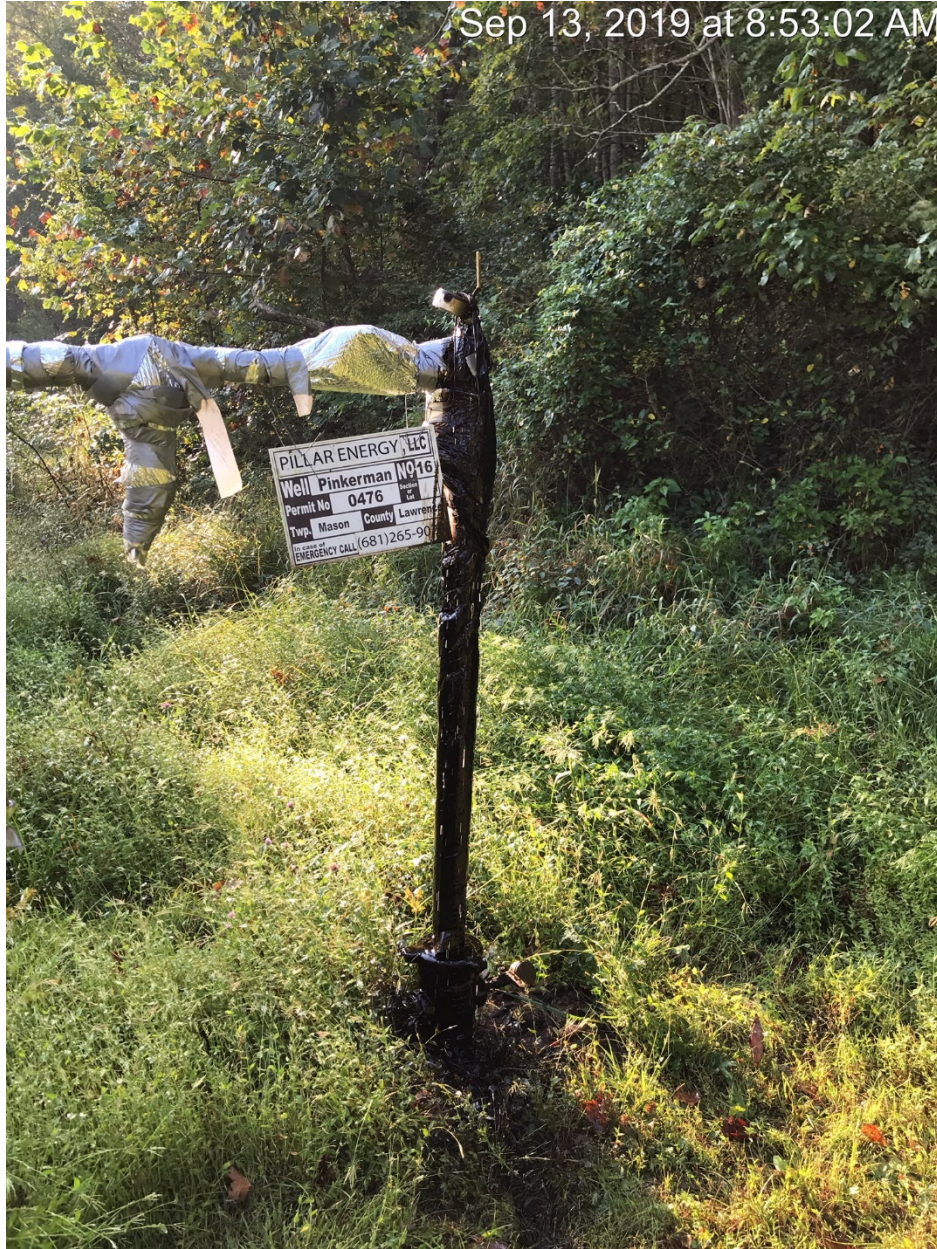
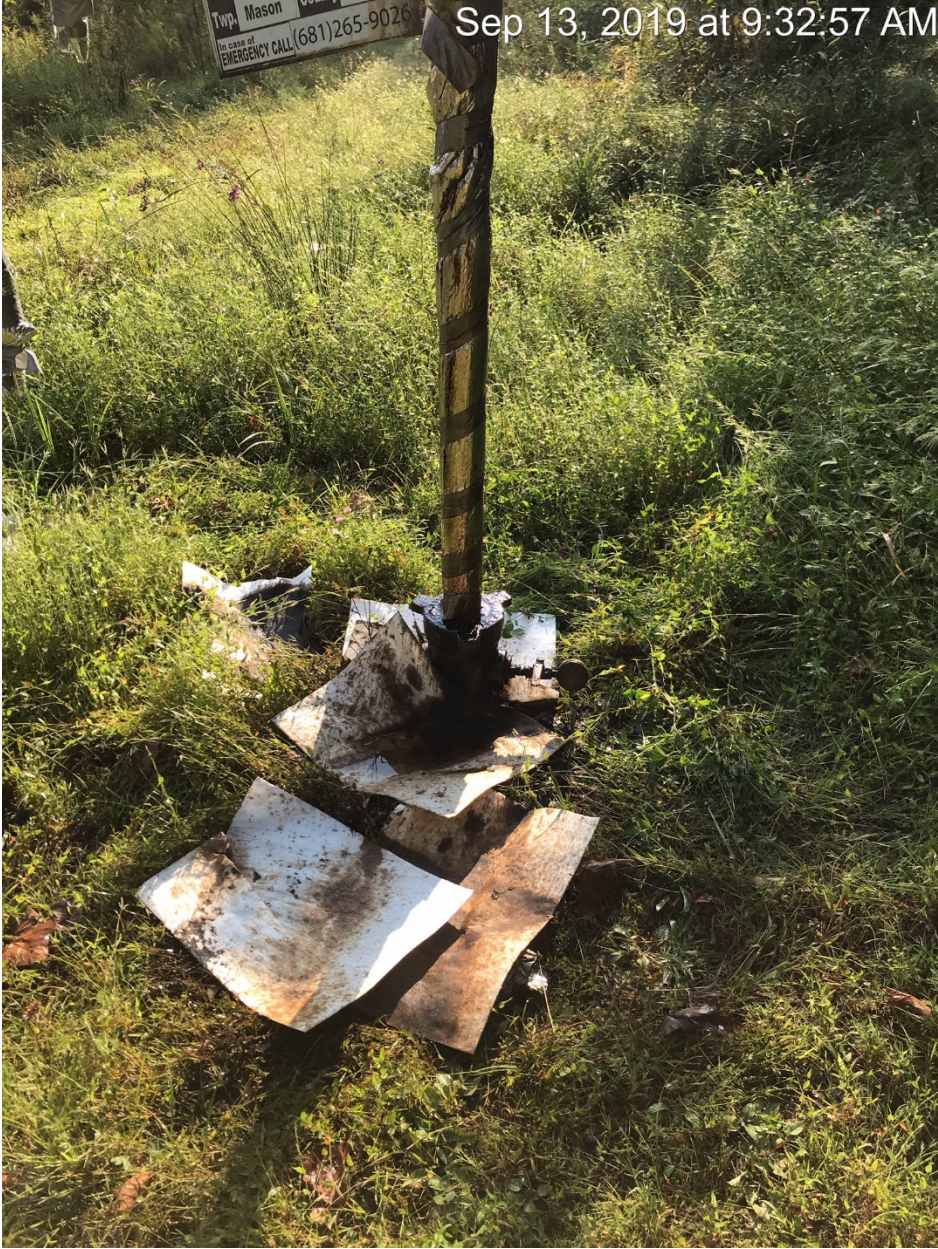
9-13-2019 UIC Quarterly inspection of the well revealed that the injection tubing 1/4 inch nipple and valve are leaking brine and oil onto the wellhead and onto the ground (a contaminated area 20 inches by 36 inches.) The injection tubing fittings need to be repaired or replaced. All contaminated soil must be removed and disposed of at an EPA approved landfill. The injection line must be shut off until repairs have been completed. Contact UIC Inspector Jon Scott at 740-624-4963

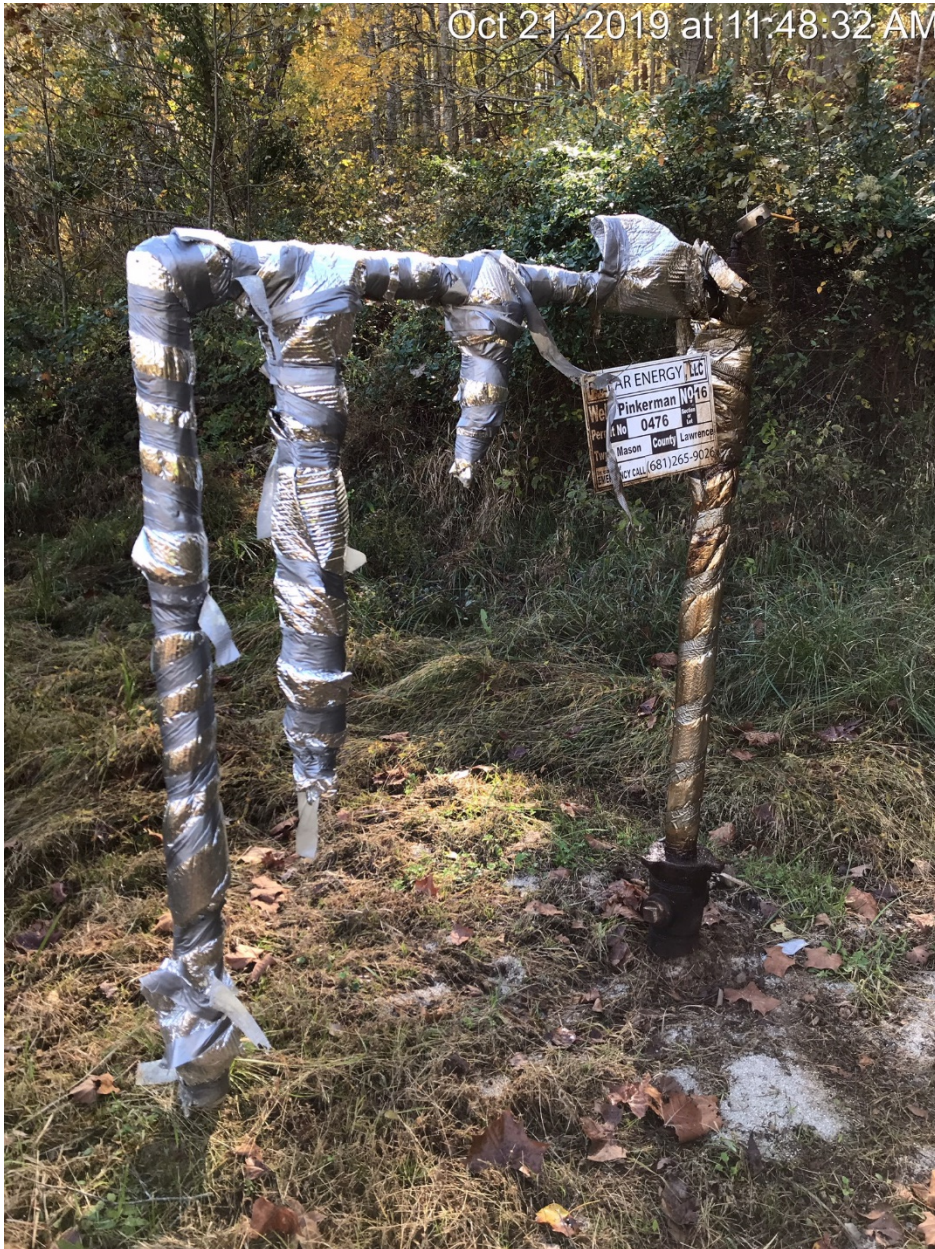
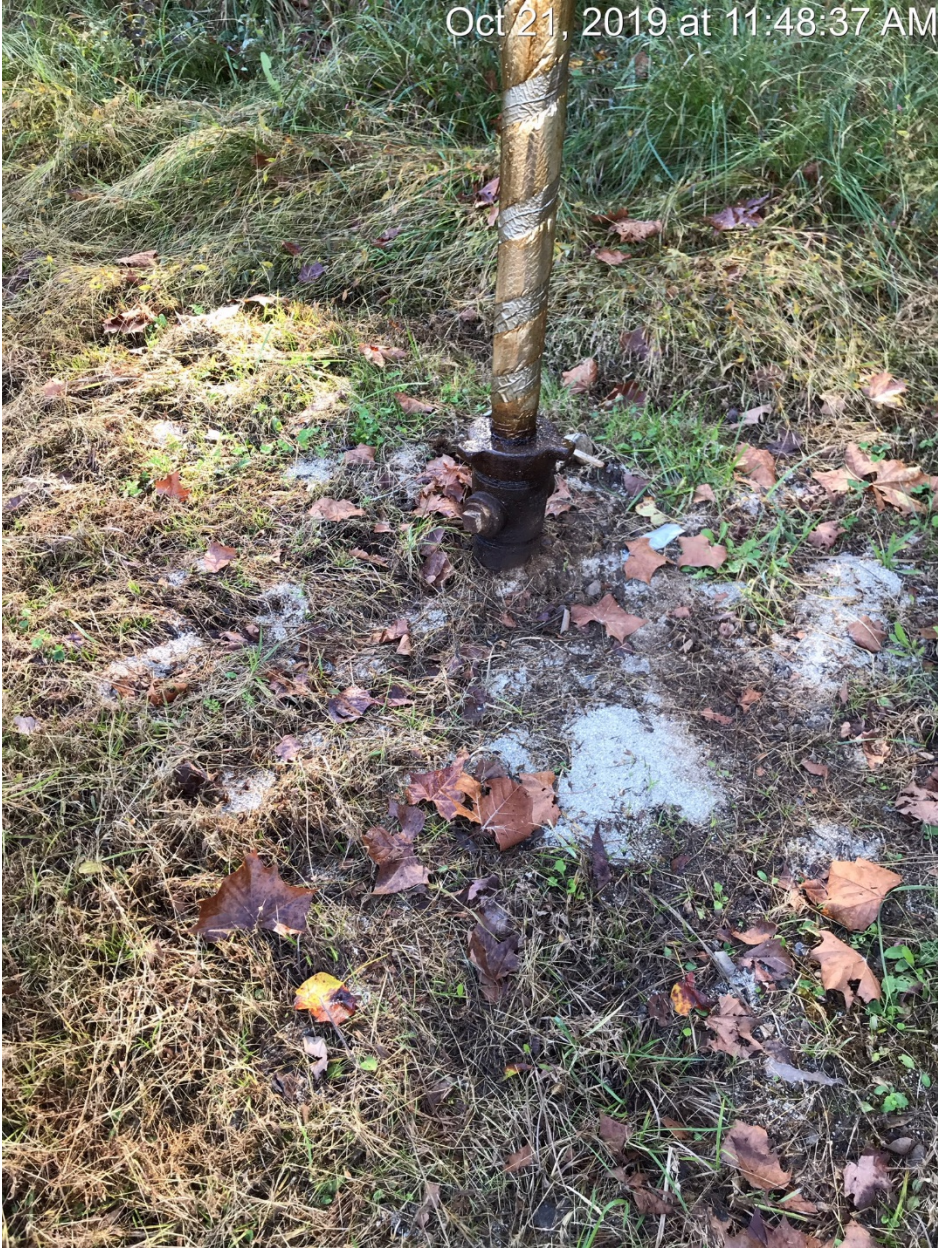
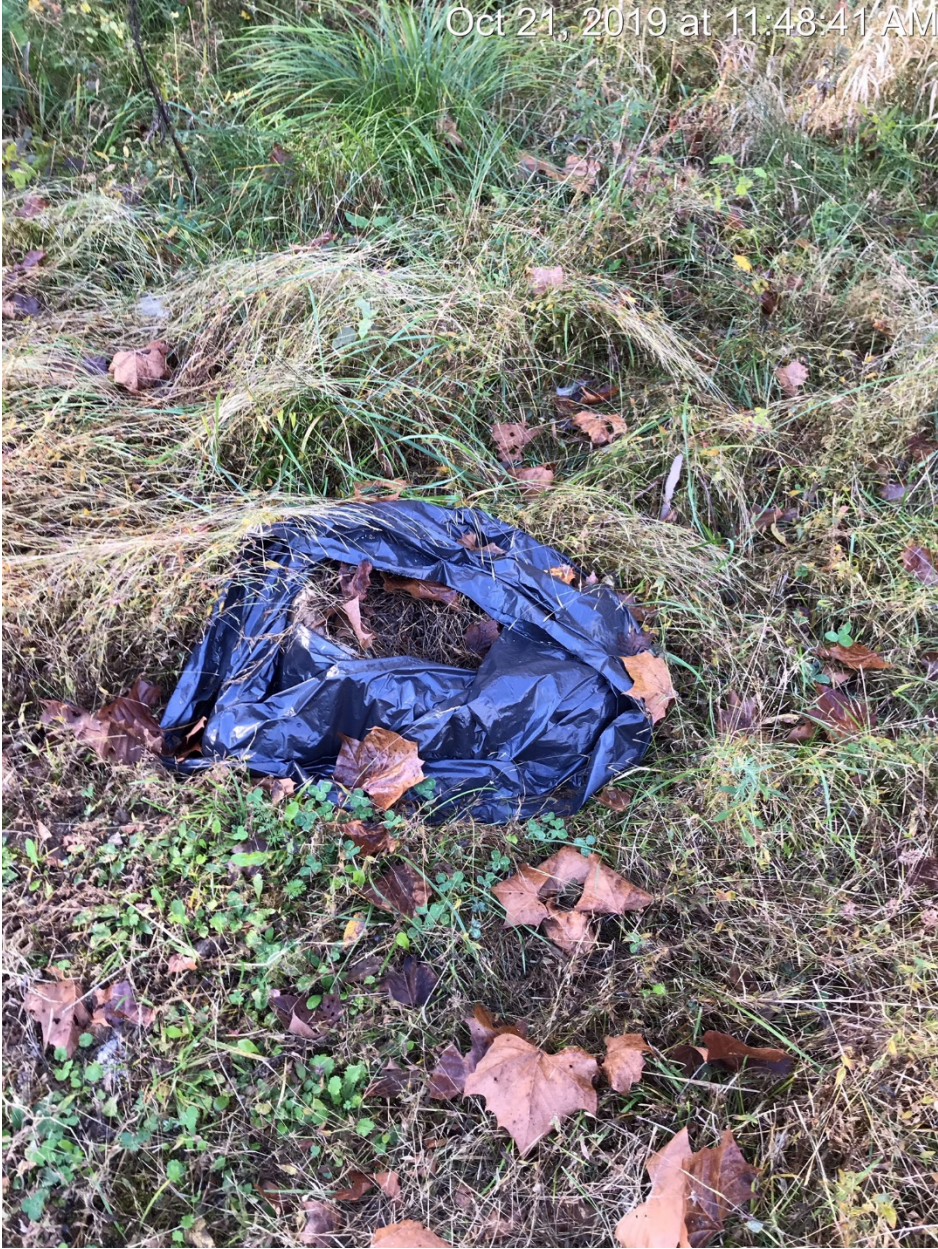
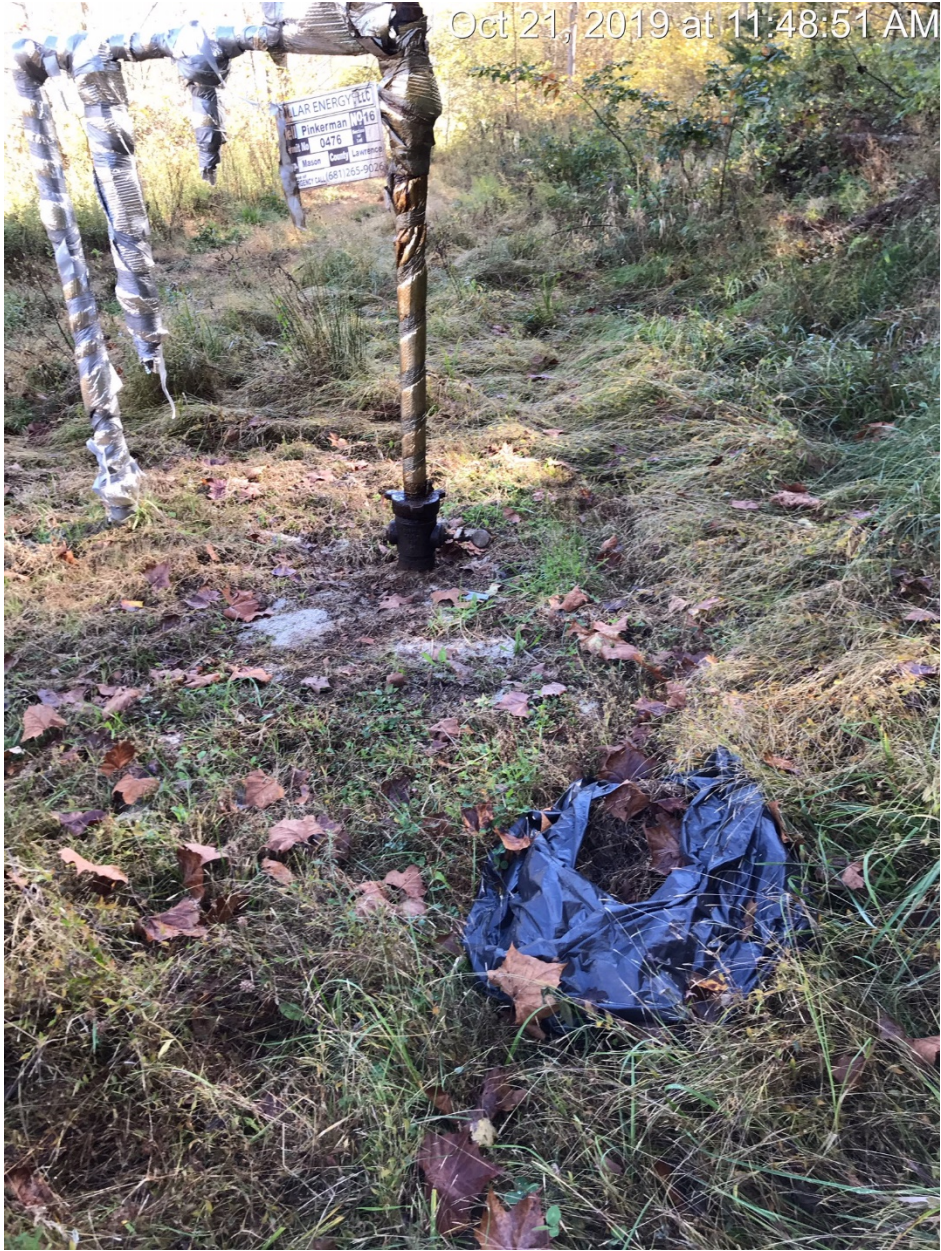
10-21-2019 Compliance Notice # 954126558 follow up inspection. A 6 foot by 4 foot area at the wellhead has absorbing material applied to the ground. A black plastic bag is on site with contaminated material and used absorbing pads in it. No contaminated soil has been removed from the spill site.

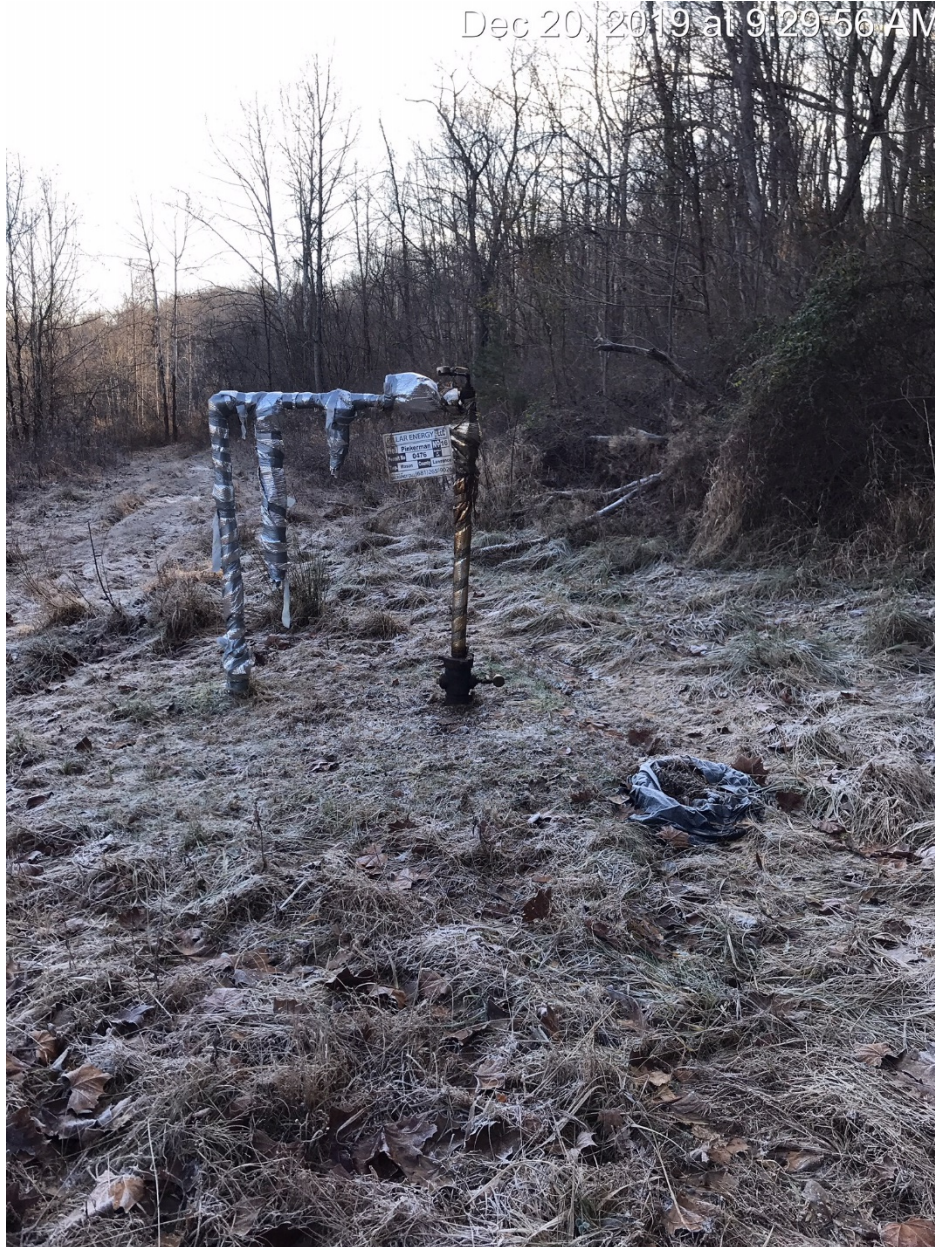
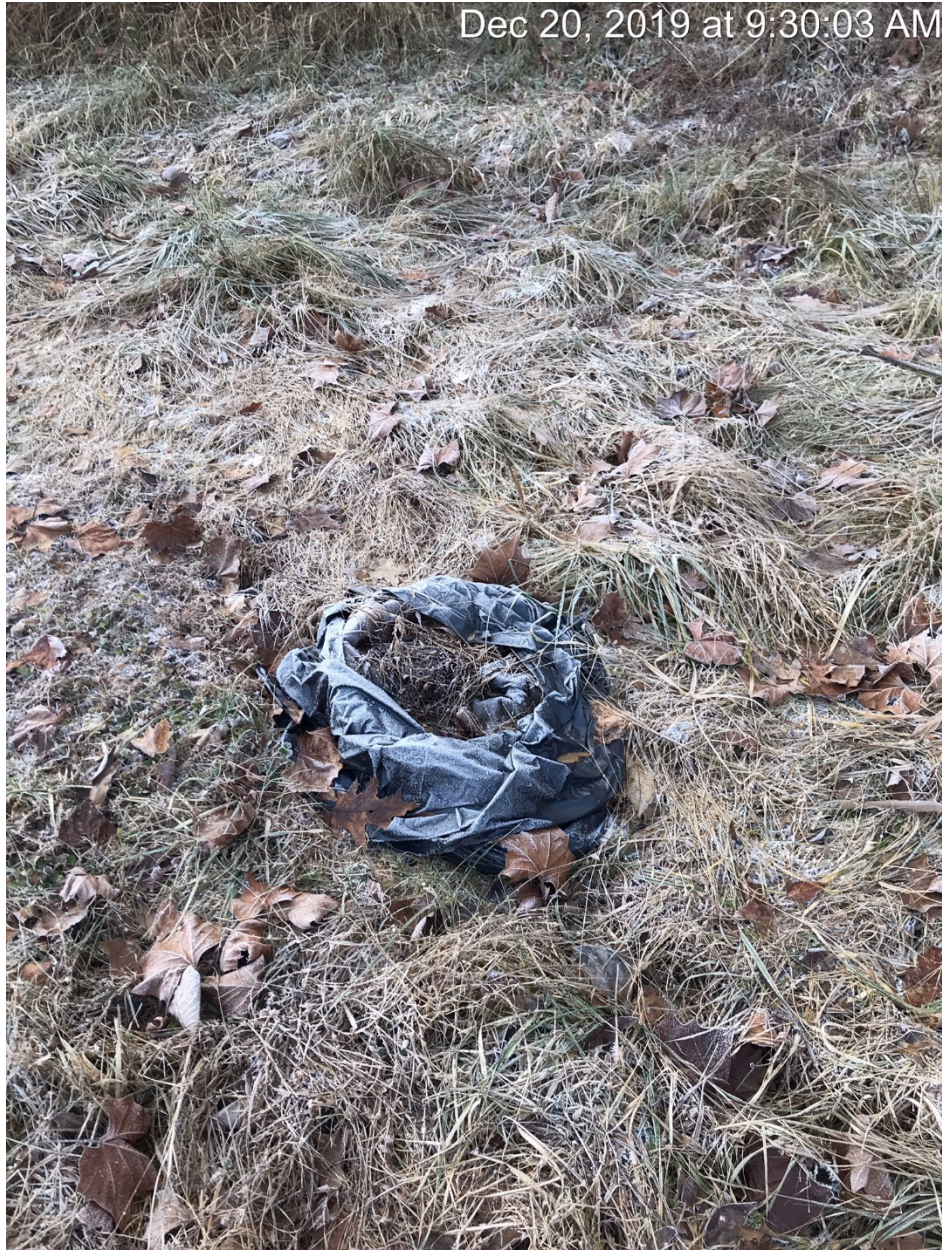
12-20-2019 Compliance Notice # 954126558 follow up inspection. Contaminated soil has not been removed from the location. Absorbent material has been applied to a 4 foot radius around the well. There is a black plastic trash bag with contaminated material, pads in it on site. The annulus is frozen.

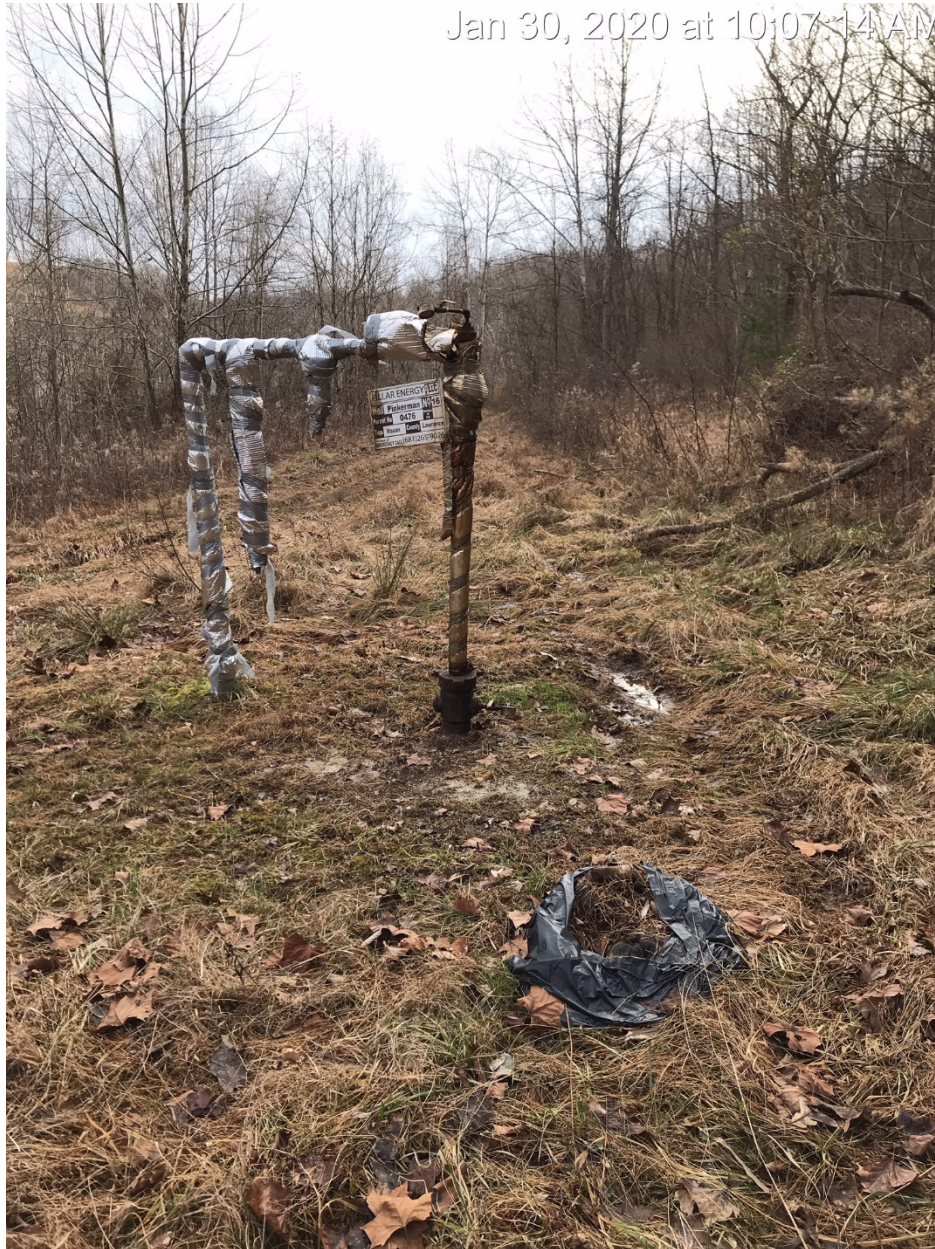
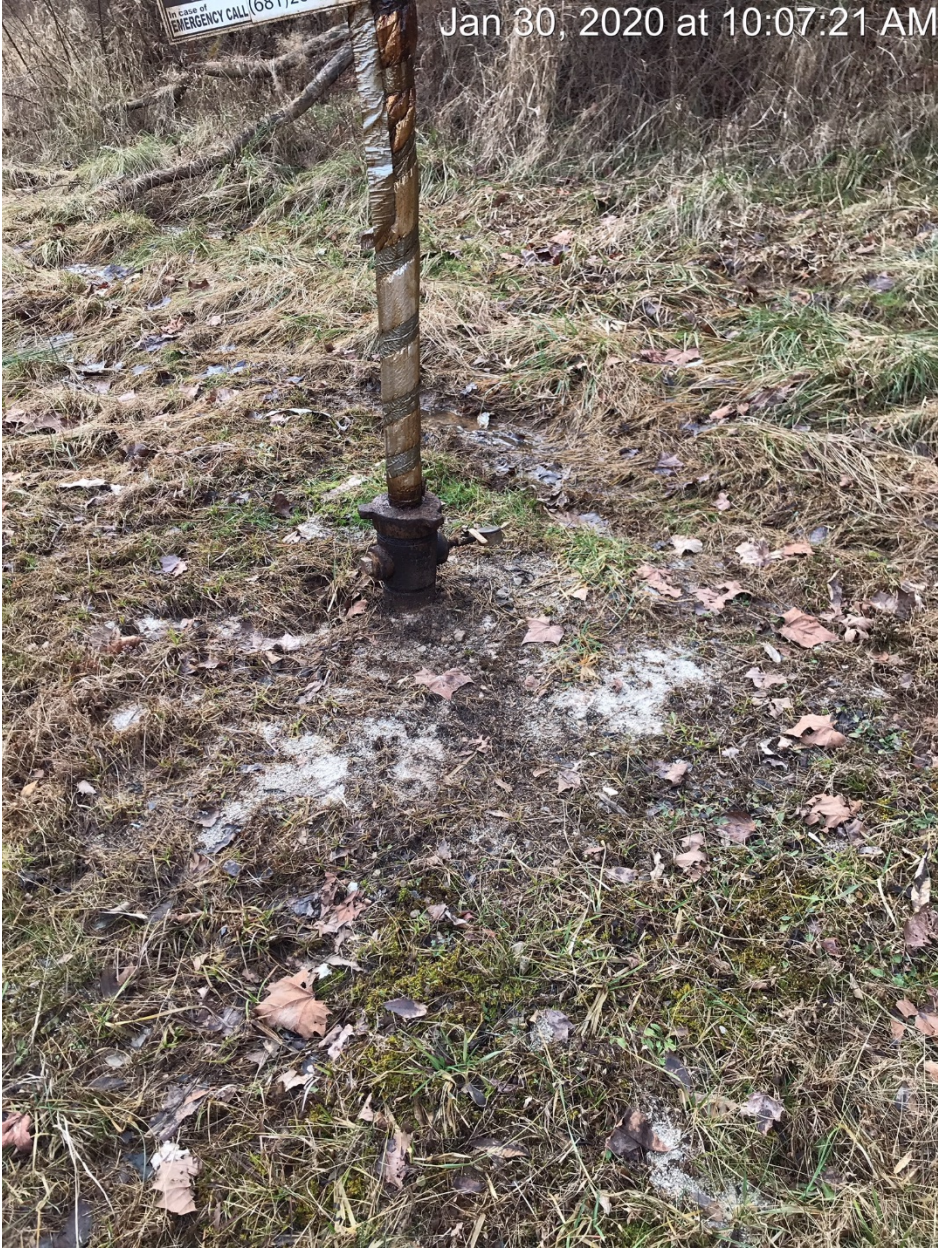
1-30-2020 Compliance Notice # 954126558 follow up inspection. There is a black plastic bag with contaminated pads and contaminated material located 6 feet from the well. There is an absorbent material (grey) on the ground surrounding the well. No contaminated soil has been removed. During a meeting with Mike Carr (Pillar Energy) Mike stated that they are not removing soil from the site.

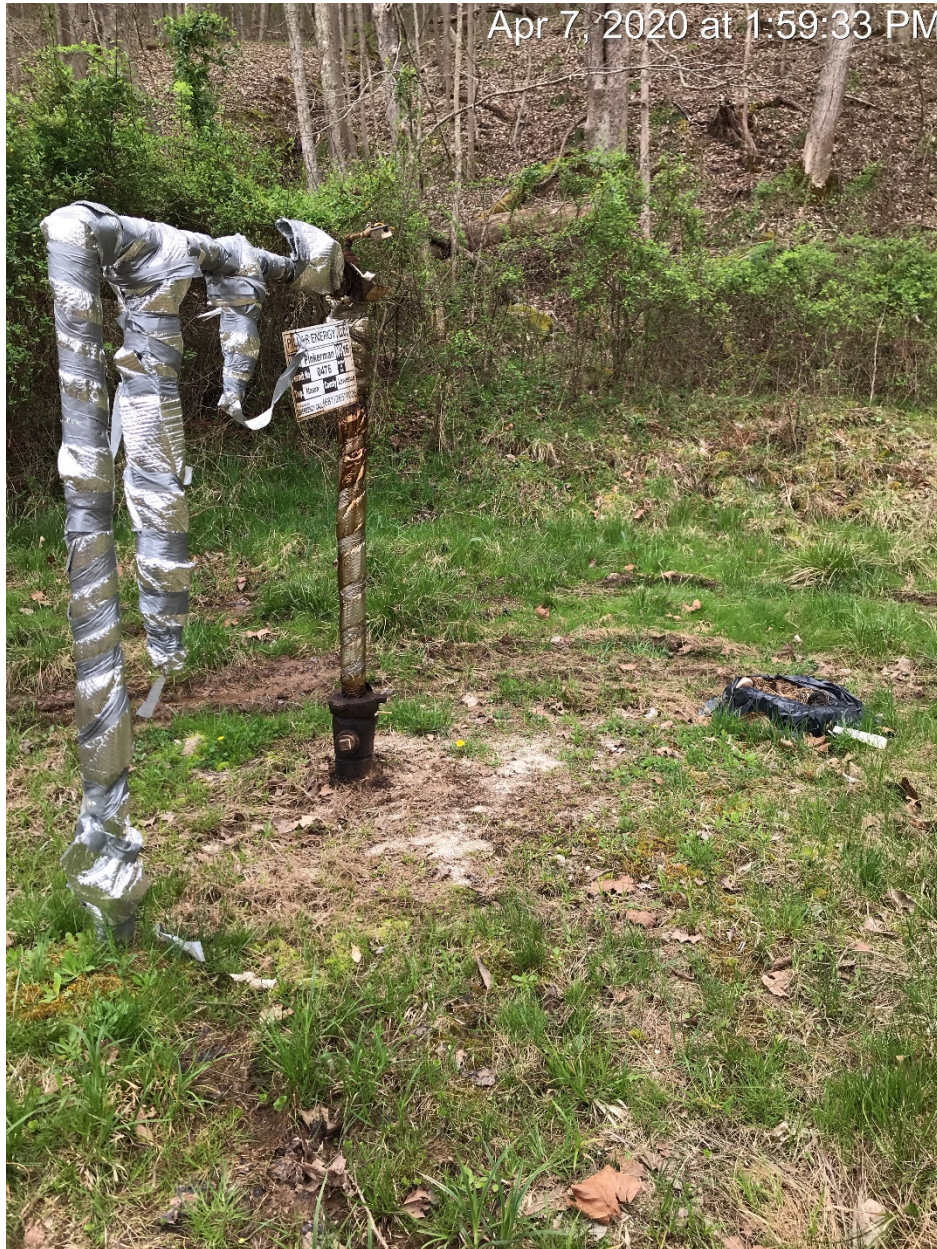
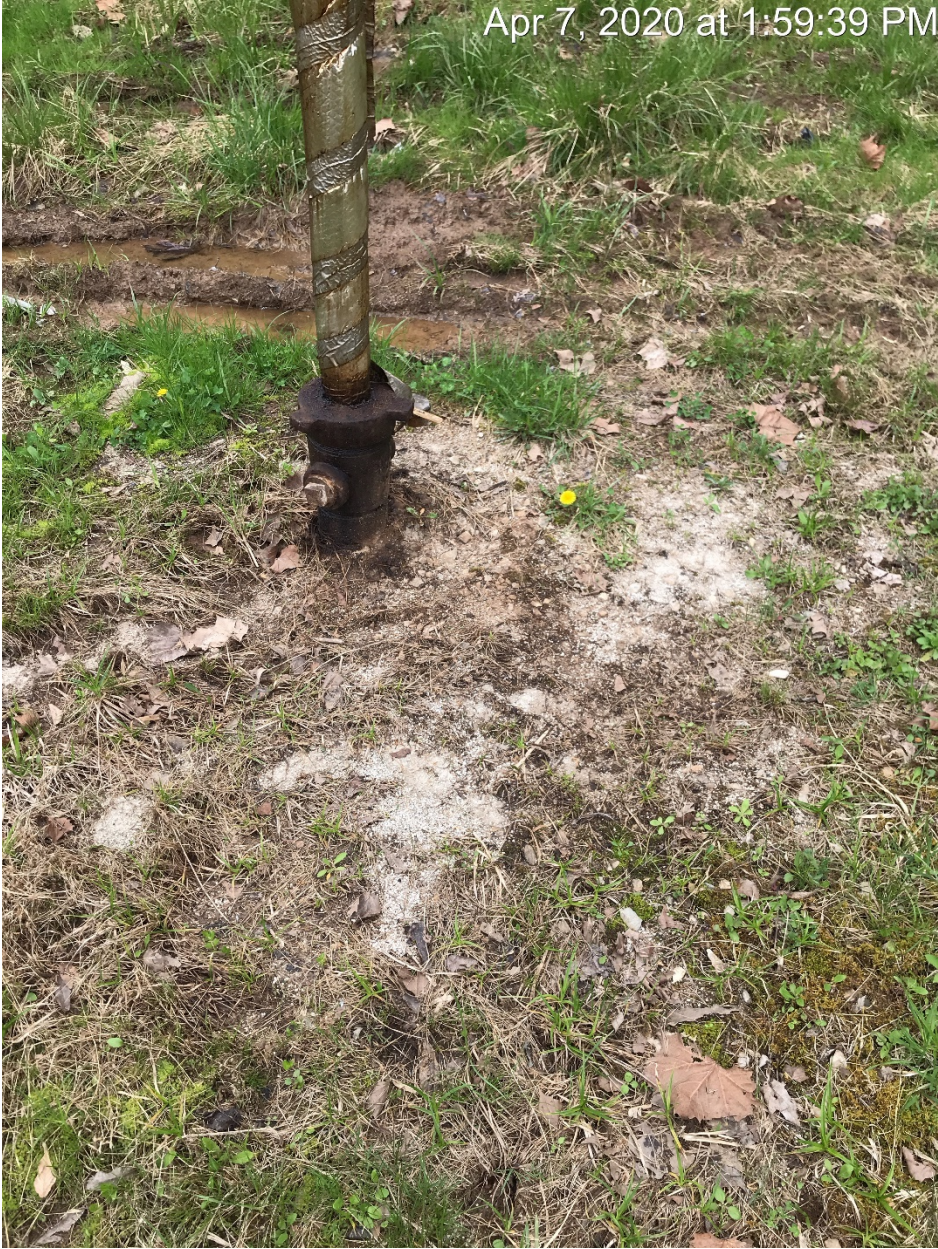
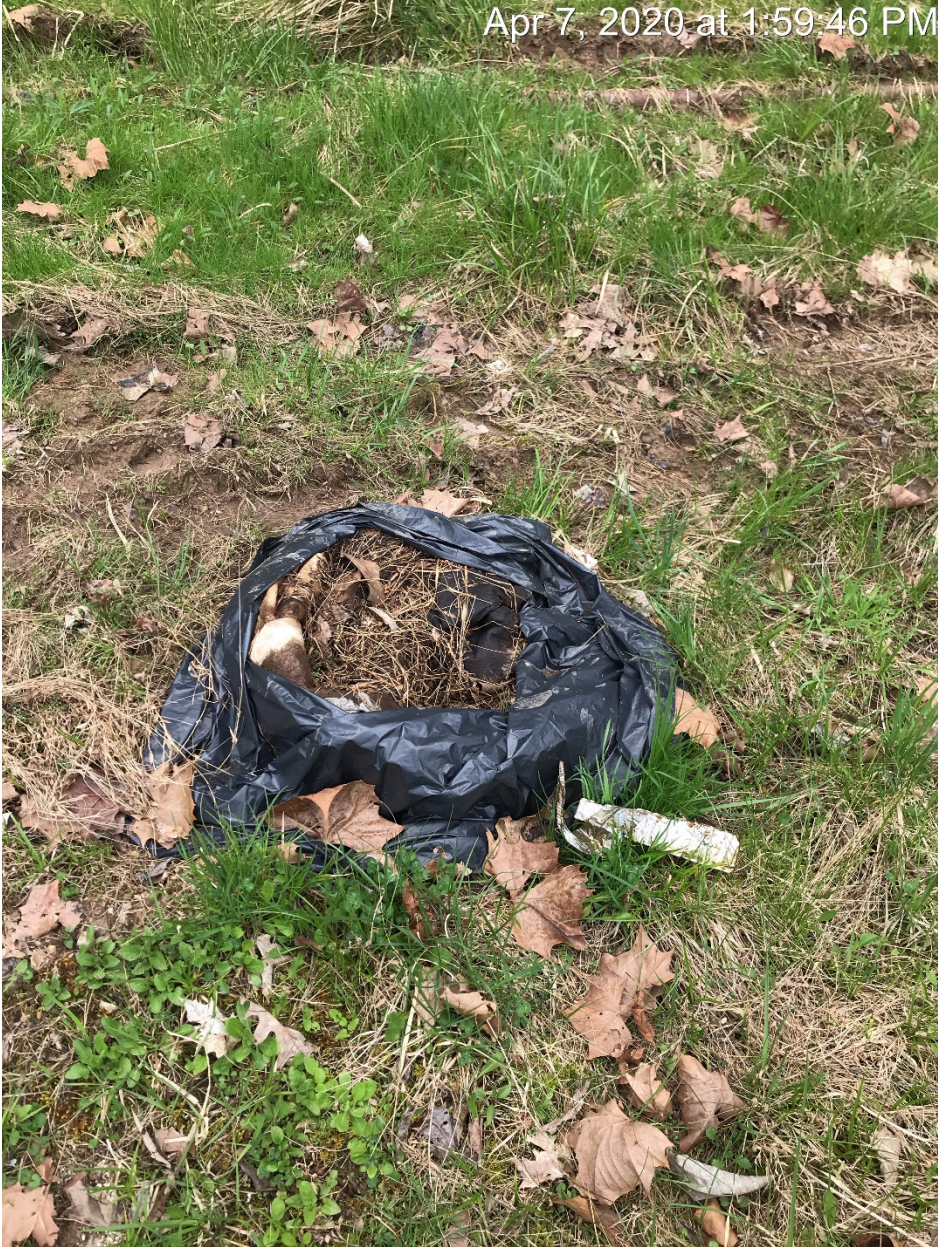
4-7-20 Compliance Notice # 954126558 follow up inspection. Contaminated soil has not been removed from the location. Grey absorbent material is still coating the ground around the well. A black plastic bag with contaminated material is on location.
