34-163-20318, Adams Oil and Gas, Enhanced Recovery Injection Well. Chief's Order 2011-50 Follow up inspection Photos.

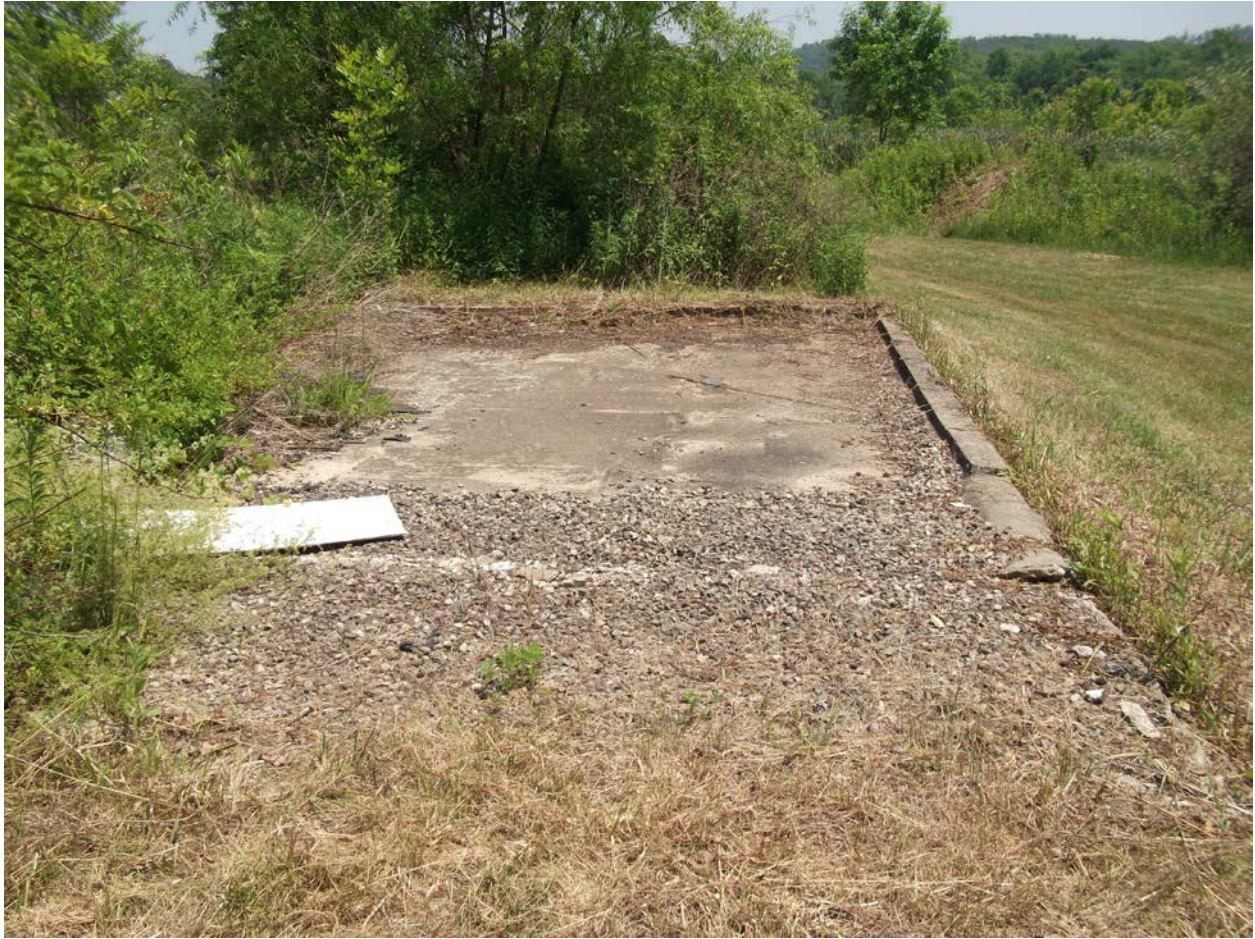
This photo shows the unloading pad for the Adams Oil and Gas Enhanced Recovery Injection well 34-163-20318. Photo taken on 6-10-15 By ODNR/DOGRM UIC Inspector Jon Scott.

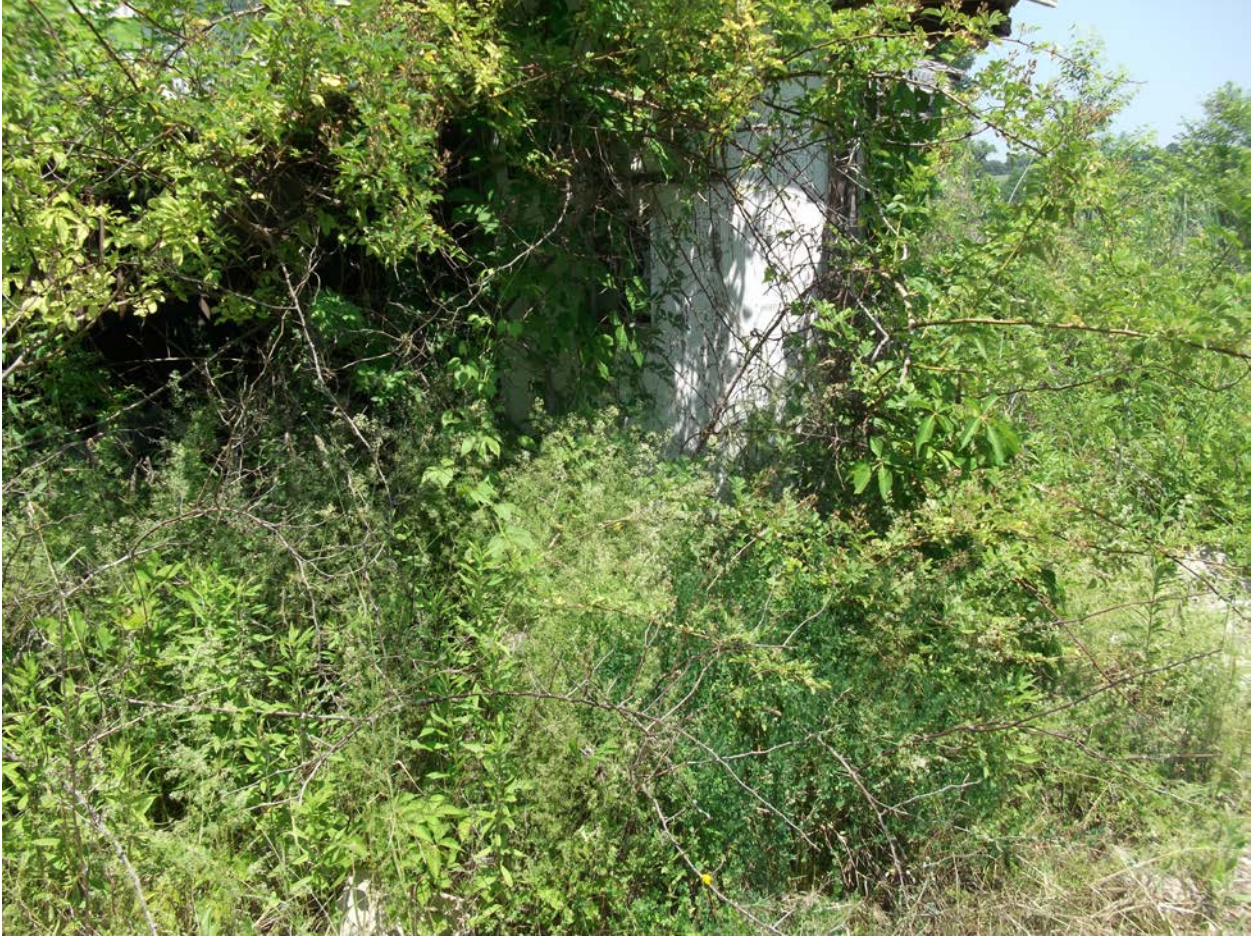
This Photo shows the side of the facility pump house. All injection equipment has been removed.

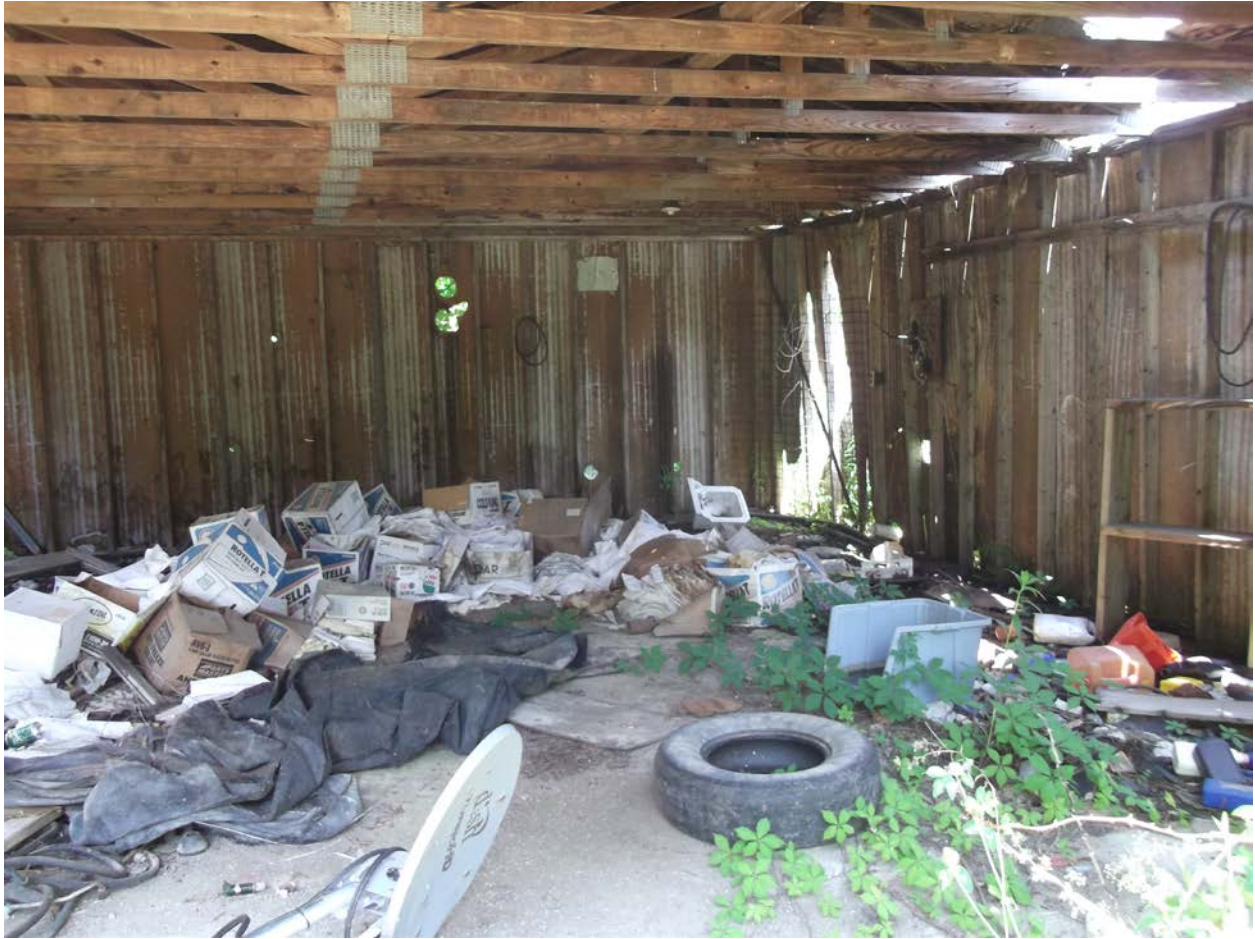
This Photo shows the inside of the facility pump house.

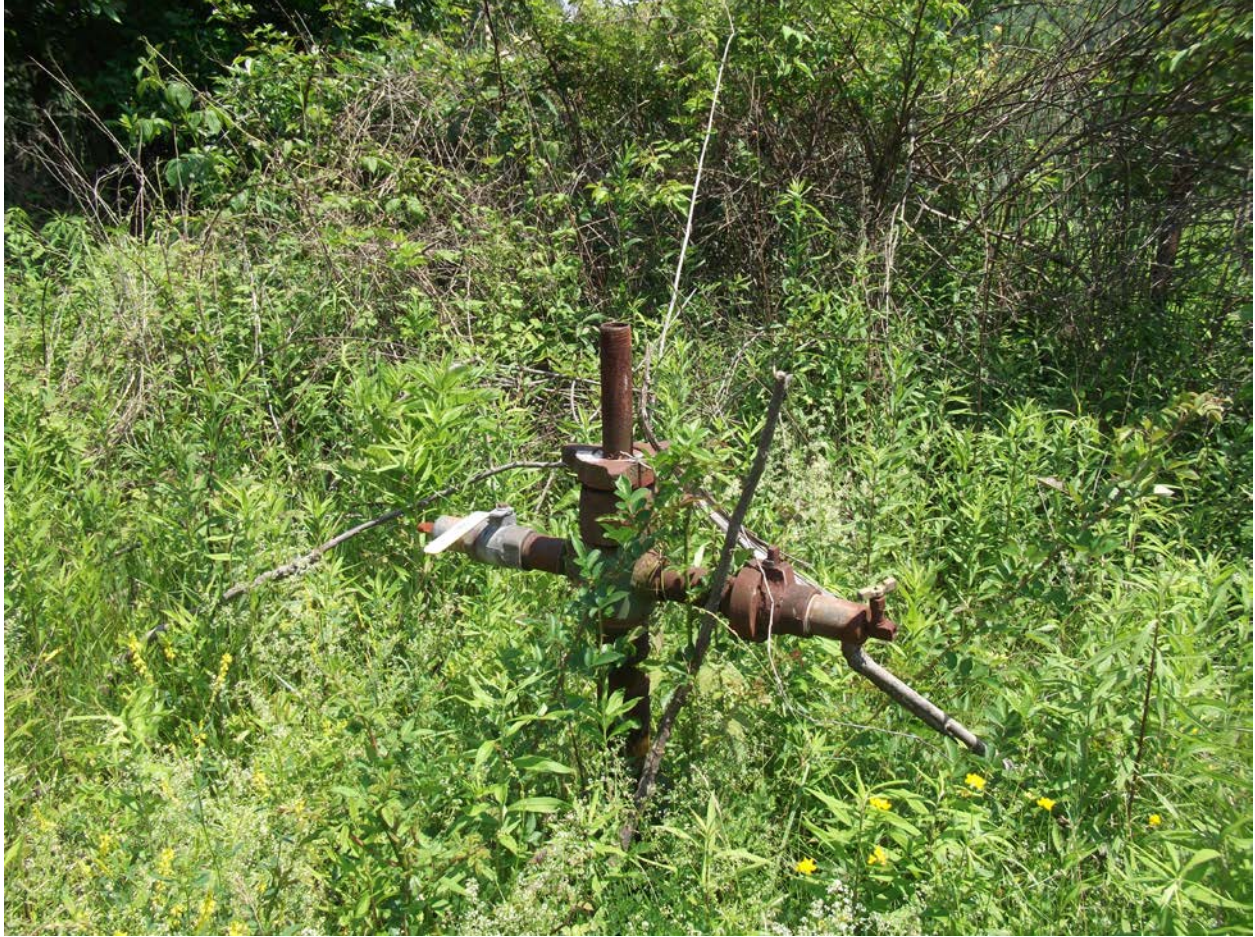
This photo shows the 34-163-20318 Enhanced Recovery Injection Well. Note the injection tubing is not equipped with a master valve. The annulus has zero pressure. The well is not connected to injection lines or equipment.

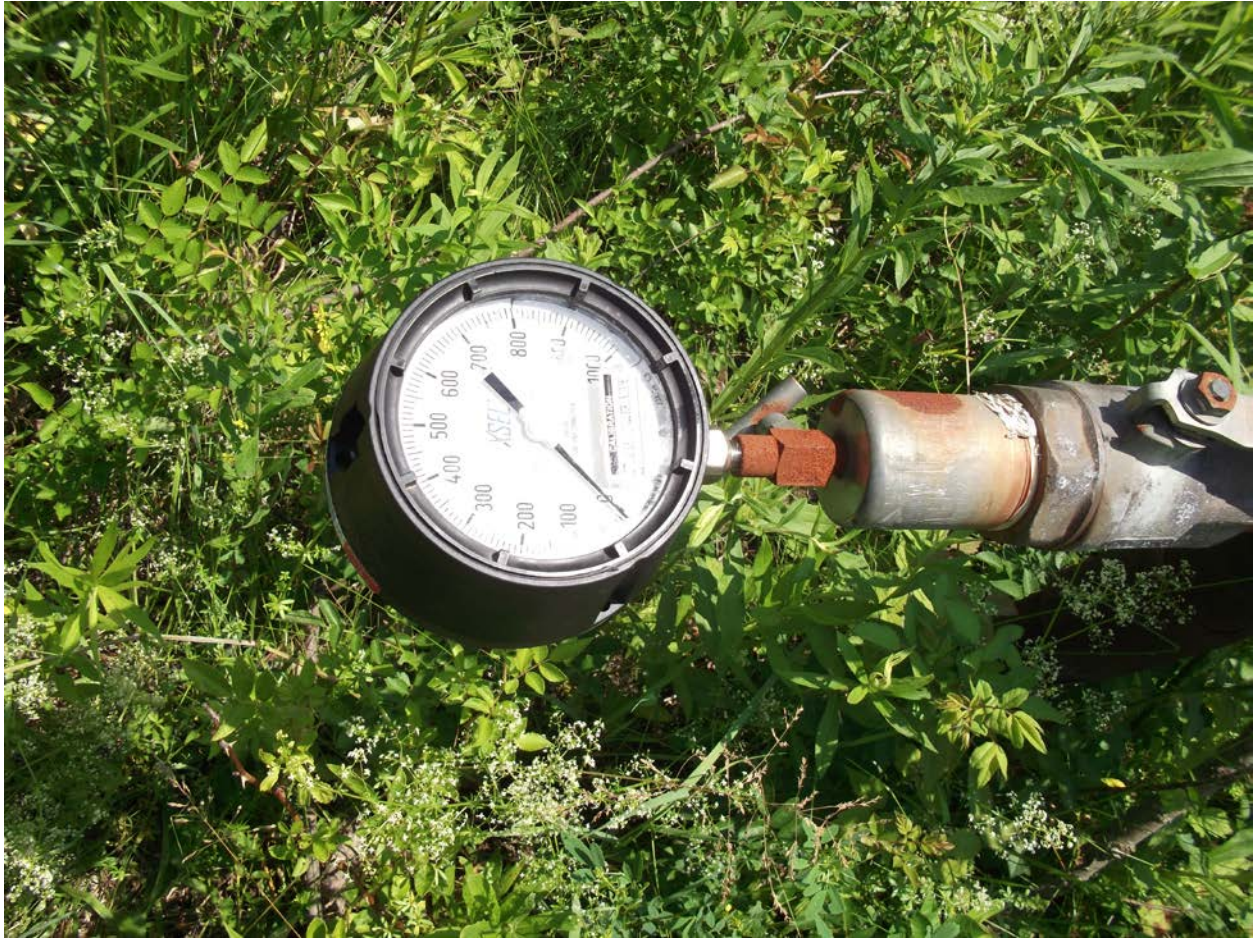
This photo shows the state issued 1000 psi gauge installed on the annulus with all valves open. Annulus has zero pressure.

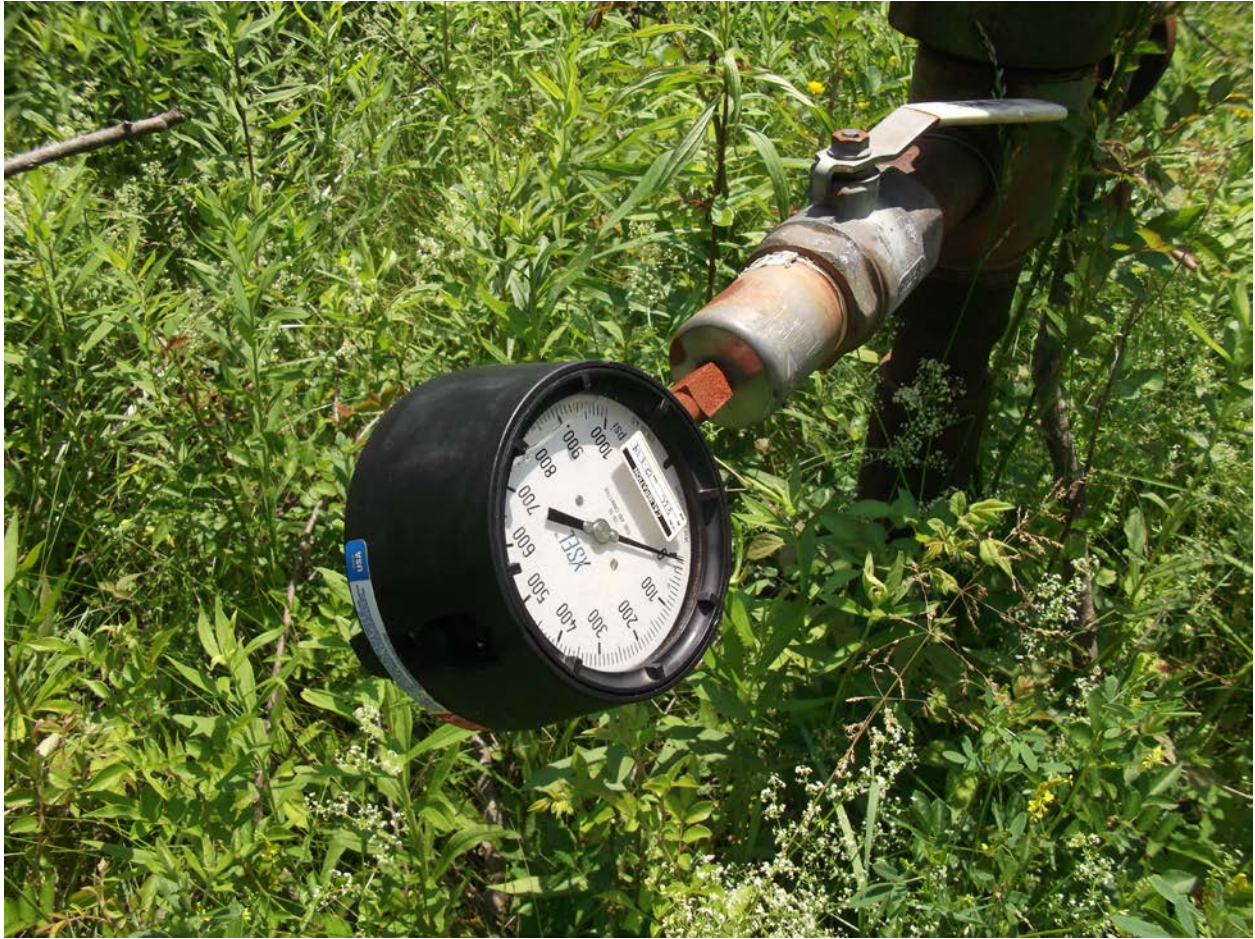
This photo shows another view of the state issued 1000 psi gauge installed on the annulus with all valves open. Annulus has zero pressure.

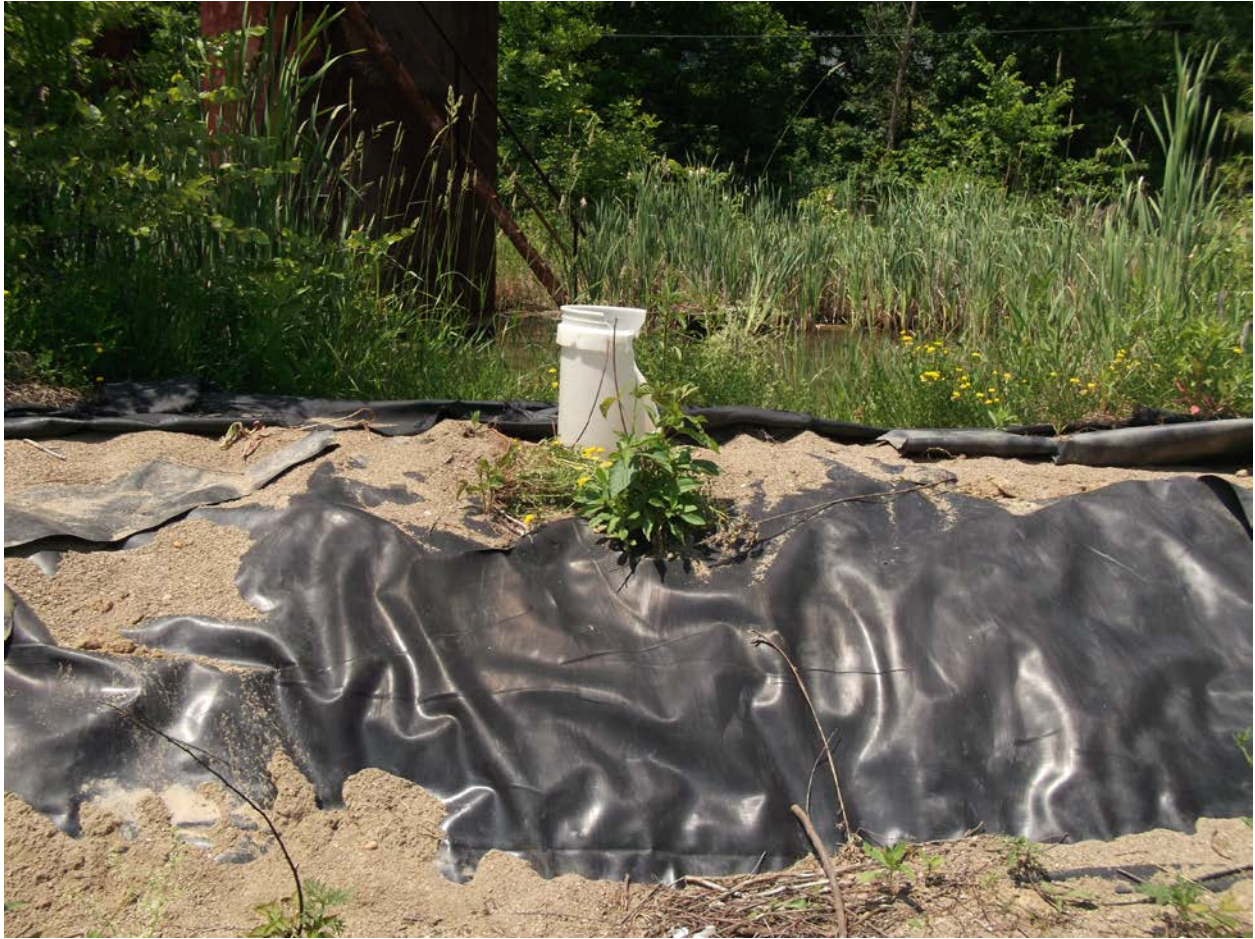
This photo shows the containment dike wall. Note the aquatic vegetation in the containment dike.

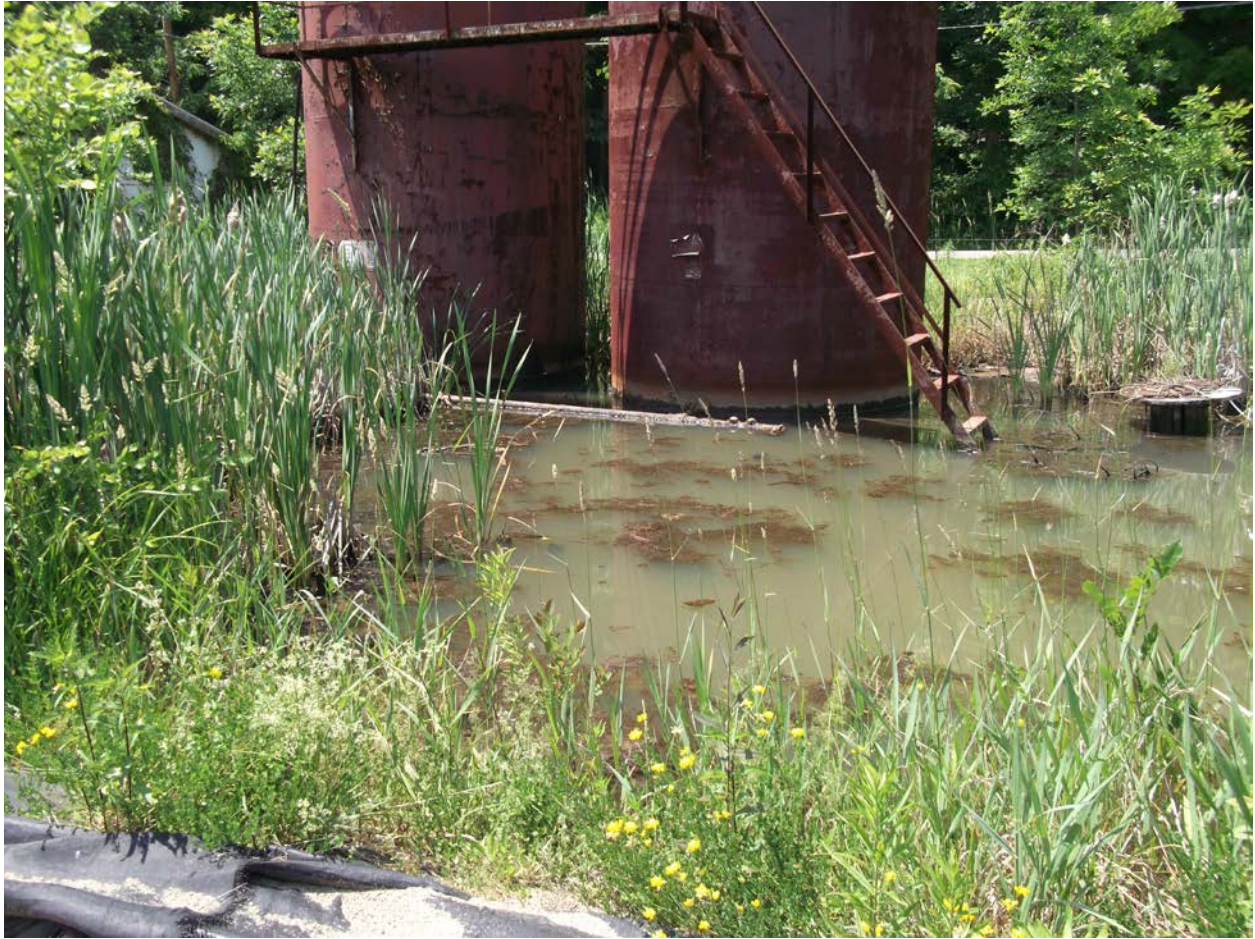
This photo shows the Containment dike with the two 210 barrel tanks. The dike is full of water and aquatic vegetation.
