Project: **ERP-1-LAWR**

Well Name **EDWARD PINKERMAN {ERP#1}** 7 No. **7** WH_LAT: **38.636890** WH_LONG **-82.447060**

Inspection Type: **Enhanced Recovery Project**

Inspection Purpose: **Compliance Notice Follow-up.**

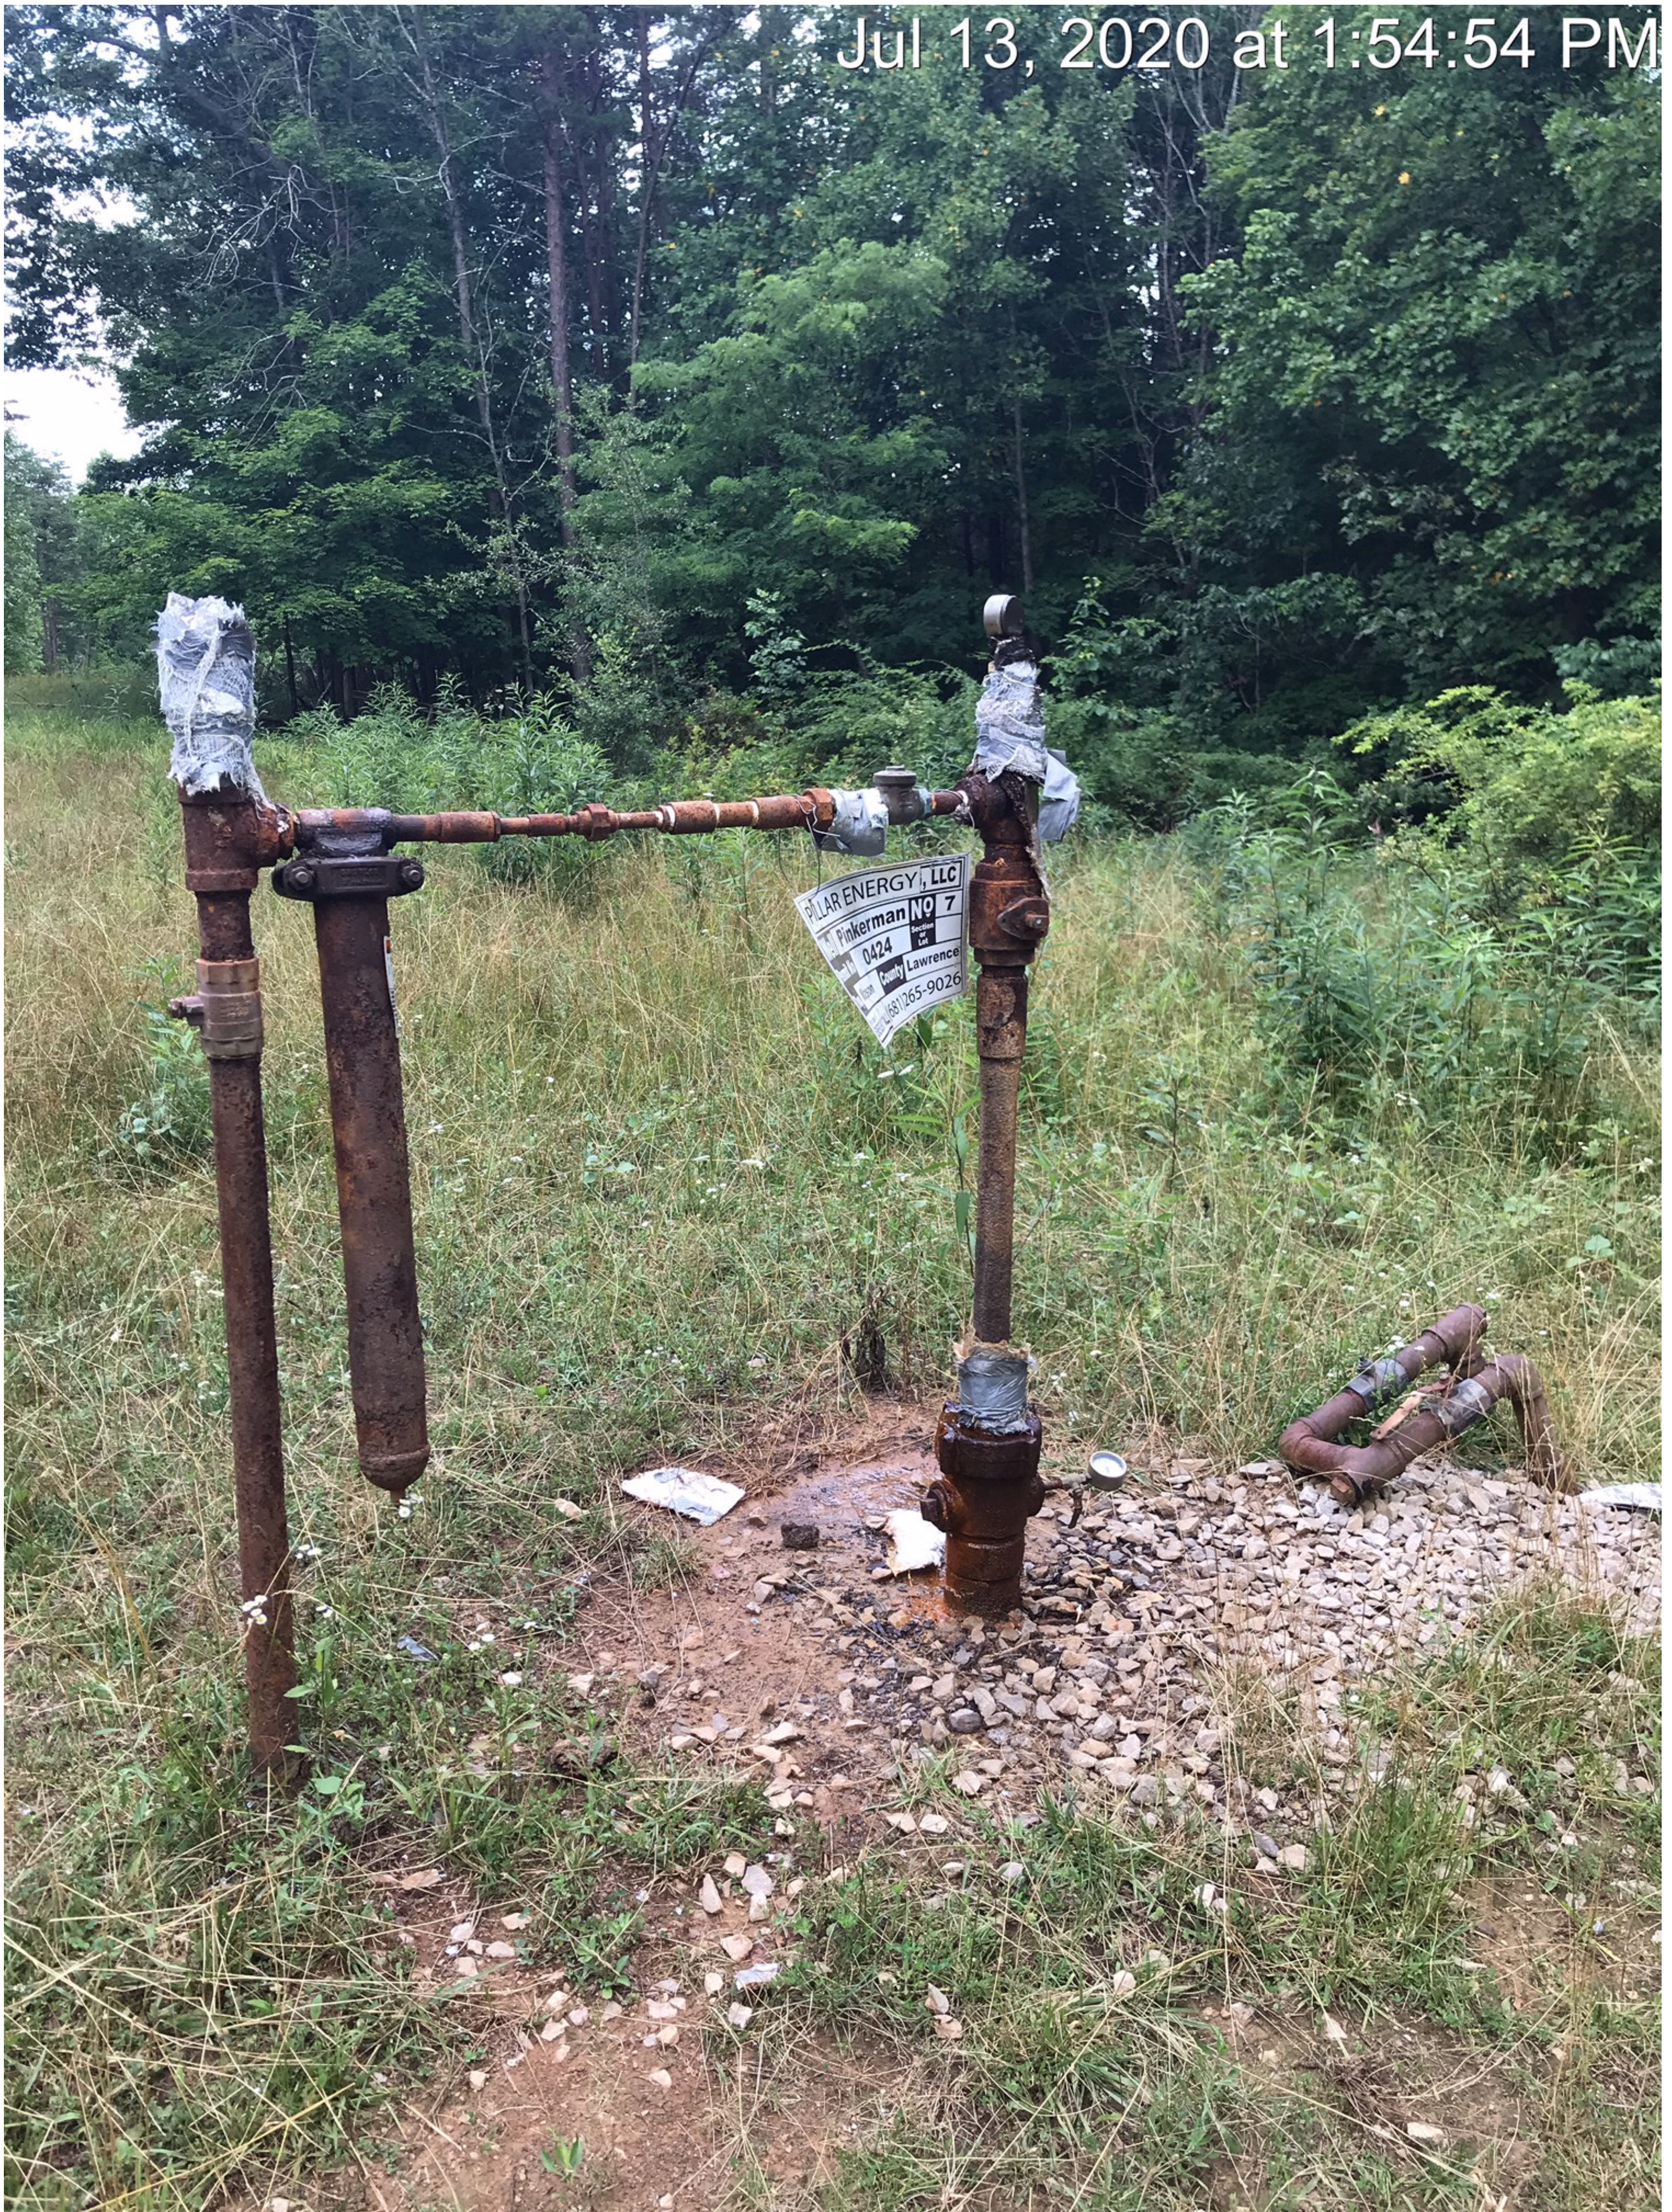
Jul 13, 2020 at 1:54:54 PM

Compliance Notice # 1567619883 follow up inspection. The injection tubing is currently leaking brine into the ground. The scald area is 48 inches by 36 inches with standing brine. The brine was tested on the ground with a high range Quantab. The Quantab was maxed out at over 6,000 ppm Cl. The injection tubing has 40 psi on it. The injection tubing master valve was closed and not opened during the inspection due to the over all poor condition of the tubing and fittings. Pictures were taken.
