34-087-20415 Pinkerman # 2 ERP CN

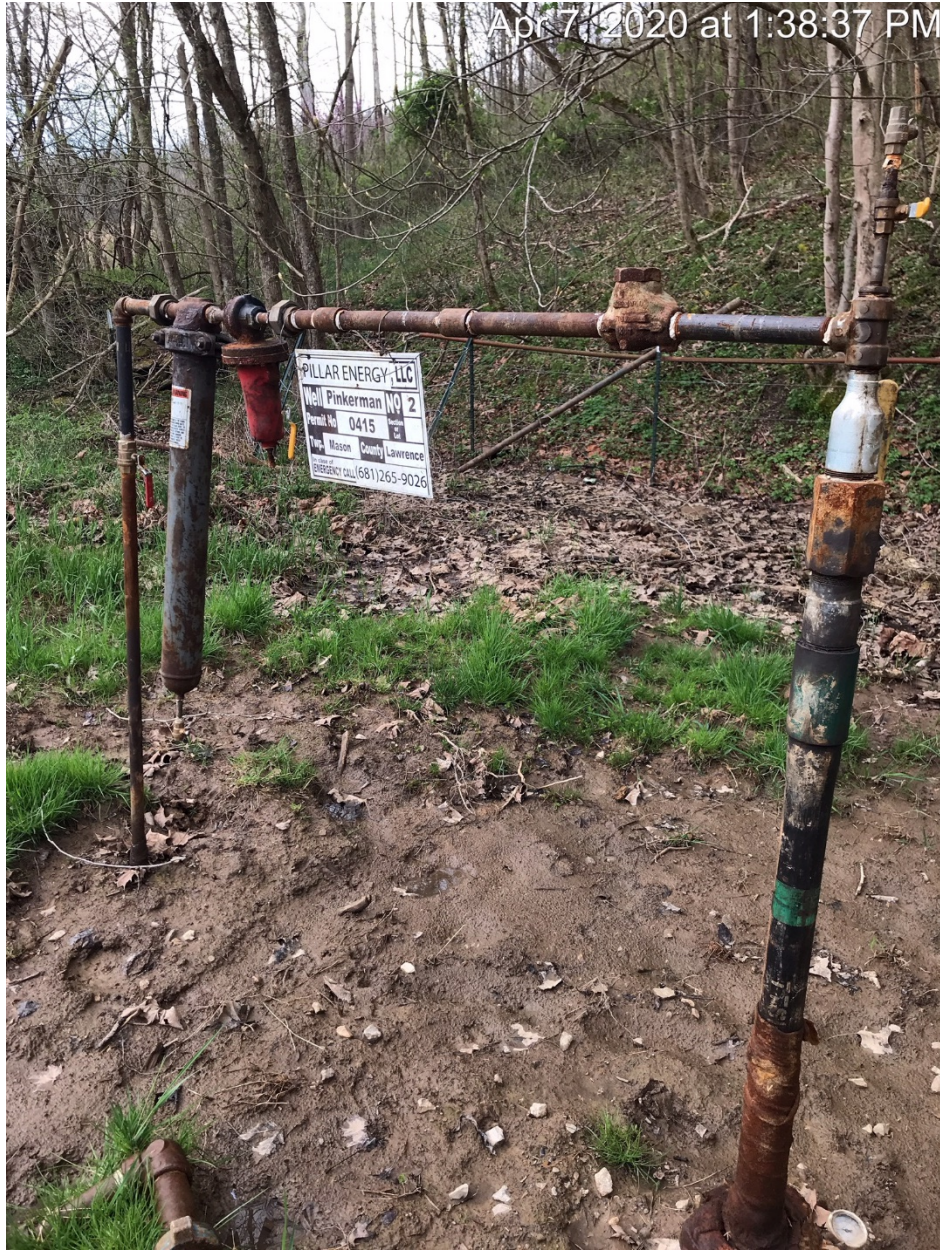
34-087-20415 Pinkerman # 2 ERP CN

4-7-20 Compliance Notice # 1536086906 follow up inspection. Contaminated soil has not been removed from the location. Flood debris was observed at the well site from a recent event. Pictures were taken of the scald area.
