**RE: Enforcement Referral for Adams Oil & Gas**

### **SUBJECT: PLUGGING REQUIRED**

Ohio Department of Natural Resources  
Division of Oil & Gas Resources Management  
Facility Report

34-163-20318, Adams Oil and Gas, Enhanced Recovery Injection Well. Chief's Order 2011-50 Follow up inspection Photos.

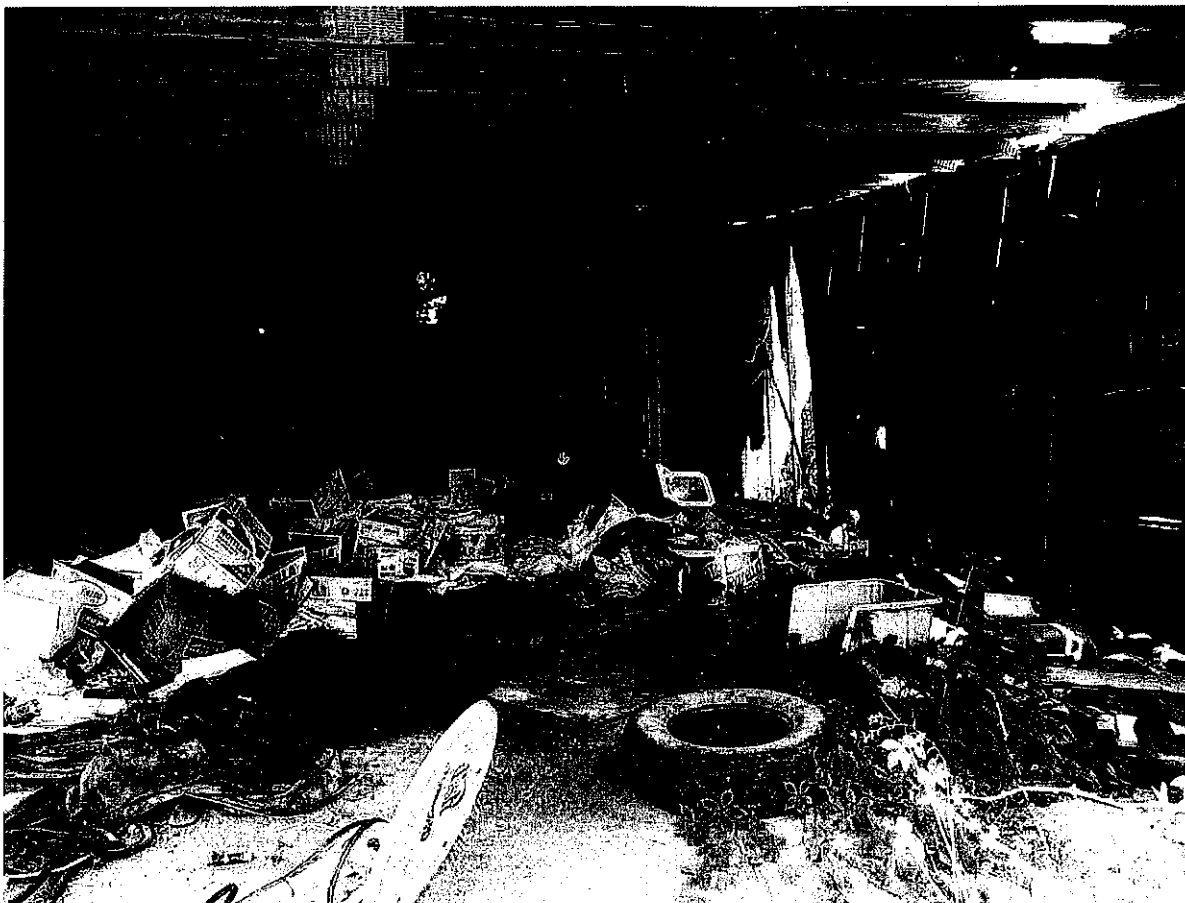
This Photo shows the inside of the facility pump house.

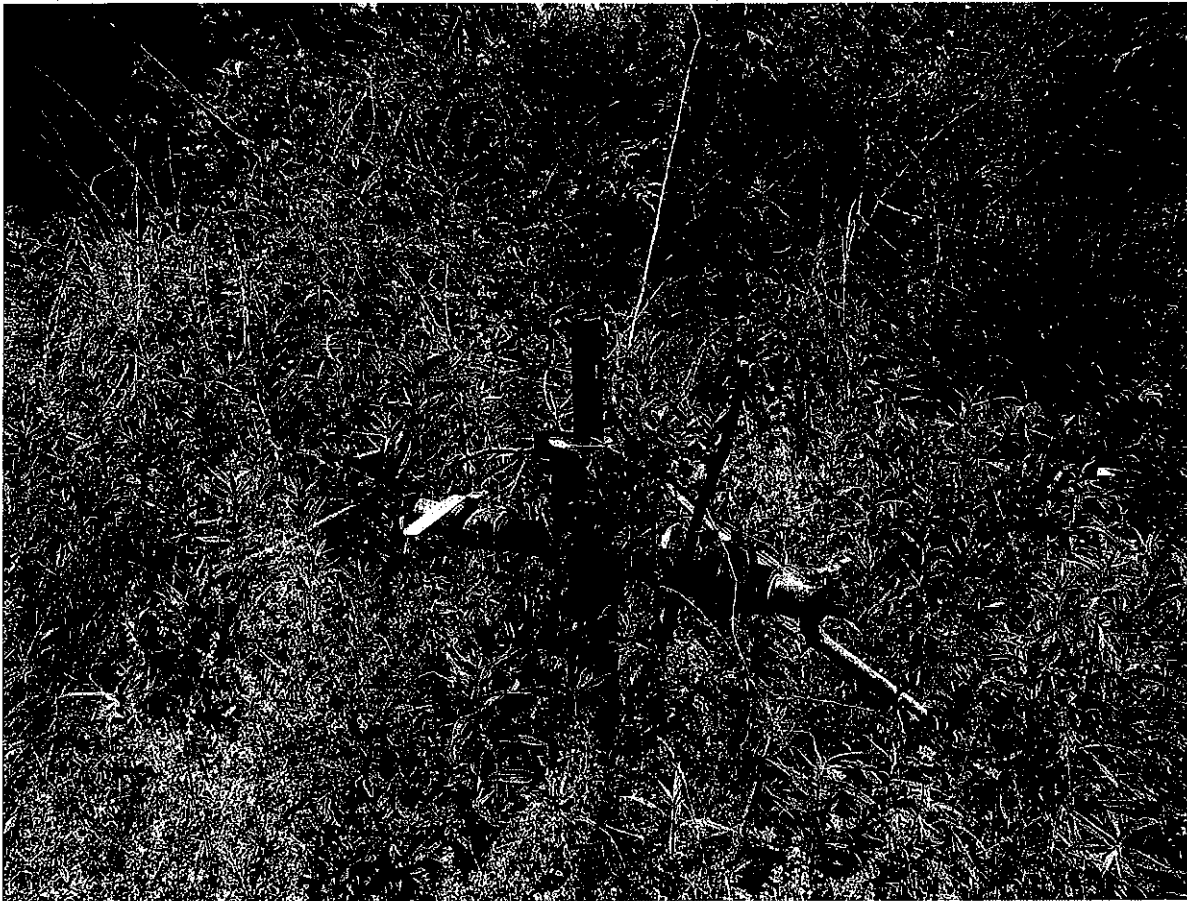
This photo shows the 34-163-20318 Enhanced Recovery Injection Well. Note the injection tubing is not equipped with a master valve. The annulus has zero pressure. The well is not connected to injection lines or equipment.

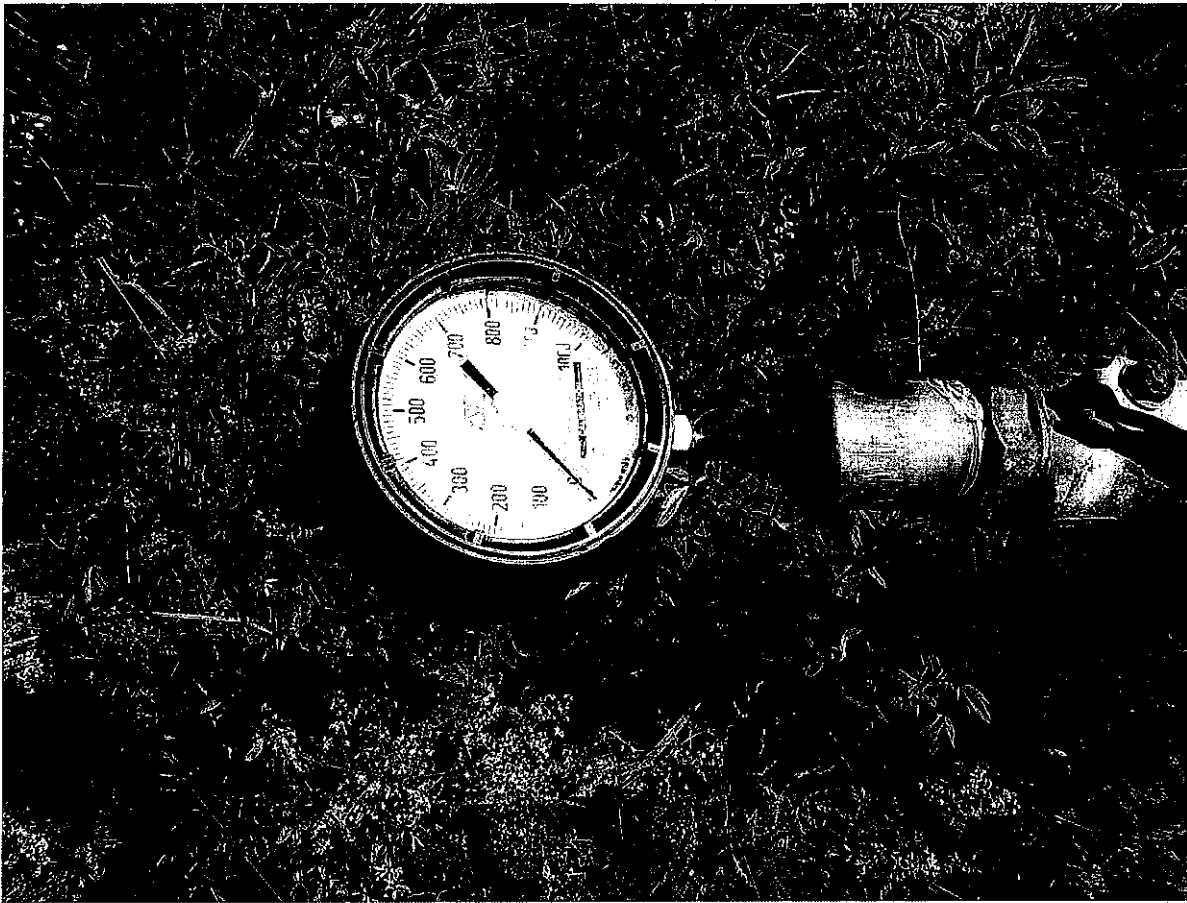
This photo shows the state issued 1000 psi gauge installed on the annulus with all valves open. Annulus has zero pressure.

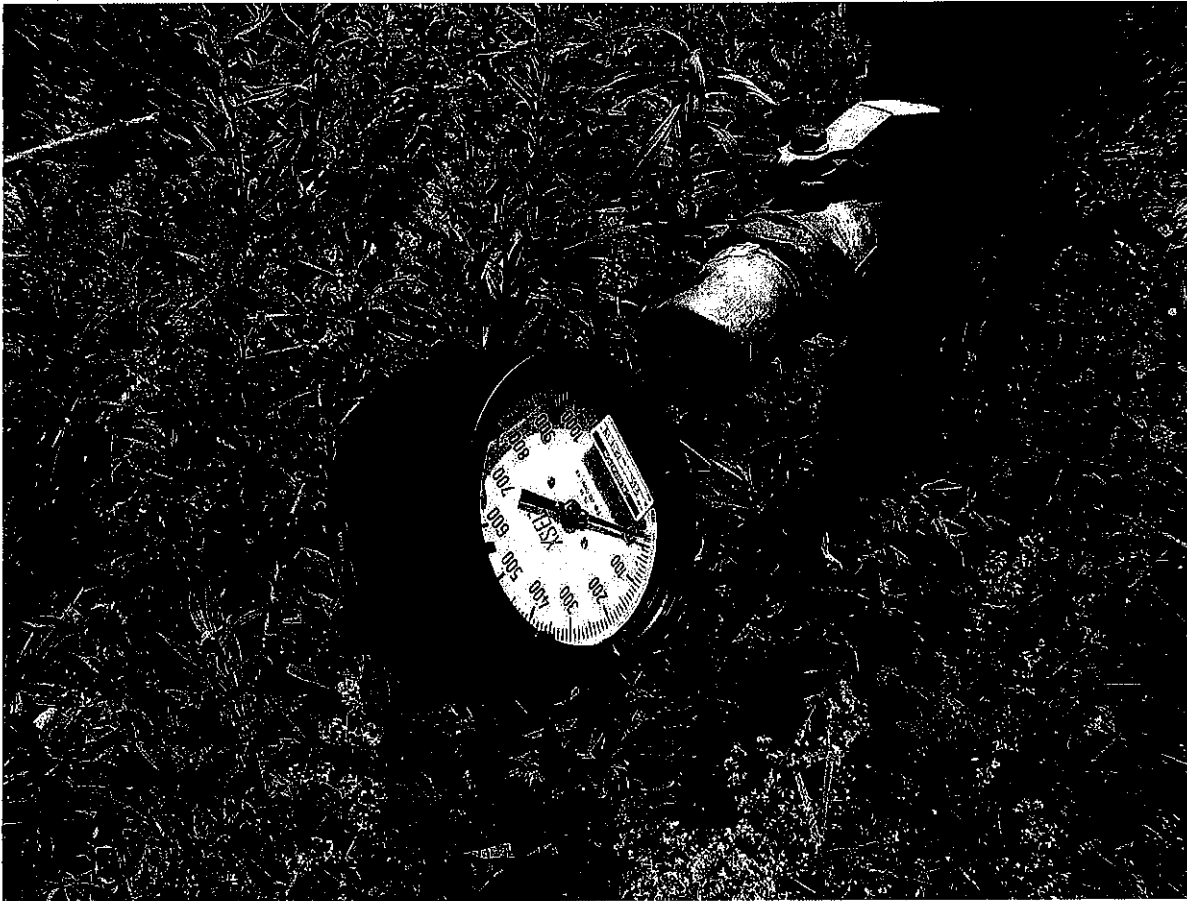
This photo shows another view of the state issued 1000 psi gauge installed on the annulus with all valves open. Annulus has zero pressure.

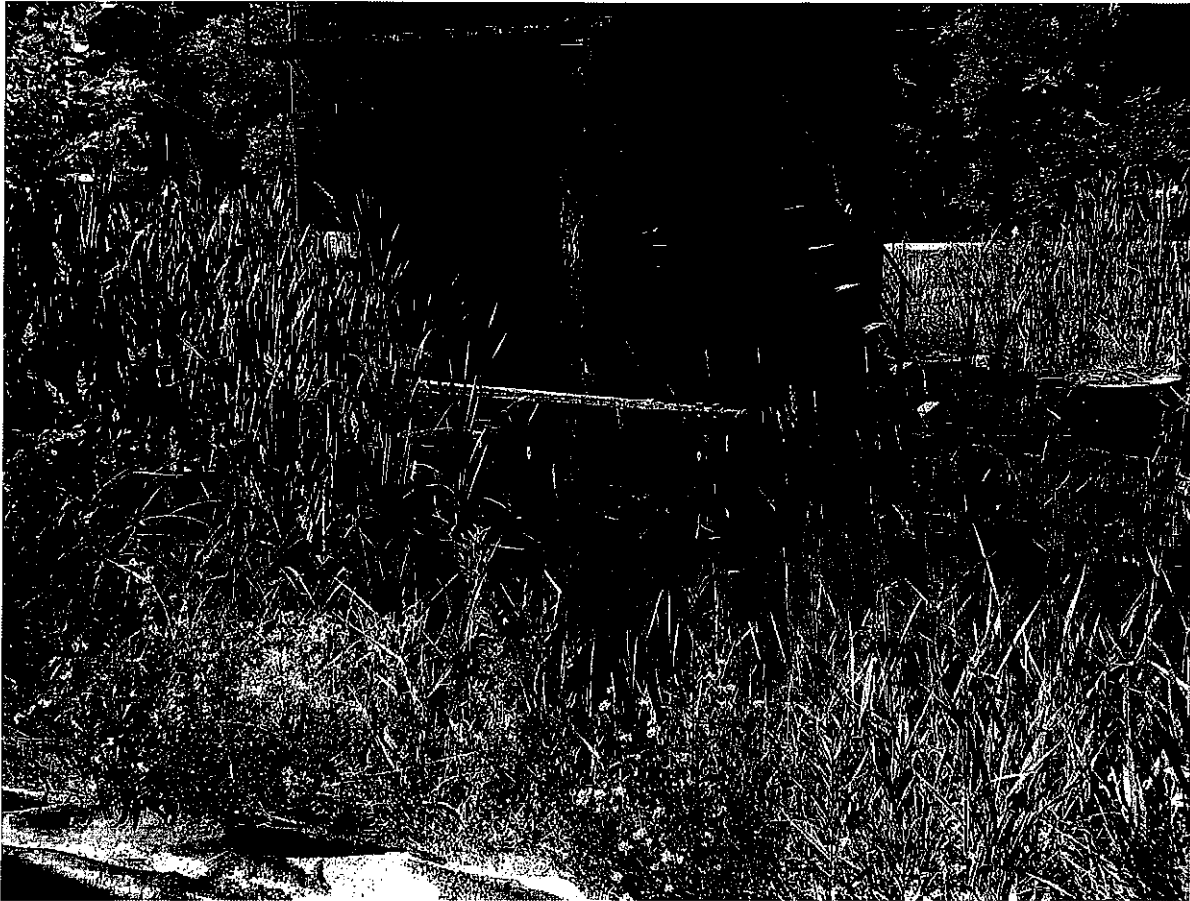
This photo shows the Containment dike with the two 210 barrel tanks. The dike is full of water and aquatic vegetation.
